A Summary of a NIOSH fire fighter fatality investigation

Volunteer Fire Fighter Died After Being Struck by an Eighteen-Wheel Tractor Trailer Truck - South Carolina

Fatality Assessment and Control Evaluation Investigative Report #99F-38

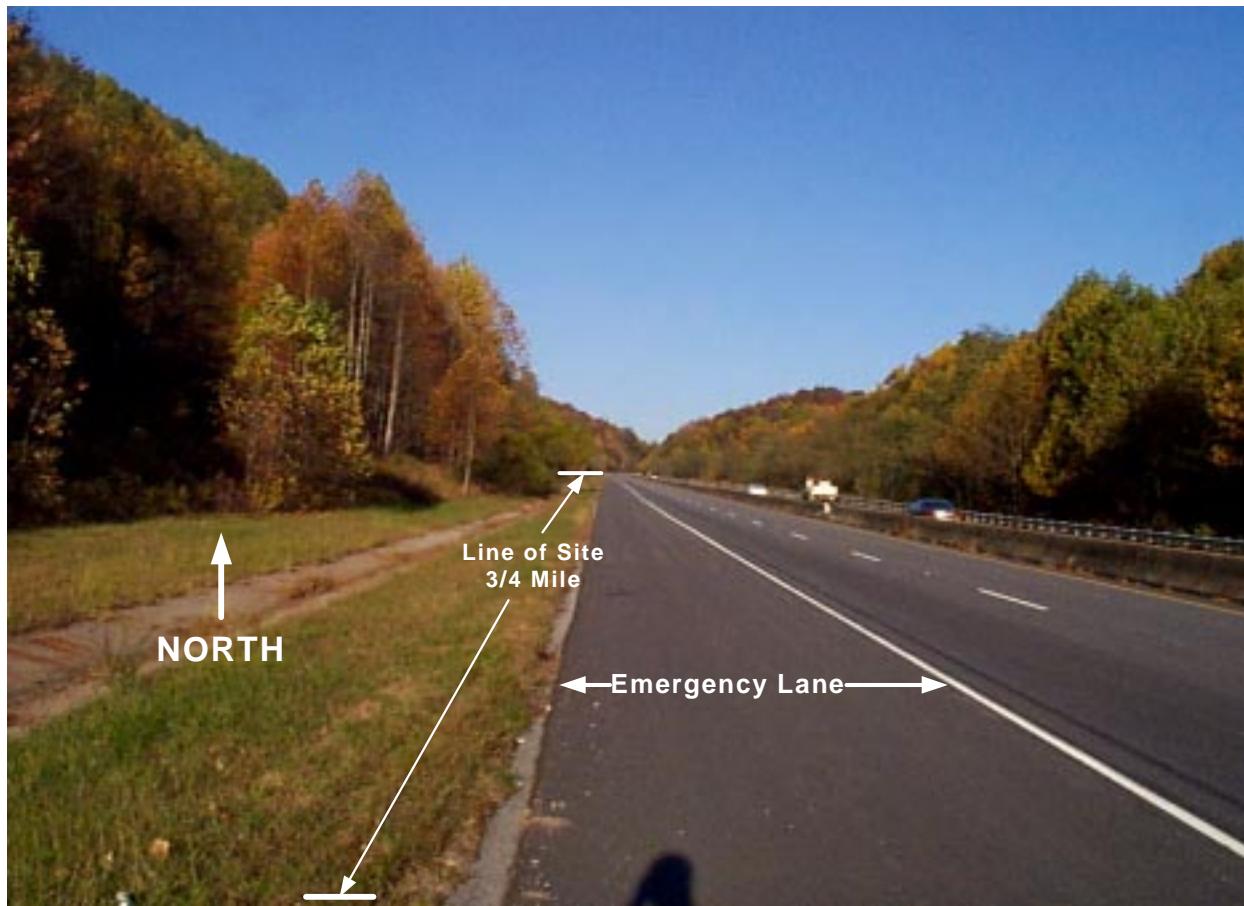
Figure 1. View Victim Had of Oncoming Traffic in Southbound Lanes

southbound lanes, facing oncoming traffic, to an area that provided the most visibility and warning to oncoming traffic (Figure 1). The emergency lights of R-205 were turned on at the time of the incident. It was customary for the victim to set up for traffic control in this location when responding to motor-vehicle wrecks occurring on this stretch of highway. The location of R-205 was $\frac{1}{2}$ mile north of the tractor trailer wreck and in the opposite lanes of the wreck (Diagram 1). Approximately 25 minutes after traffic control measures were established by the victim, the Lieutenant from Volunteer Fire Department #2 received a radio call from the victim who was checking to see if they had their rain gear on. Due to the heavy rainfall, the Lieutenant told the victim that they did have their rain gear on and that if he (the victim) was getting wet, to go ahead and sit in the truck (R-205). Approximately 5 minutes later, the sound of a truck applying its brakes caught the attention of the fire fighters from both departments and one highway patrol officer. They saw the tractor trailer, in the southbound lane, fish tailing and then coming to a complete stop. They recalled seeing the driver of that truck get out of his vehicle and walk around the truck as if he were looking for something that might be wrong with the truck. The driver then got back into his truck and drove away. (Note: the truck was later found and identified by the police as the vehicle that had struck R-205.) Approximately 2 minutes later, another truck driver heading southbound stopped and informed the fire fighters that he had passed a fire fighter who was lying on the ground in front of a fire truck. Fire fighters from both departments drove up to R-205 and found the victim lying face down, on his side, in front of R-205. The front of the apparatus, on the passenger's side, was severely damaged, indicating that both the fire fighter and the truck had been struck by a motor vehicle. The victim was wearing a brightly colored yellow rain suit (both pants and jacket) and a ball cap. He was not wearing an orange vest or any other type of retro-reflective material. A hand held

Discussion: When a fire company arrives on the scene of a highway emergency and there are no police to control traffic, fire fighters must first control the oncoming vehicles before safely turning their attention to the emergency. The fire department initially responding to the incident scene had set up traffic control measures in the northbound lanes but was unable to set up traffic control measures in the southbound lanes. The second fire department was called to provide assistance for traffic control and scene cleanup. R-205 had its emergency lights on at the time of the incident and the victim was using a “stop/slow” paddle. No other warning signals were being utilized for traffic control in the southbound lanes. The use of warning signals such as flares (taking into account flammable/combustible hazards), signs, cones, or flags is recommended, in addition to the operation of lights in blocking mode on the apparatus. It is recommended that warning signal devices be placed at a minimum of 350 feet behind the apparatus (further distance may be required taking into account speed limits above 45 mph, line of sight, visibility, road conditions, and weather conditions) and be positioned so they are visible to oncoming traffic for at least 350 feet beyond that. This placement allows the driver a minimum of 700 feet in which to stop a vehicle.

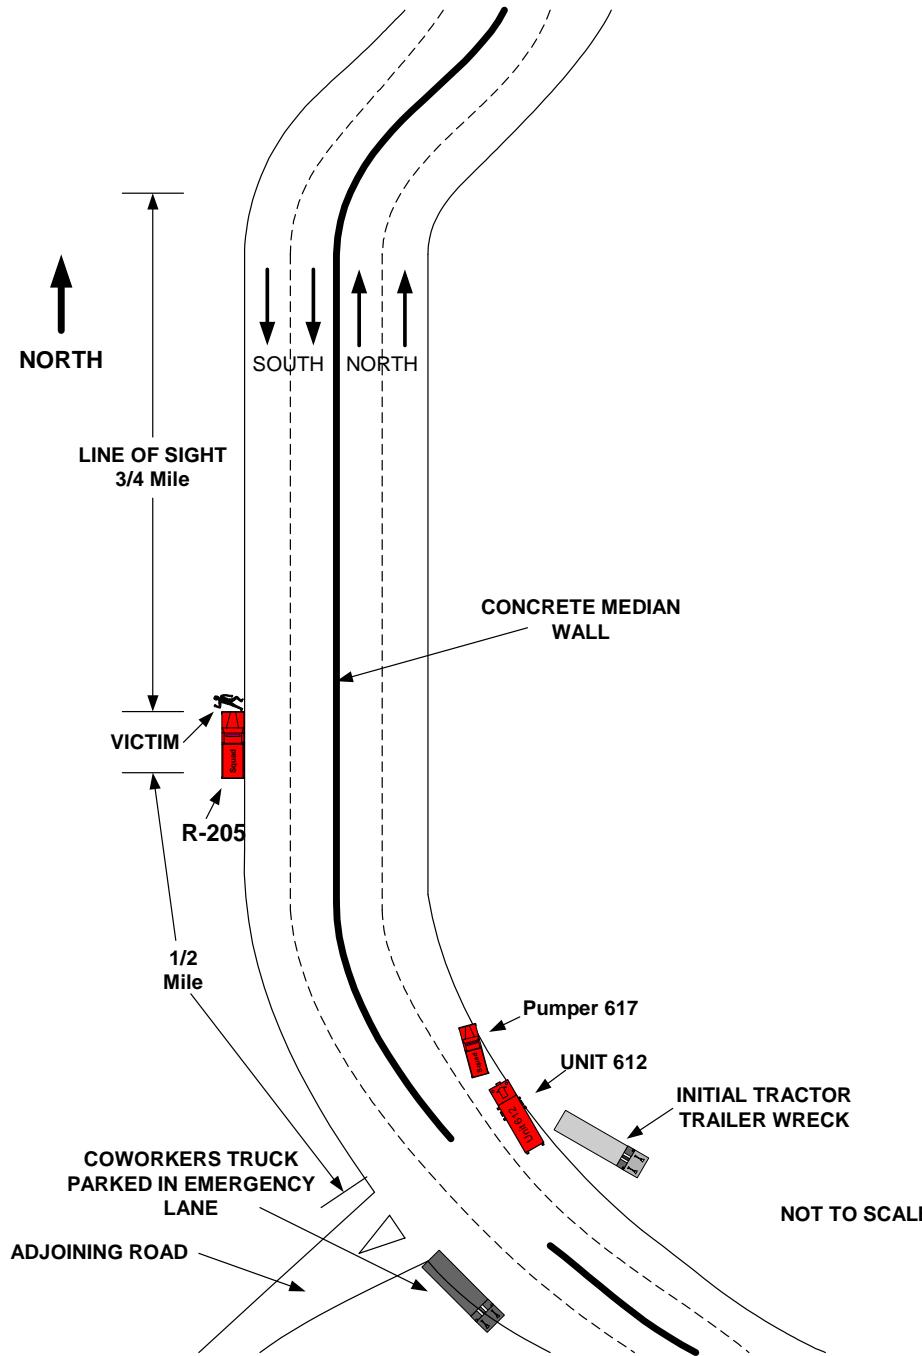
Diagram 1. Aerial View of Incident Scene

On September 27, 1999, at 1155 hours, a call came into Central Dispatch reporting a wreck involving a tractor trailer truck on a four-lane highway approximately 1-mile south of the North Carolina State line. The tractor trailer was heading southbound during a heavy rainstorm when the driver swerved to miss a deer, causing the truck to travel

across the northbound lanes and over an embankment (Diagram 1). The driver of the wrecked tractor trailer was being followed by a coworker/driver in another tractor trailer when the incident occurred. The second truck stopped and parked in the emergency lane of the southbound lanes (directly across from the initial wreck) after seeing his coworker's truck go over the embankment. The units responding from Volunteer Fire Department #1 at 1200 hours included the following: Pumper 617 with two fire fighters, Pumper 612 with two fire fighters, and an Assistant Chief on Pumper 622. Pumper 617 was the first on scene with one of the fire fighters assuming Incident Command (IC). The IC released Emergency Medical Service (EMS) from the scene at 1214 hours after it was determined that the driver of the tractor trailer was not injured. Pumpers 612 and 622 were en route at this time. The IC had Volunteer Fire Department #2 toned out to provide backup assistance and traffic control for the southbound lanes while the IC's fire fighters were busy spraying spilled diesel fuel off the road and conducting traffic control in the northbound lanes. At approximately 1220 hours, fire fighters from Volunteer Fire Department #2 arrived in privately owned vehicles (POVs), and the victim arrived in Rescue Unit 205 (R-205). The driver (victim) of R-205 was directed to provide traffic control assistance in the southbound lanes. (Note: Traffic control was needed in the southbound lanes because the tractor trailer truck was still parked in the emergency lane, partially blocking the outer southbound lane, directly across from the initial wreck.) This stretch of road has had frequent wrecks partly due to bad weather conditions, the steep grade (6%), and the curves that occur along this 1-mile stretch of road. The South Carolina Department of Public Safety reports that this 1-mile stretch of road had a total of 39 collisions resulting in 25 persons injured and 1 fatality between the years 1994 and 1999 (1999 figures are preliminary). The victim then drove R-205 northbound on the outer emergency lane of the

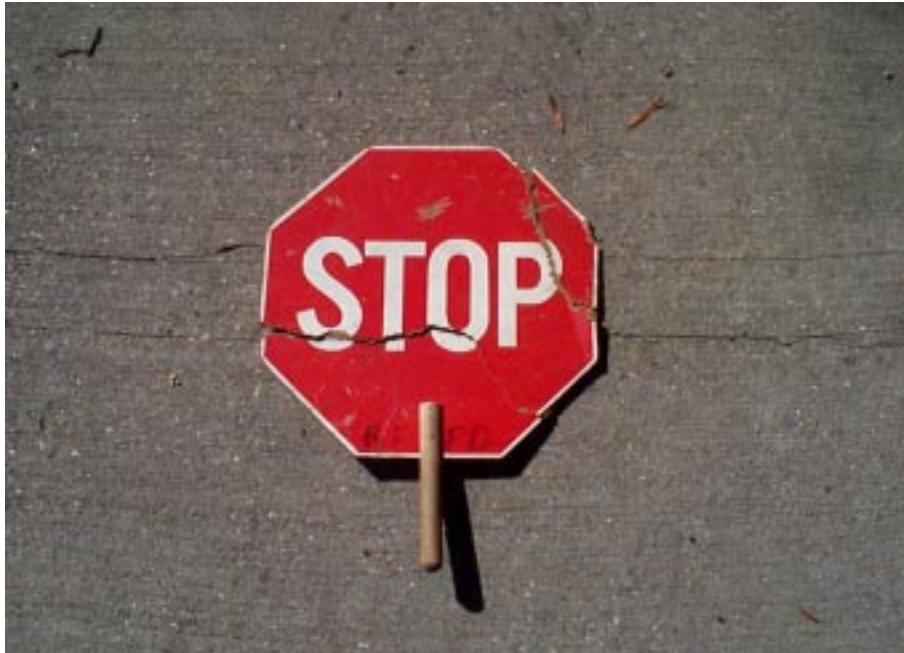
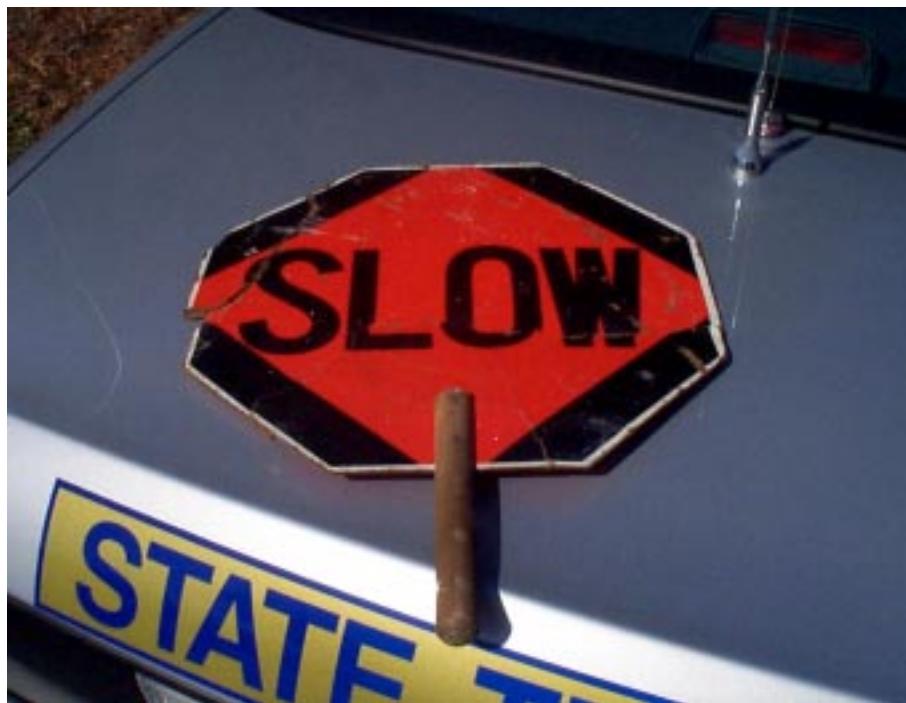
Figure 2. Traffic Control Sign Used by Victim (Width of Sign Is 20 Inches)

“stop/slow” traffic control sign (see Figure 2) was found on the ground near the victim, and it was broken into several pieces. Law enforcement called for an ambulance at 1257 hours. An EMT from fire department #1 turned the victim over and saw that he had massive head injuries and a flailed chest, and that he was belly breathing. The EMT inserted an airway with no resistance and began administering basic life support. An ambulance arrived on scene at 1314 hours and transported the victim to the regional hospital at 1317 hours. Time of arrival at the hospital was 1348 hours. The victim was later pronounced dead at the hospital.

Discussion: The stop/slow paddle used by the victim is a standard paddle (Figure 2). Other devices such as a flashing stop/slow paddle have been used at temporary work zones on roads and found to be highly effective. Such devices increase the flagger's ability to get the drivers' attention. The paddle has high-intensity lamps mounted on the sign that can be

Recommendation #5: Ensure that personnel conducting traffic control measures use a highly visible stop/slow paddle.⁵
