## **Two Fire Fighters Injured When an Automated External Defibrillator Battery Exploded or Ruptured During Testing - Florida**

## Fatality Assessment and Control Evaluation Investigative Report #99F-39

### ***Two Fire Fighters Injured When an Automated External Defibrillator Battery Exploded or Ruptured During Testing - Florida***

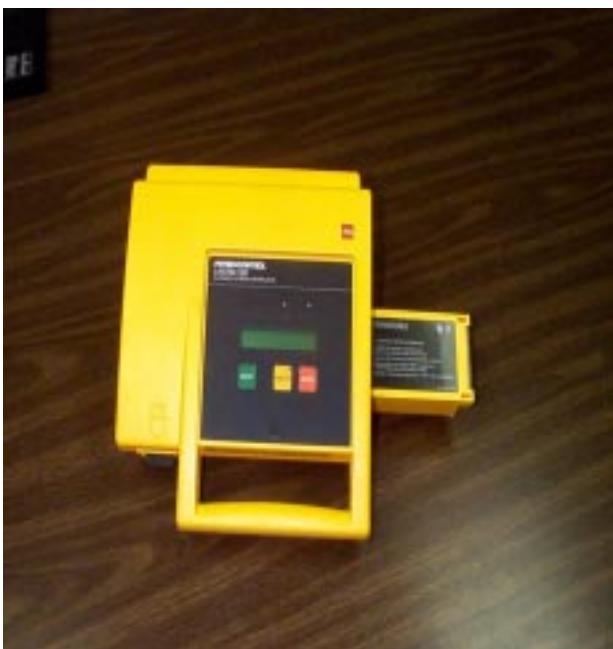
*AED with Battery*

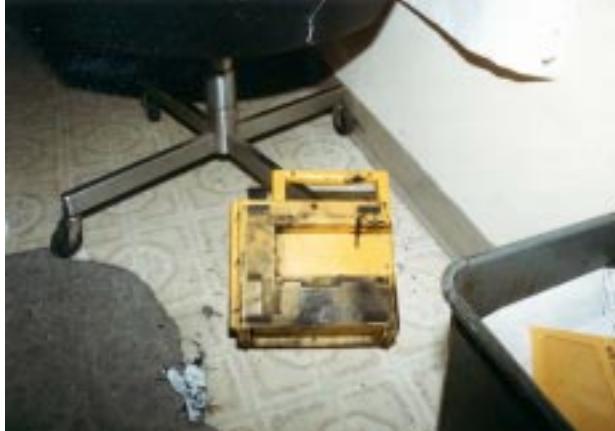
battery rupture occurred. The explosion or battery rupture blew out the back of the AED (see photo #2), and it was reported by the Assistant Chief and Captain that the concussion blew the Assistant Chief out the office door onto the floor and blew the Captain against the office wall. The office was filled with white acrid smoke which made breathing difficult. The Assistant Chief reported that he received flash burns to the left arm, a sprained left wrist, and an injured back, and the Captain reported that he suffered upper respiratory inflammation from the acrid smoke. Both fire fighters were transported to a local hospital, treated, and released.

According to the State Fire Marshal's report and interviews that were conducted, the lithium battery pack, which is located in the rear of the unit, either exploded or ruptured. The explosion or rupture blew the rear of the unit apart and sent pieces flying throughout the room. The explosion or rupture projected the AED in an upward trajectory.

***Photo 2. AED after Explosion or Rupture***

***Recommendation #1: Fire departments, emergency medical services, and other users of AEDs should follow the manufacturers instructions to replace battery packs immediately when the unit indicates a low battery or replace battery message.***

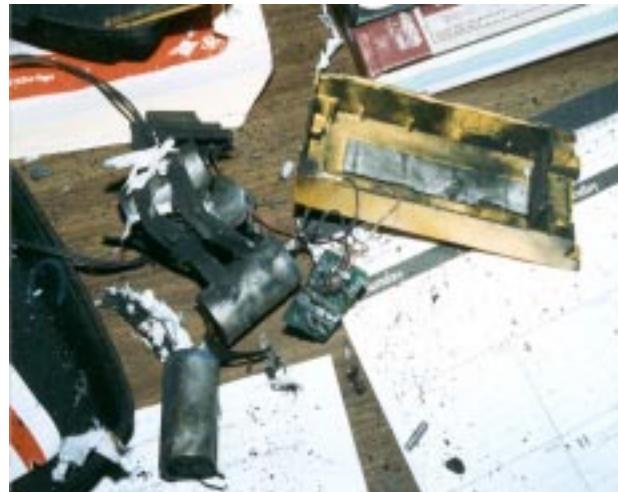
***Photo 3. Battery Pack after Explosion or Rupture***
