NIOSH
Fire Fighter Fatality Investigation
and Prevention Program

A Summary of a NIOSH fire fighter fatality investigation

Six Career Fire Fighters Killed in Cold-Storage and Warehouse Building Fire - Massachusetts

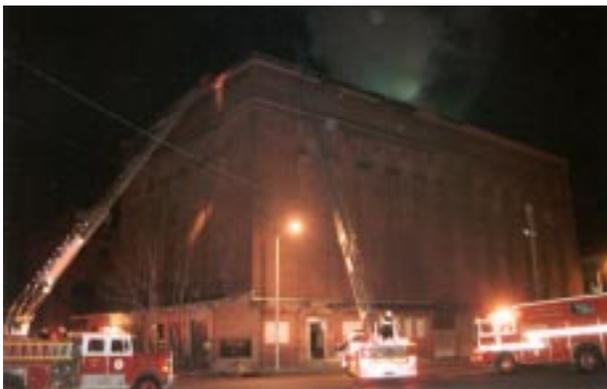
Cold Storage and Warehouse Building Shortly After First Alarm - 1825 Hours

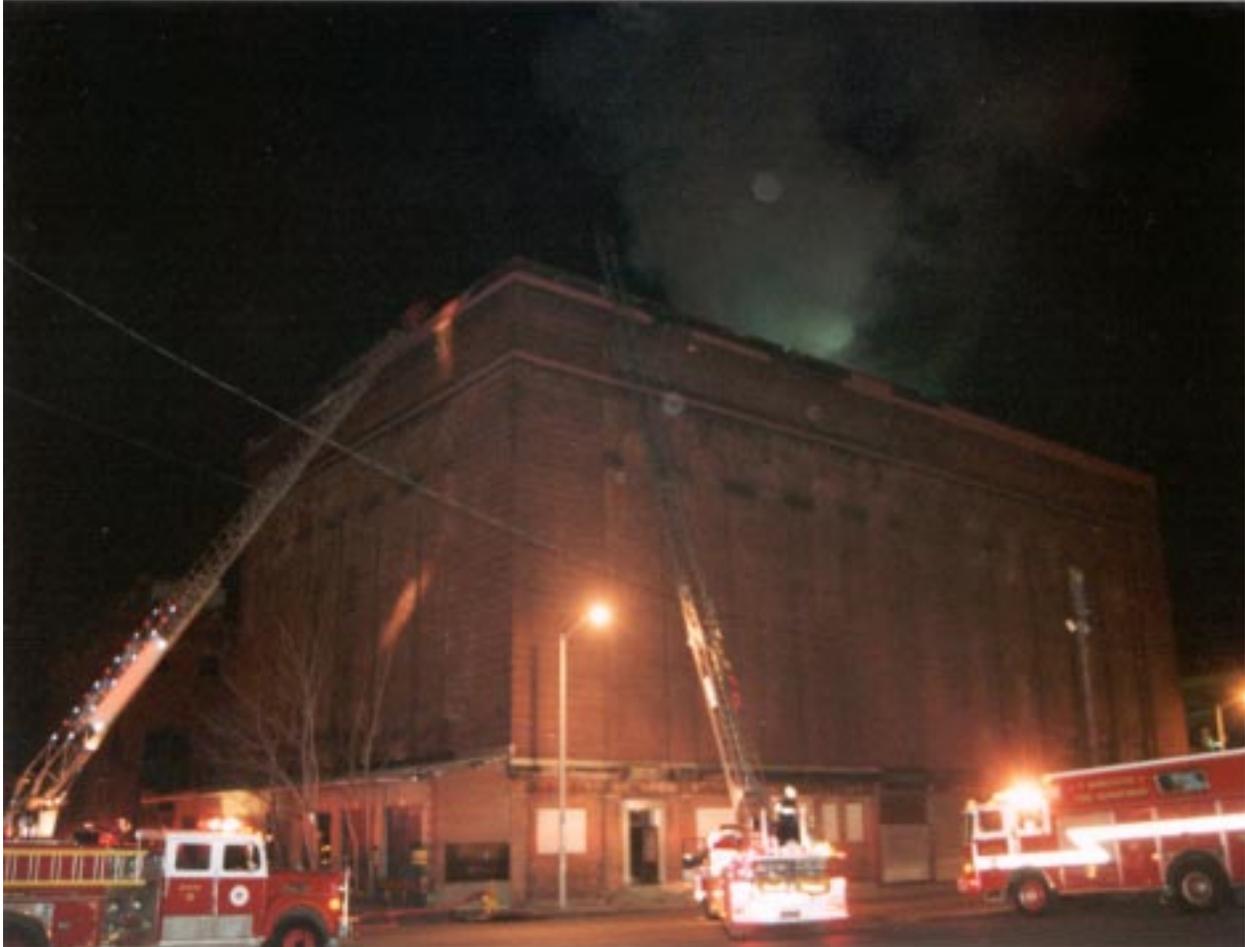
Photo 4. Cold-Storage and Warehouse Building Shortly After First Alarm - 1825 Hours

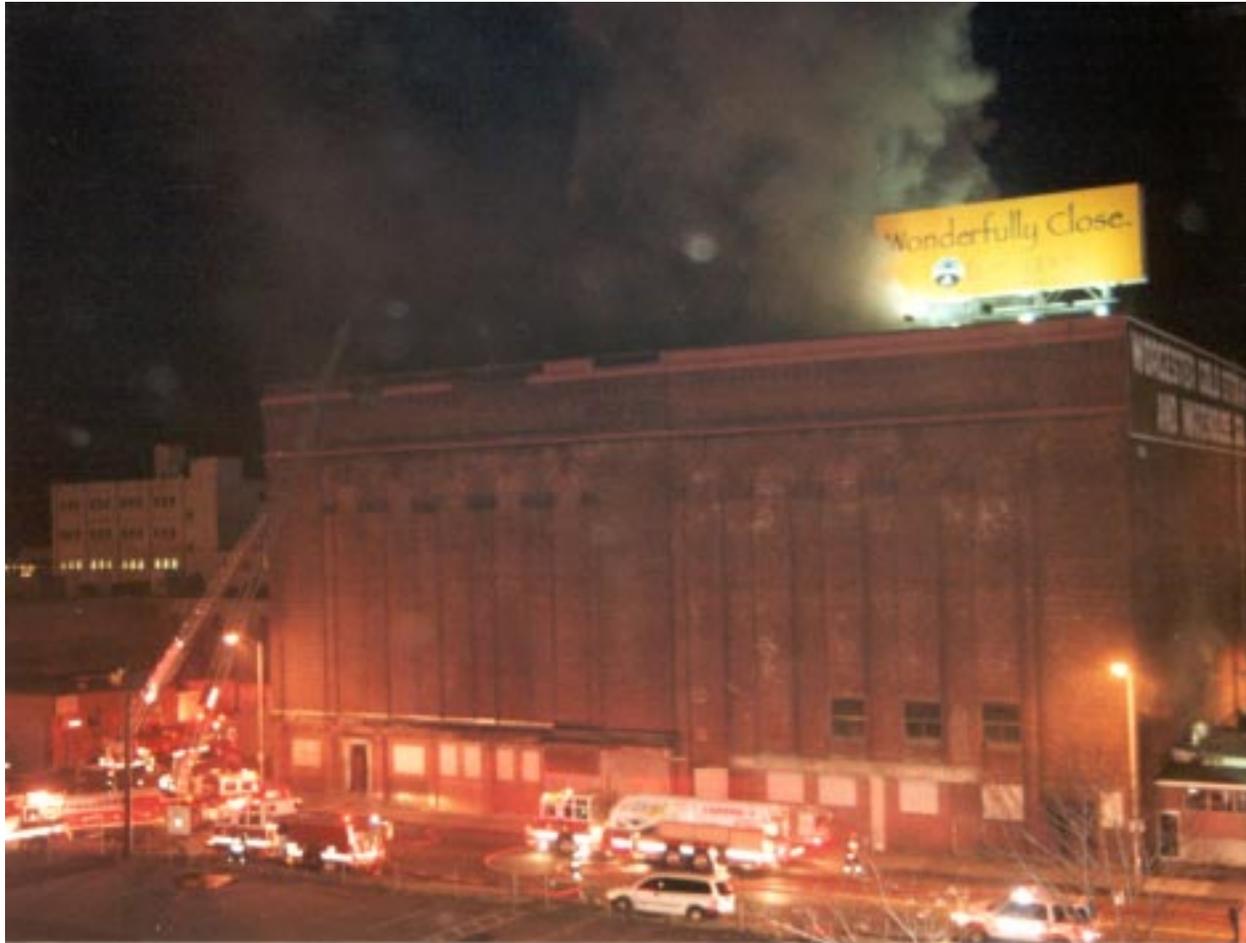
Photo 7. Cold-Storage and Warehouse Building After Third Alarm - 1842 Hours

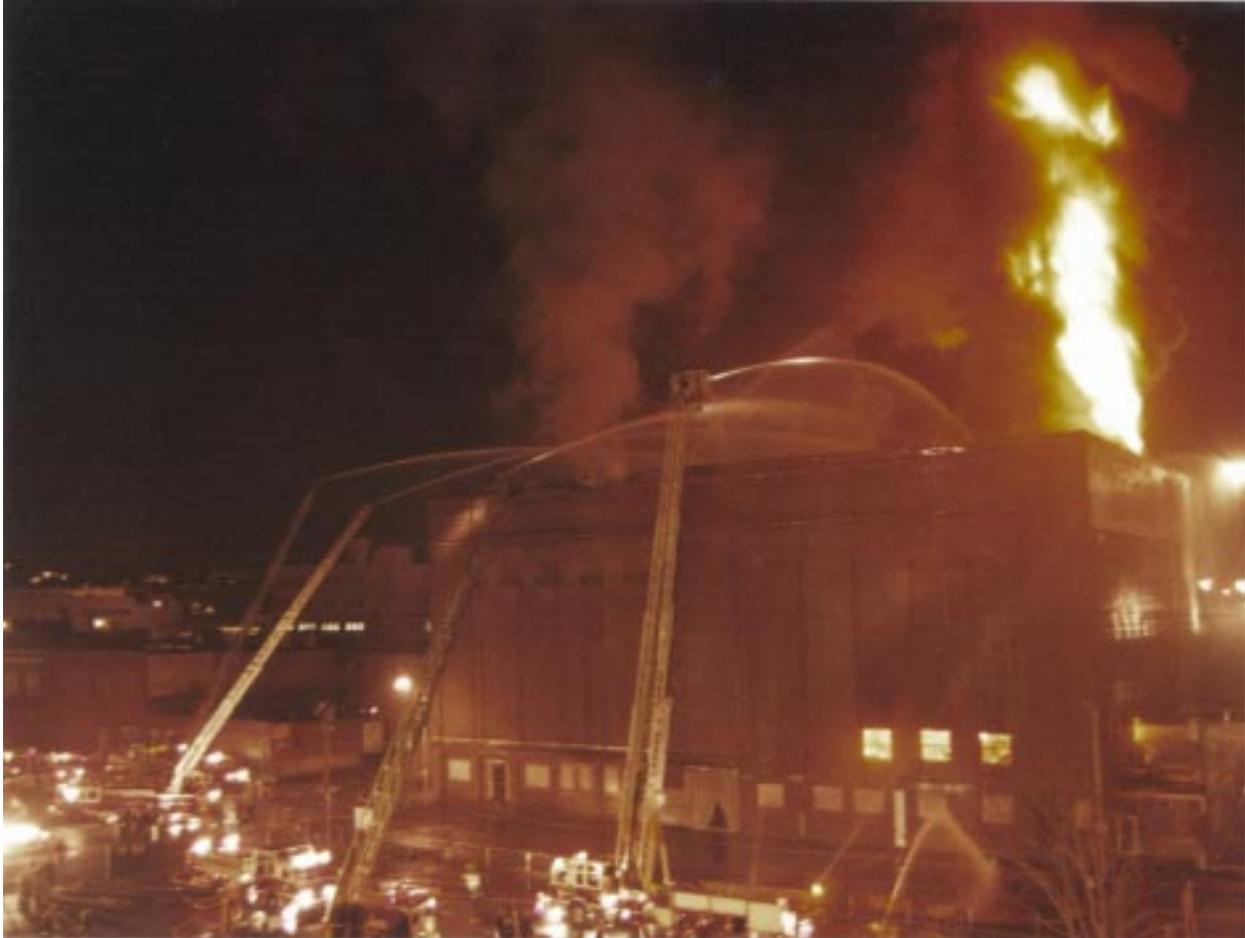
Photo 8. Cold-Storage and Warehouse Building at 2030 Hours
