Warehouse Fire Claims the Life of a Battalion Chief - Missouri

SUMMARY

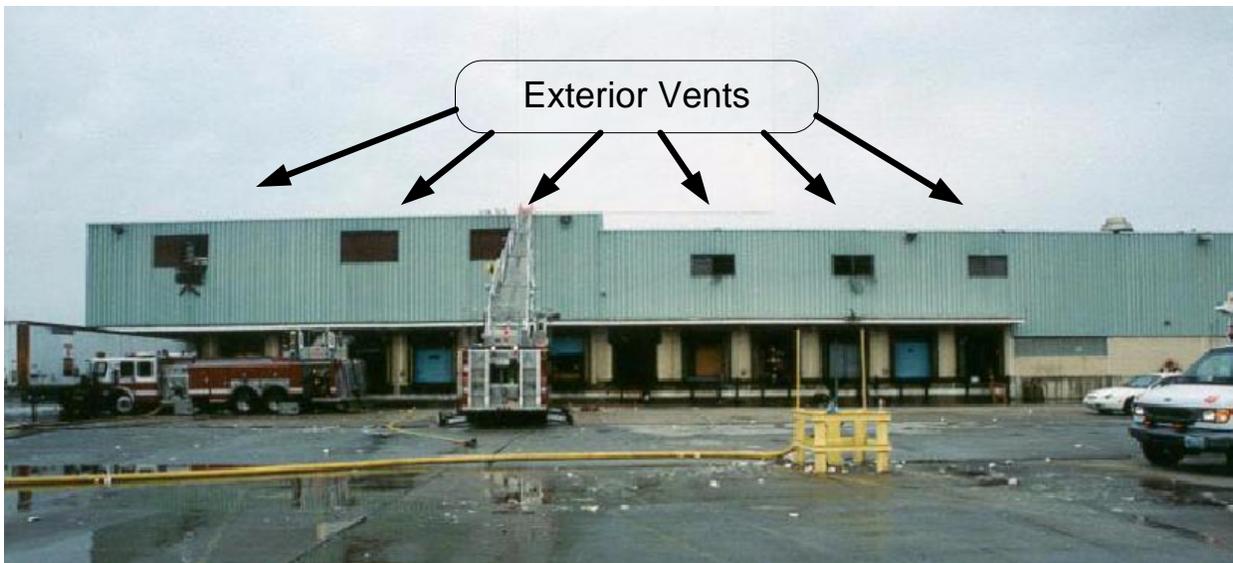
Photo 1. Exterior View of the Warehouse From the East Side.

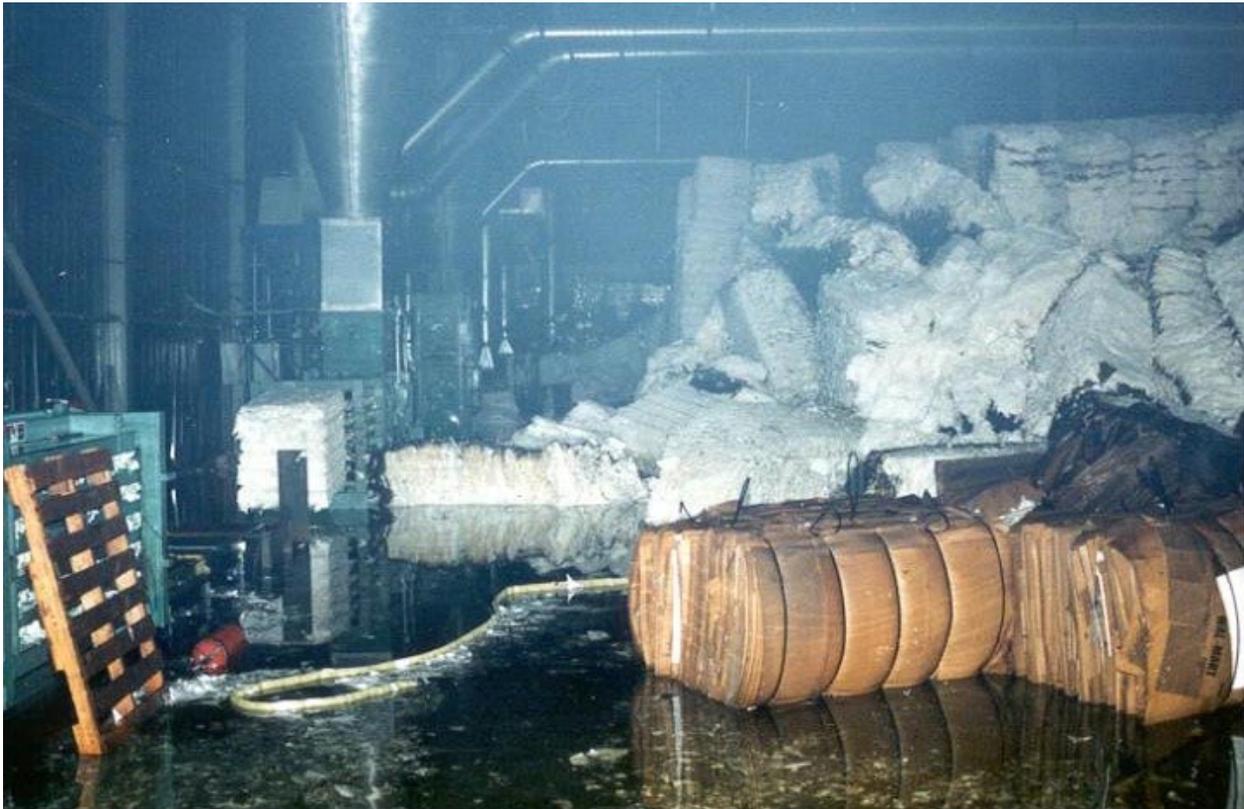
Photo 2. Paper Bales Which Caught Fire; Area Where Fire Fighters Entered Through the South-End Door With Hoselines.

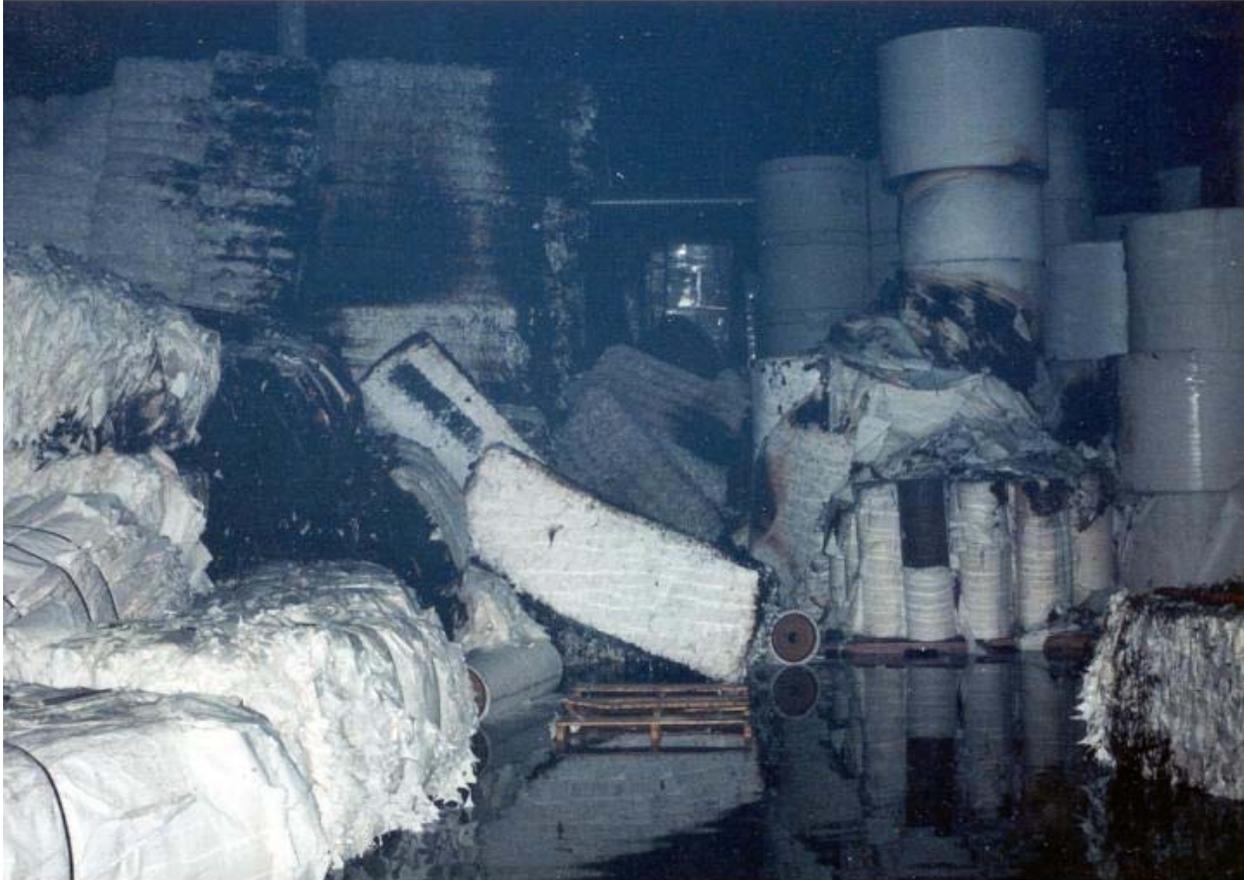
Photo 3. Area Where Victim Was Positioned Before He Became Disoriented.

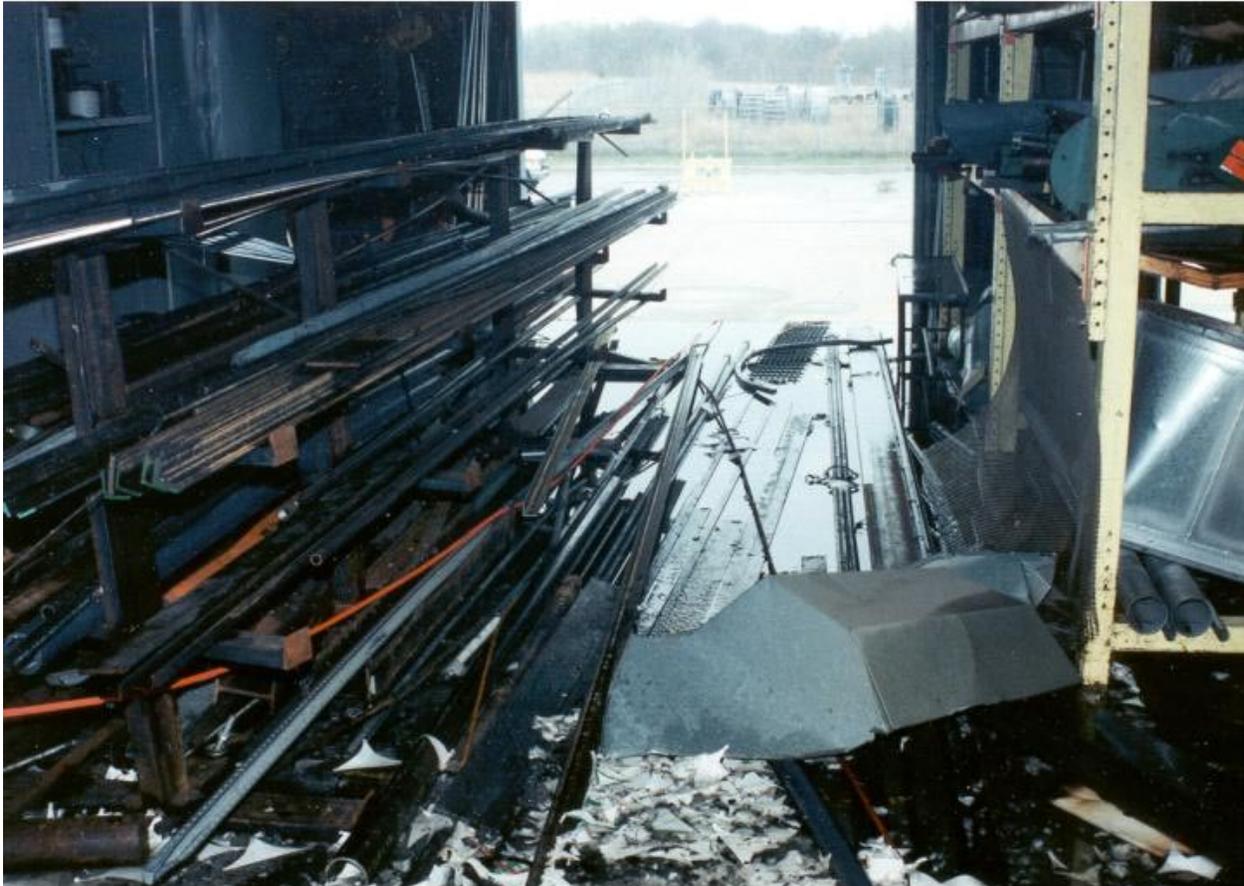
Photo 4. Dock Door Which Some of the RIT Members Entered.

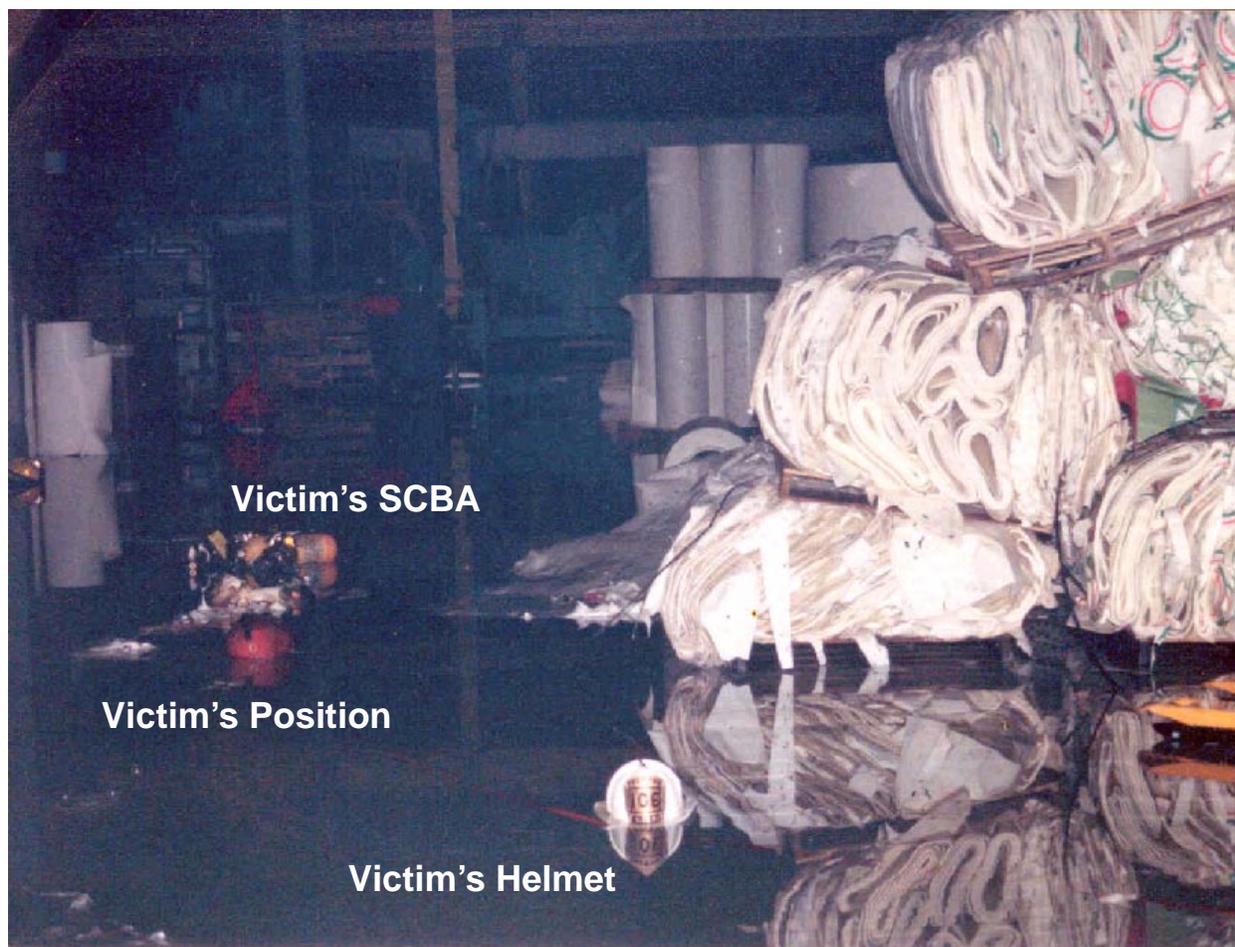
The victim's helmet was found on the floor in an area where he was operating throughout the fire attack. His SCBA was found approximately 10 feet away from him. He was found equipped with a PASS device, but it was not turned on. *Note: The victim's SCBA cylinder was sent to NIOSH for further testing. The test concluded that the cylinder was empty of breathable air but contained a substantial amount of water (see Attachment 1).*

Photo 5. Area Where Victim Was Found

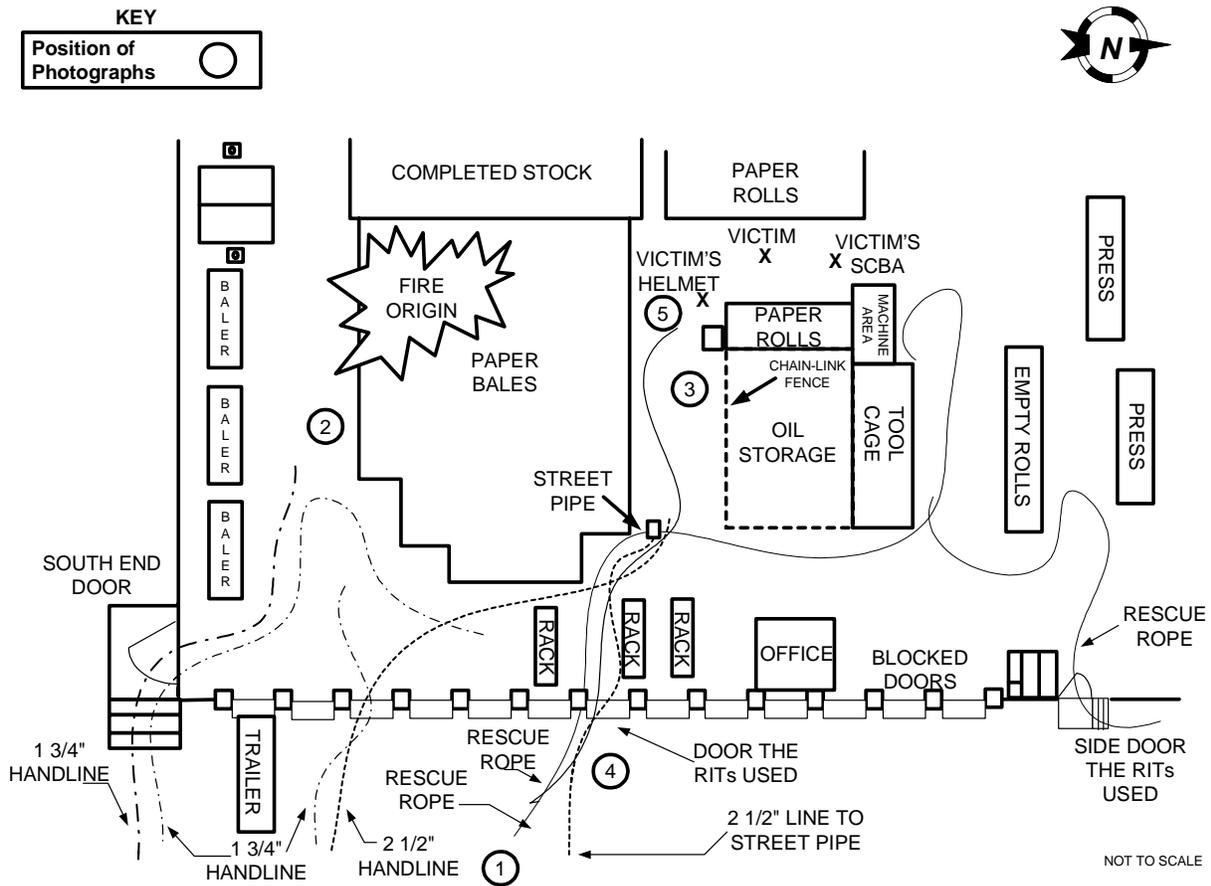
Diagram 1. Warehouse Interior

The origin of the fire was determined to be in the paper bale section of the building (see Diagram 1). This section of the building had no windows. There were six exterior vents in this section, all located at the ceiling level (see Photo 1). There were 13 dock doors located in this section, and one standard door was located on the south side. The ventilation system was not in operation when the fire occurred. The structure was equipped with a sprinkler system.
