LINE OF DUTY  
DEATH REPORT

REPORT F2023-03 • January 2026

***Career Firefighter Dies While Trapped during Overpressure Events in a Mixed-Use Structure – New York*****Executive Summary**

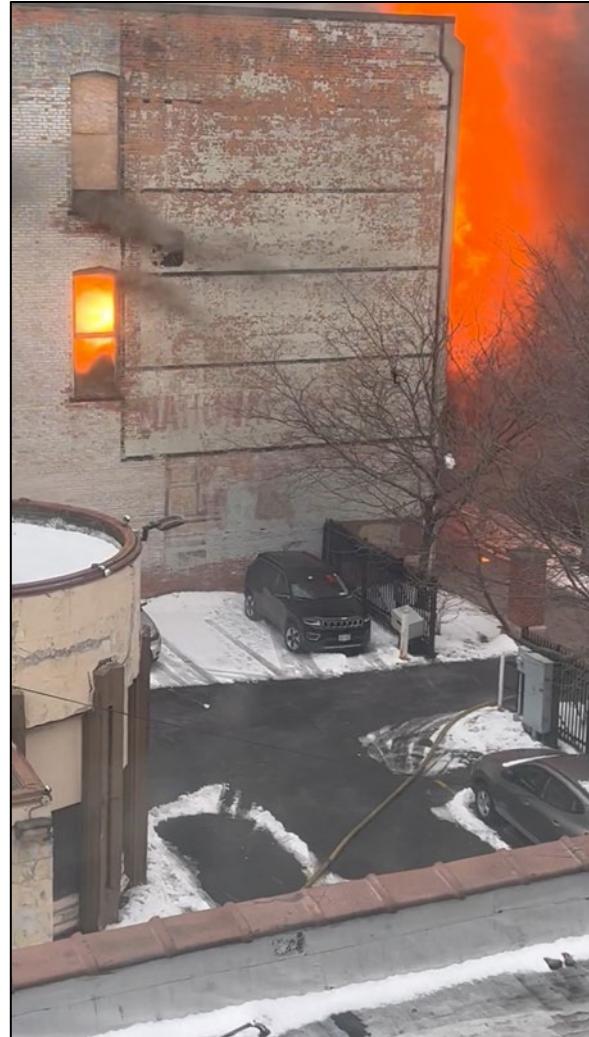
**Photo 1: View of Side Bravo during an overpressure event showing flames exiting Side Alpha.**

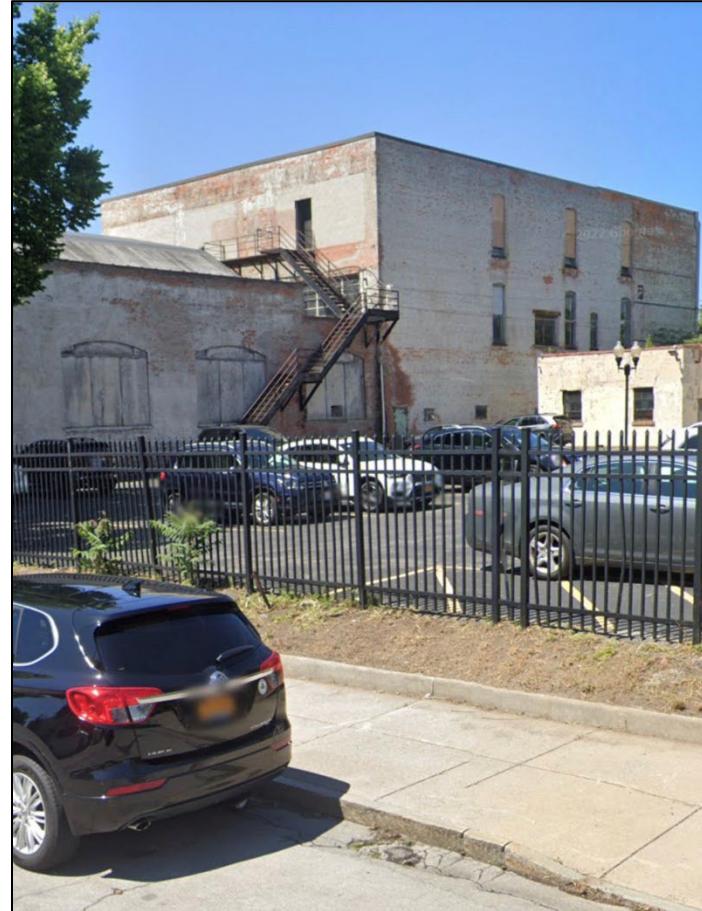
This incident involved a building constructed pre-1900 that was comprised of two portions: the front portion was a three-story mixed-use type III construction with masonry exterior walls and basement, and the rear portion originally a dance hall with a partial bow-string roof (see photo 2). The front portion was approximately 19,800 square feet equally divided between the three stories (see Photo 3). The front portion of the building was a typical mixed-use “main street” type III construction with masonry exterior walls and a basement. It contained 3 first floor storefront spaces each with stairway access to the basement. The second and third floors were office spaces. A costume fabrication and sales business specializing in theater productions occupied one storefront for several decades. Over time, the business expanded into the center storefront, opening the wall between the storefronts and placing a wall separating the basement from the third storefront access. The business used the basement area for fabrication and included equipment such as irons, cutting tables, heat presses, etc. The basement was accessed from inside of the costume business by a stairwell about 10 ft wide located about 40 ft inside the Side Alpha door.

The rear portion of the building was a one story, bow roof construction open space building. The rear portion was originally used as a dance hall, then later was used for storage. At the time of this incident, the costume business was the only occupant, and the unoccupied areas were emptied of all contents. Side Bravo of the building included a gated and fenced parking area that was accessible only with remote access (electronic key).

**Photo 2: View from the rear of Side Bravo showing the front and rear portions of the building. (Photo provided by fire department)**

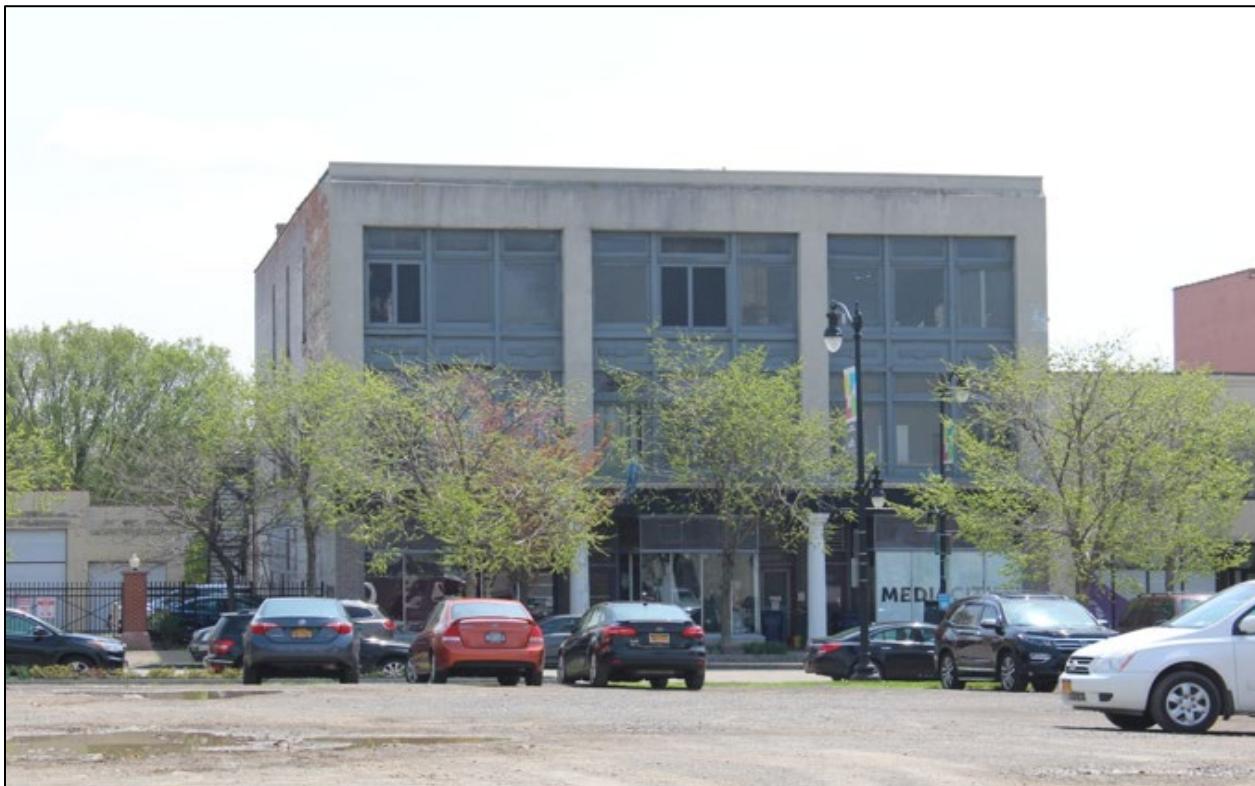
**Photo 3: Pre-fire view of Side Alpha of the fire building with the secured parking lot on Side Bravo. (Photo provided by the fire department)**

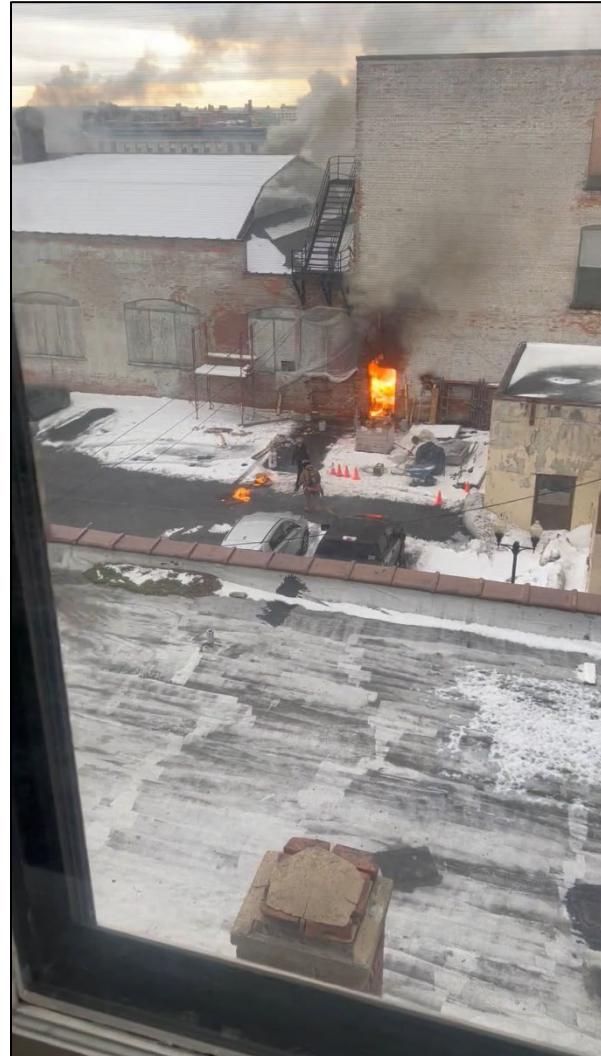
**Photo 4: View of the area of fire origin on Side Bravo. (Photo provided by fire department)**

The ATF cause and origin investigation determined that the fire started on Side Bravo and was classified as accidental. The fire was believed to be started by the application of an open flame via a propane torch to melt ice.

In this incident, the fire originated at the exterior door on Side Bravo of the costume business. The business had a heavy fire load of costumes, masks, props, and other items used in theater productions made with a variety of materials. Clothing racks were noted to be stacked to the ceiling throughout the first floor. This contributed to the intensity and rapid growth of the fire. The condition of the building also impacted fire spread. Prior to the fire, the flooring on floors two and three were in poor condition and included holes. There was a large opening on the first-floor ceiling to the second floor near the originating point of the fire. Windows on the upper floors were partially replaced with plywood and

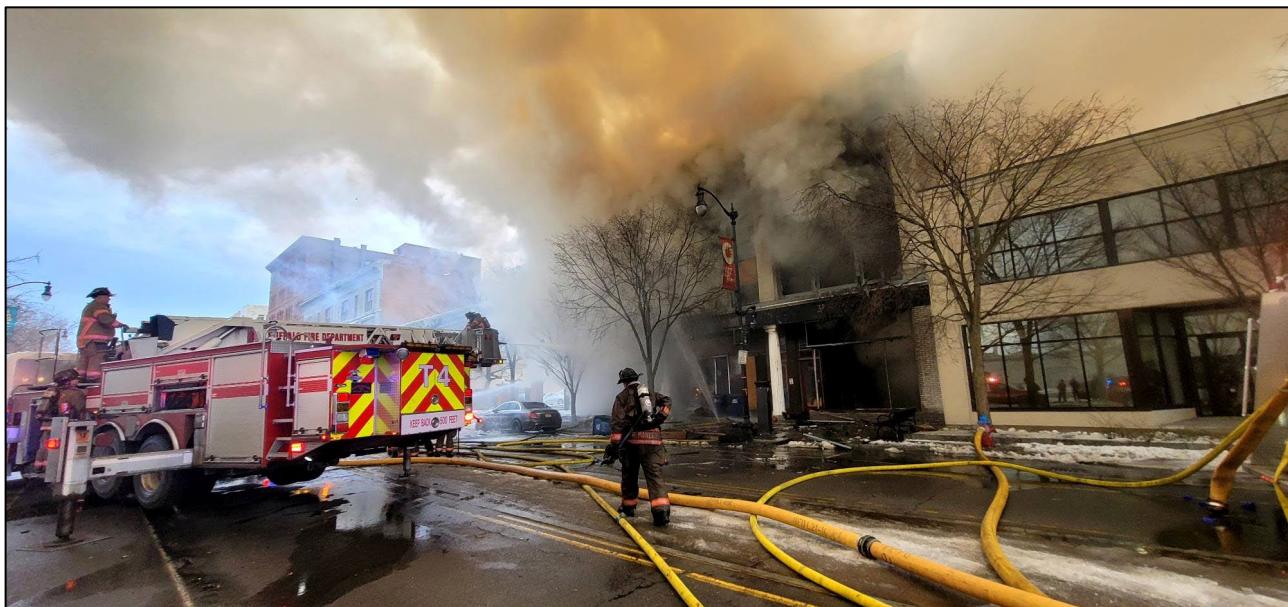
**Photo 5: View of Side Alpha operations post-OPE. (Photo by fire department)**

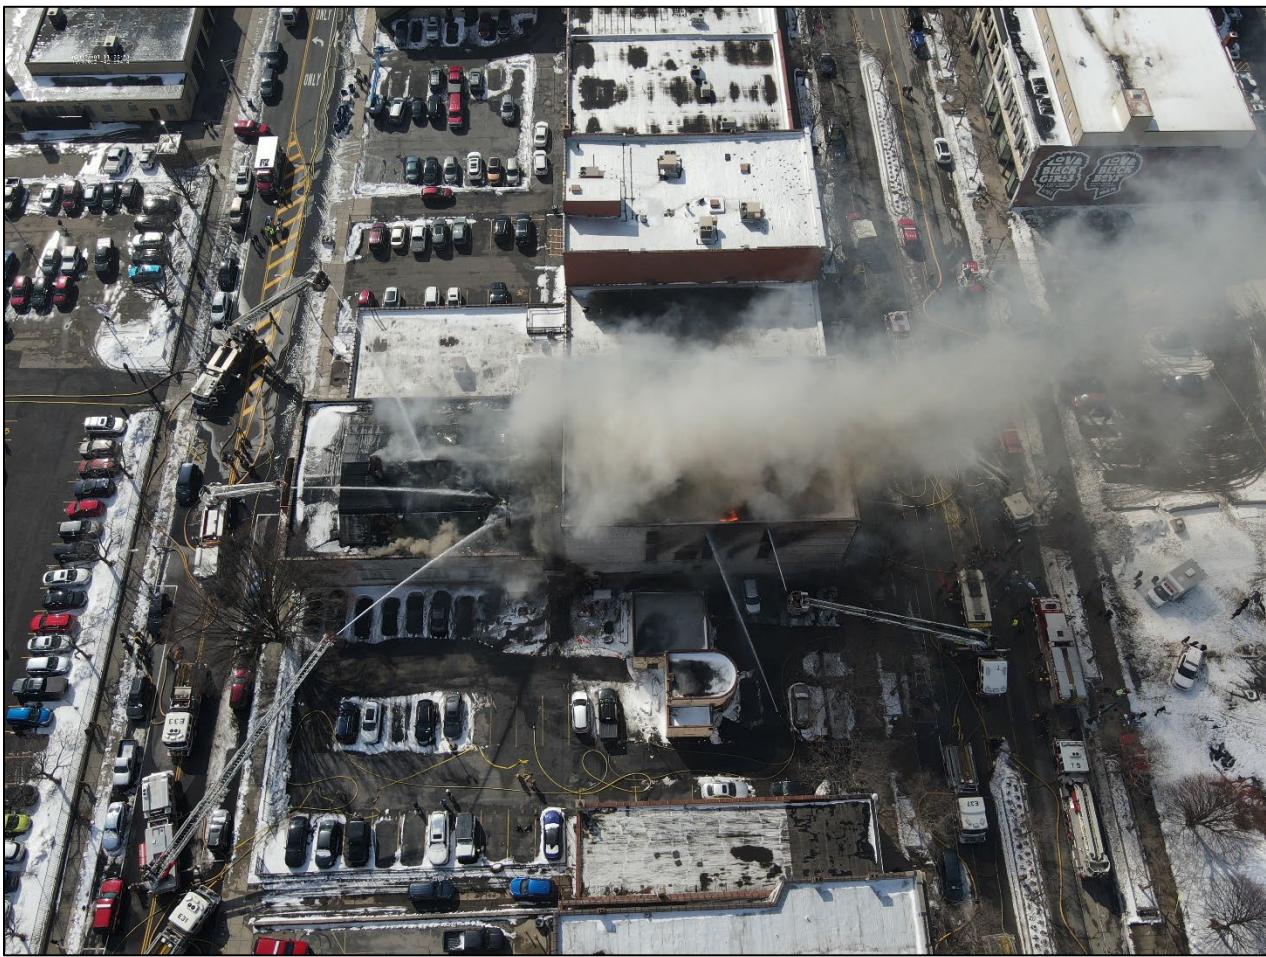
IC requested a PAR from PSAP-T and reported a second “backdraft”. An R-1 firefighter radioed, reporting they were disoriented with no acknowledgement or response. IC ordered B-43 to pull everyone back once they exited the building. IC began a PAR and the PSAP-T sounded the evacuation tones. Someone called by radio to R-1 driver/operator ordering them to “Get out. Get out and bring your partner.” The rescue attempt for E-2B was abandoned with B-43 ordering R-1 to evacuate the structure due to deteriorating conditions and intense heat. Additional rescue attempts were not considered until the fire was under control hours later. Between 10:21 and 13:40 hours, defensive operations continued (see Photo 6).

**Photo 6: Aerial view of incident during defensive operations. (Photo provided by police department)**

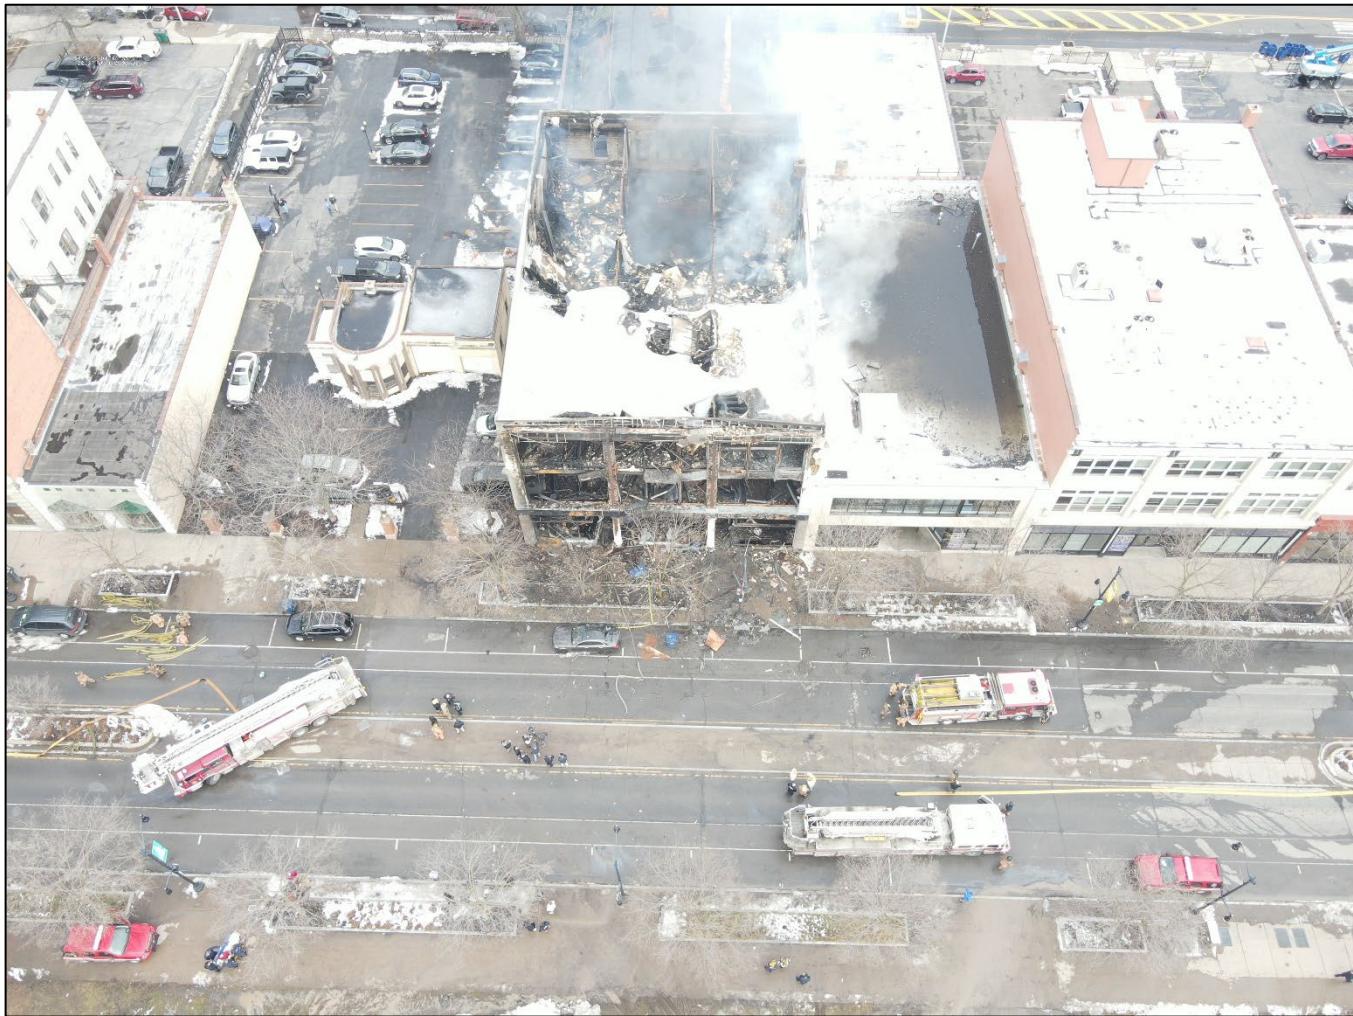
A city building engineer was consulted to assess building stability so crews could be ready to recover E-2B immediately. All apparatus were moved from an established collapse zone. At 13:41 hours, recovery personnel made entry and recovery was completed at 13:44 with E-2B transported to a local hospital and pronounced deceased. Overhaul and scene evidence processing began with all companies clearing hours

**Photo 7: View of Side Alpha post-fire. (Photo provided by police department)**
