# SERIOUS INJURY REPORT

REPORT F2025-01 • March 2026

## **Senior Captain and Two Firefighters of Ladder Company Burned During Primary Search in Garden Apartment Fire – Texas**

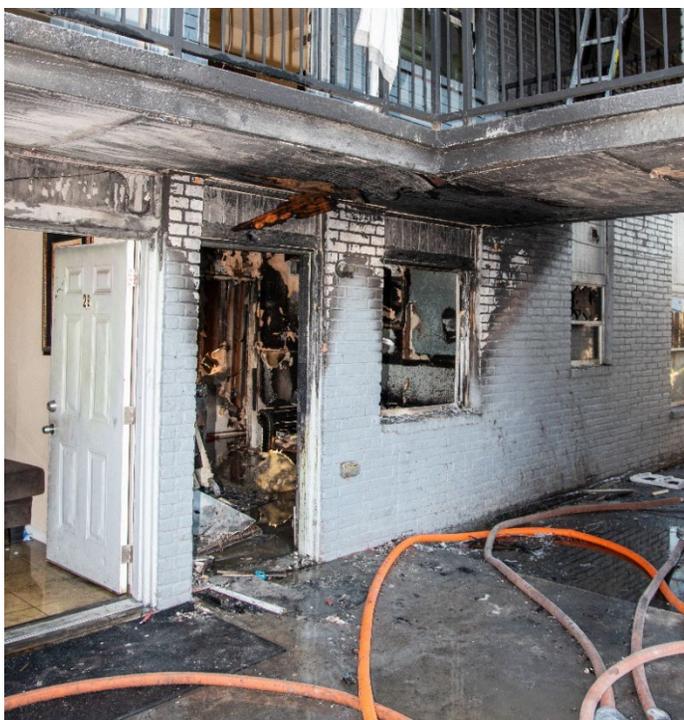
District Chief 46 (DC46) arrived on scene with smoke showing in the courtyard. DC46 pulled past Side Alpha to view Side Charlie where fire had self-ventilated through a window. DC46 positioned across the street from the apartment complex facing the courtyard of the building and provided a size up of “District 46 on scene, fire showing on a two-story apartment, establishing command.” DC46 updated Engine 35 (E35) that the fire appeared to be on the first floor past the courtyard (see **Photo 1**).

**Photo 1: View from the courtyard into the fire apartment, Side Alpha.**  
*(Courtesy of the fire department)*

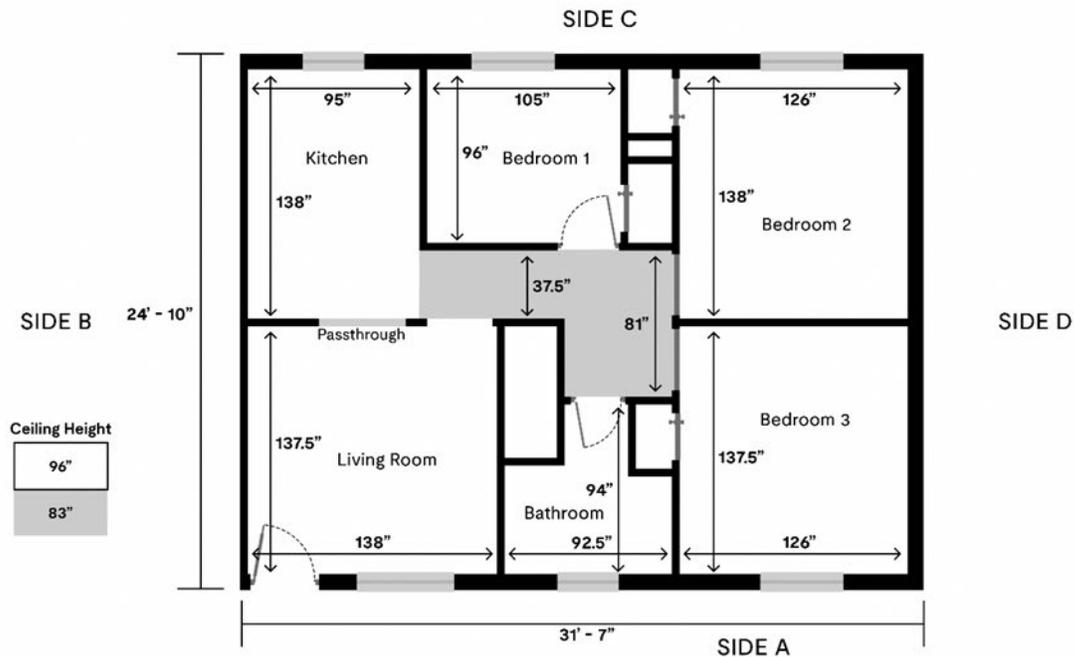
**Figure 1: Dimensioned floor plan of the fire apartment. Note that the ceiling height of the hallway is 13 inches shorter than the ceiling height of the rooms. The lowered ceiling height in the hallway provided space for the HVAC duct work. (Courtesy UL FSRI)**

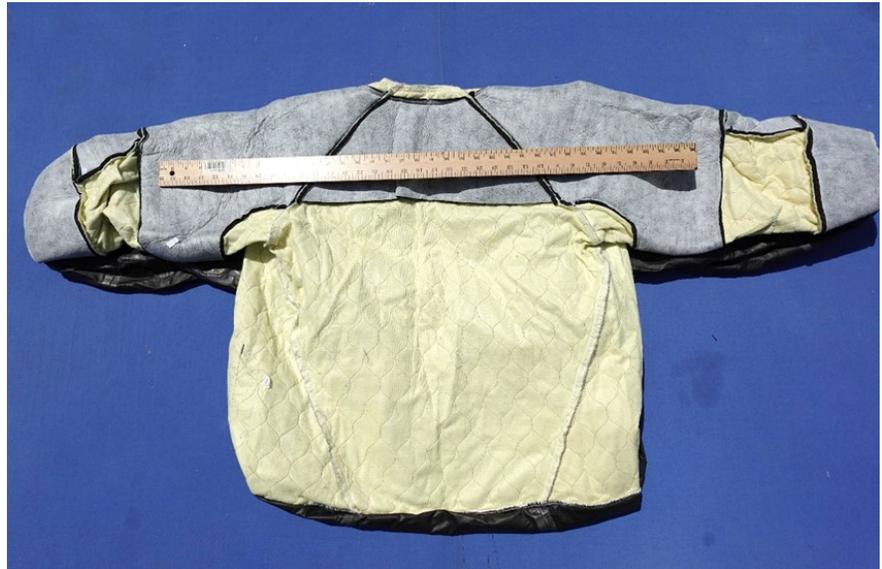
- The protective coat had additional insulation throughout the upper back, shoulder areas, upper front, and sleeves. Proportionally, the protective coat had about 20% more coverage with four or more layers compared to the standard three-layer composite that solely consists of the outer shell, moisture barrier, and thermal barrier. **Photos 2 and 3** compare the extra insulation between the coat used by the incident department and a coat from a different fire department.

**Photo 2: Incident department insulation in upper portion of protective coat. (Photo courtesy of Jeff Stull)**

There were several pieces of the ensemble that were insulated beyond the requirements of NFPA 1970, including the coat, hood, and helmets. Increased insulation has the potential to affect the ability of firefighters to perceive fire environment temperatures or rapidly changing conditions.

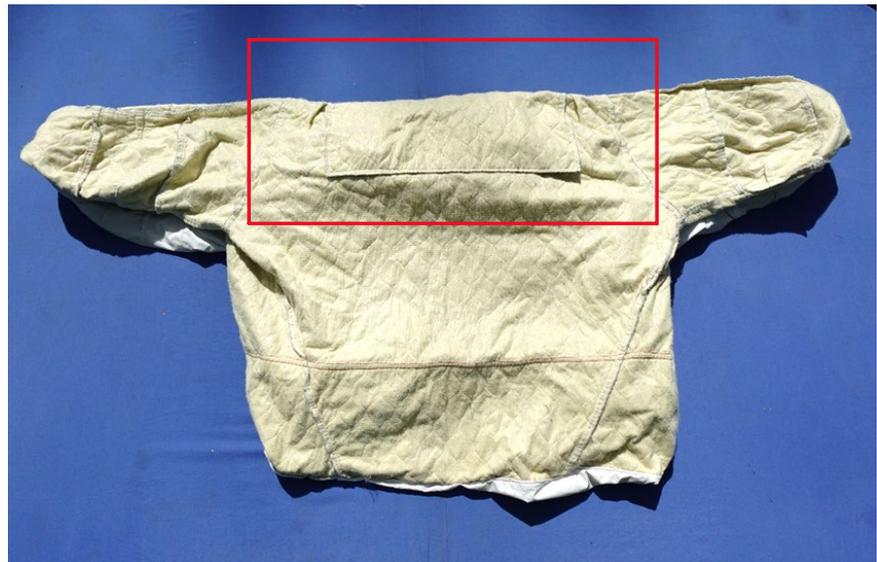
**Photo 3: Different fire department protective coat with less insulation in upper portion [where additional shoulder insulation layer would be outlined in red rectangle]. (Photo courtesy of Jeff Stull)**

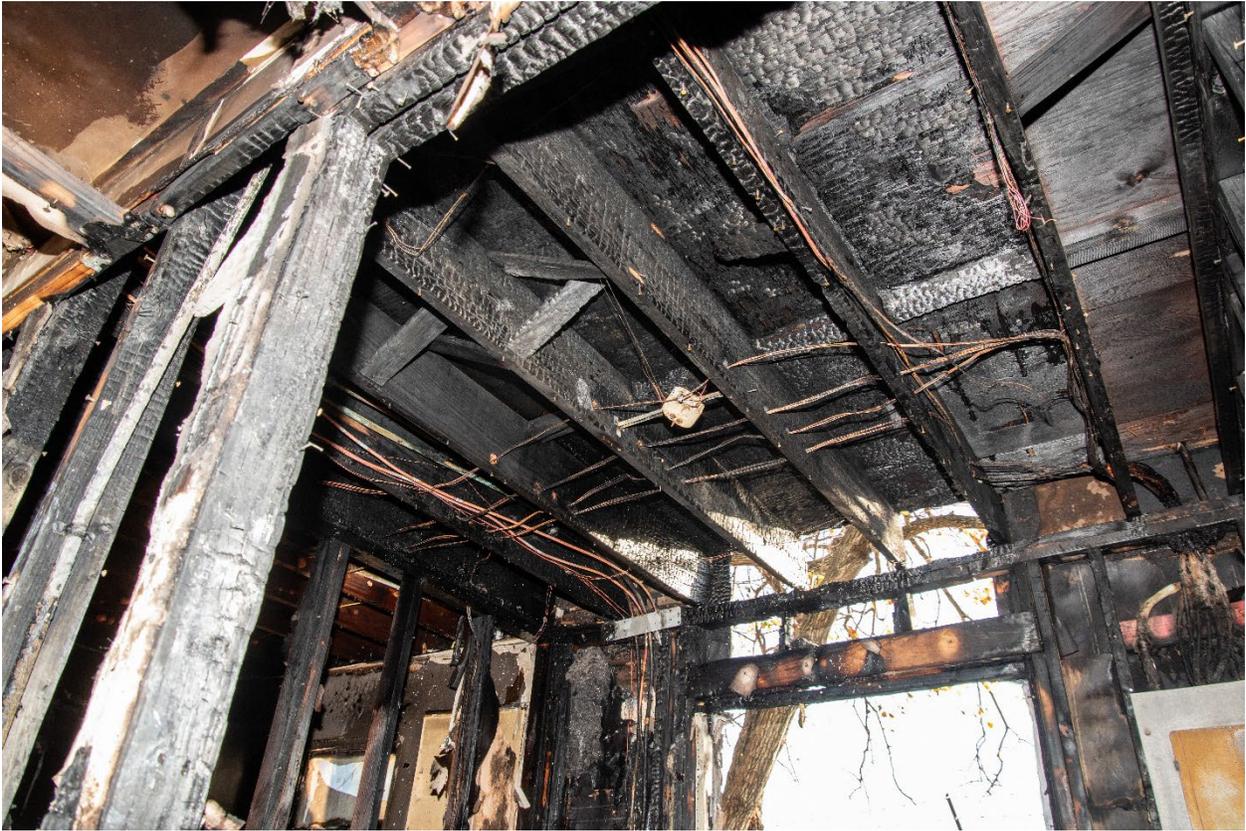
**Photo 4: Detail of ceiling construction in bedroom 1. Charring and evidence of mass loss from the joists and bottom of the subfloor of division 2 are shown.**

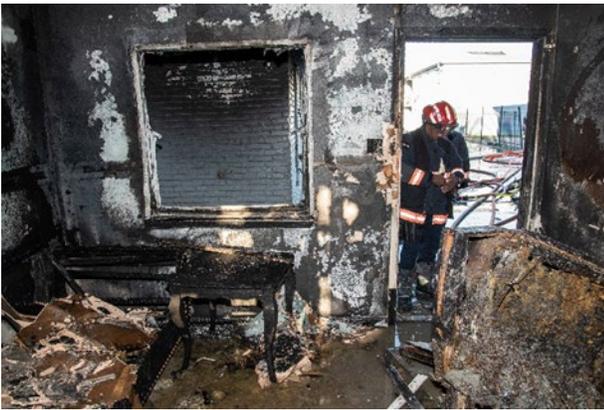
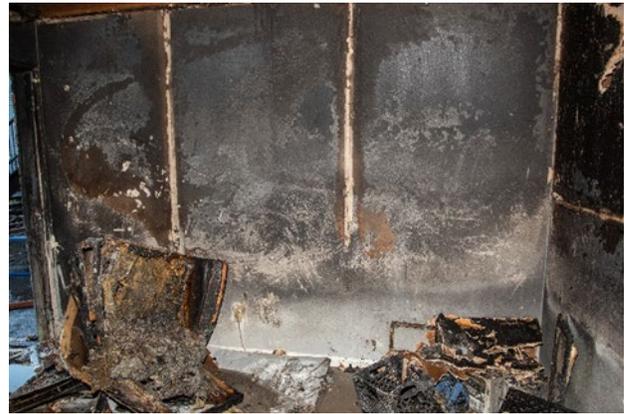
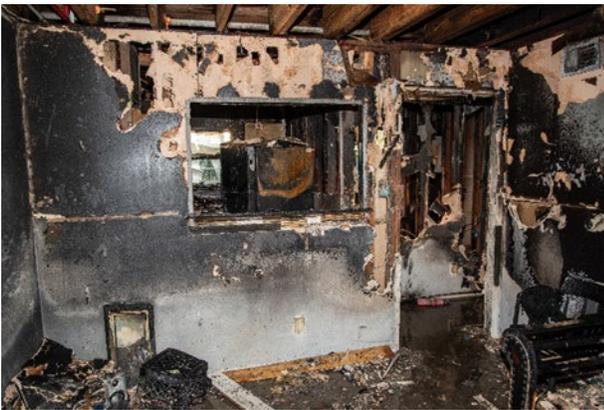
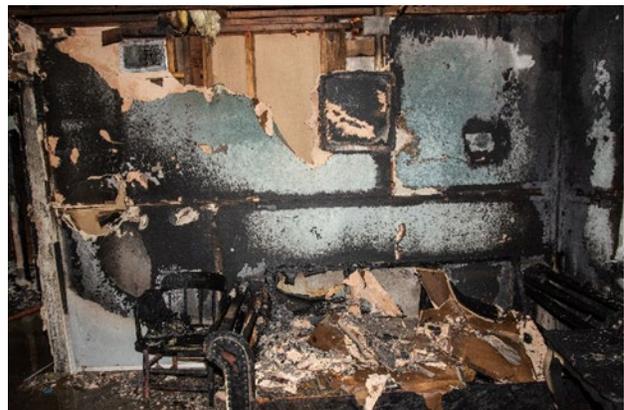
From the L46 search crew perspective, the living room flashed over. The fire damage in the living room indicates that technically, the living room did not complete the transition through flashover as shown in **Photos 5, 6, 7, and 8**. However, the flames from the chair would have:

- Increased the pyrolysis rate from the adjacent fuels in the living room, resulting in increased smoke and gaseous fuel.
- Flowed out of the doorway, as observed by the E35 firefighters and others.
- Eliminated the visibility in the living room.
- Caused the firefighters to get down toward the floor from increased heat.

The closed door reduced the flow of fresh air to the living room, which interrupted the transition through flashover (i.e., full room involvement in fire). The closed door reduced the oxygen available for combustion, so flames decreased in the living room. This also trapped heat and smoke in the living room until suppression occurred from the two hose streams. The fire development time from the 911 call to water on the fire was about 10 minutes.

**Photo 5, 6, 7, and 8: Vantage points of the living room. Top left - Side Alpha, top right - Side Bravo, bottom left - Side Charlie, bottom right - Side Delta. (Photos courtesy of the fire department)**

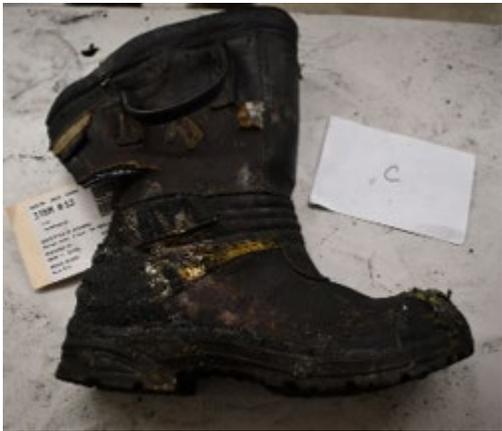
**L46C Right Boot (Outboard View)**

One firefighter was likely more susceptible to some burn injuries due to the accidental misfit of their gear. Properly fitting gear may provide better protection from burns. L46C wore pants that were too big. The loose fit of the pants allowed hot air to move up the pant leg. The firefighter also wore boots that were too small. This reduced the air gap in the boots between the inner surface and the firefighter's skin and allowed for greater heat transfer from the outside of the boot to the skin.
