**SERIOUS
INJURY REPORT**
REPORT SLIDES

F2025-01

Senior Captain and Two
Firefighters of Ladder Company
Burned During Primary Search in
Garden Apartment Fire – Texas

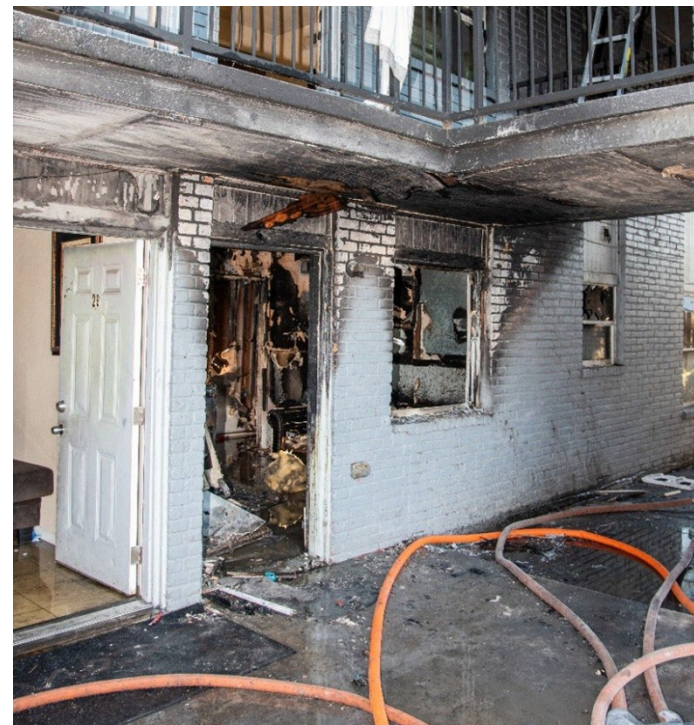
View from the courtyard into the fire apartment, Side Alpha.
(Courtesy of the fire department)

- The altercation between the civilian and E35 continued and subsequently distracted many of the personnel on scene.
- The door and living room window to the apartment were open with fire venting out when L46 made entry.
- Fire conditions progressed rapidly while L46's crew was inside conducting the primary search.
- During the civilian altercation with E35, flames filled the doorway and the door closed to the unit.

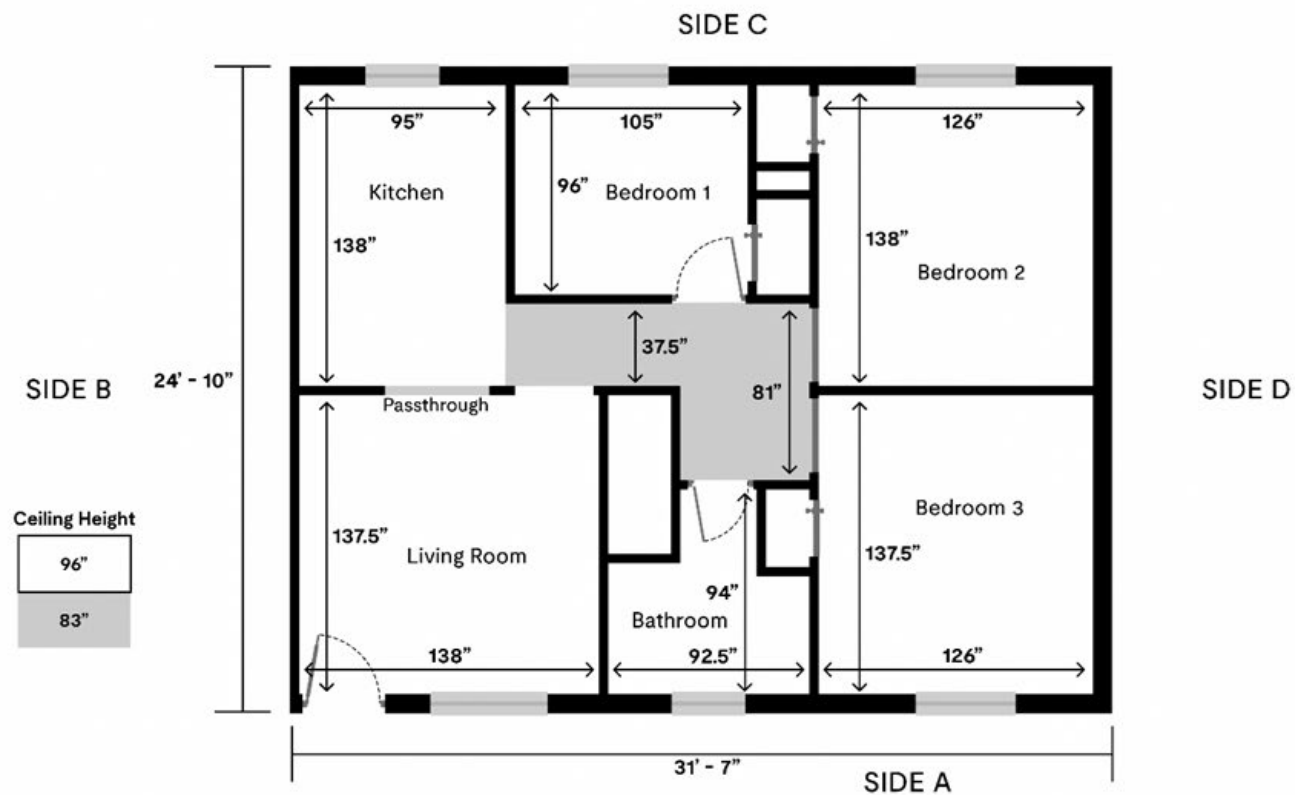
Dimensioned floor plan of the fire apartment. Note that the ceiling height of the hallway is 13 inches shorter than the ceiling height of the rooms. The lowered ceiling height in the hallway provided space for the HVAC duct work. (Courtesy UL FSRI)

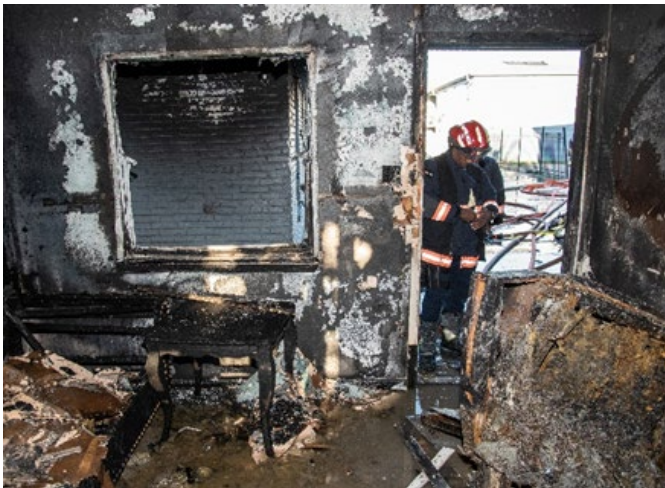
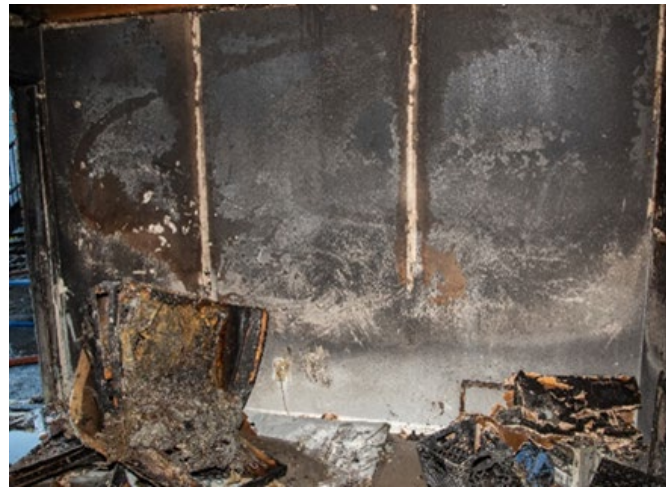
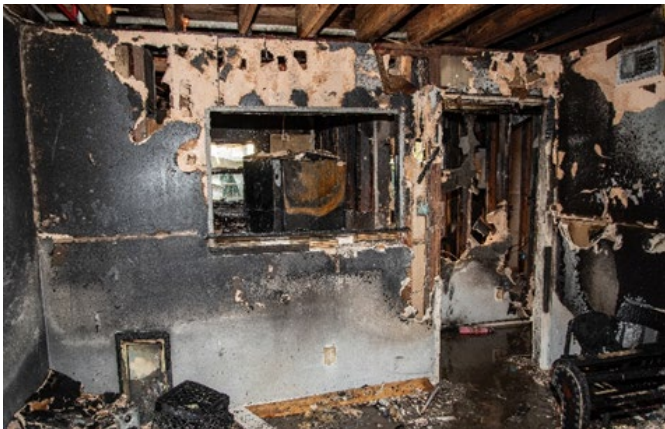
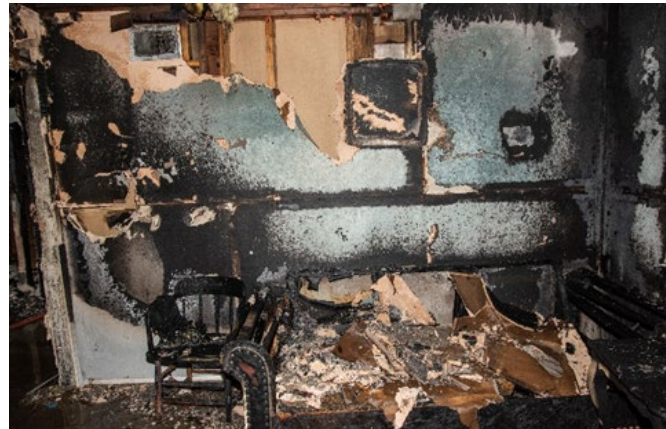
Vantage points of the living room. Top left - Side Alpha, top right - Side Bravo, bottom left - Side Charlie, bottom right - Side Delta. (Courtesy of the fire department)
