SERIOUS INJURY REPORT

REPORT F2025-08 • December 2025

Nine Career Firefighters Injured at Residential Structure Fire – Texas

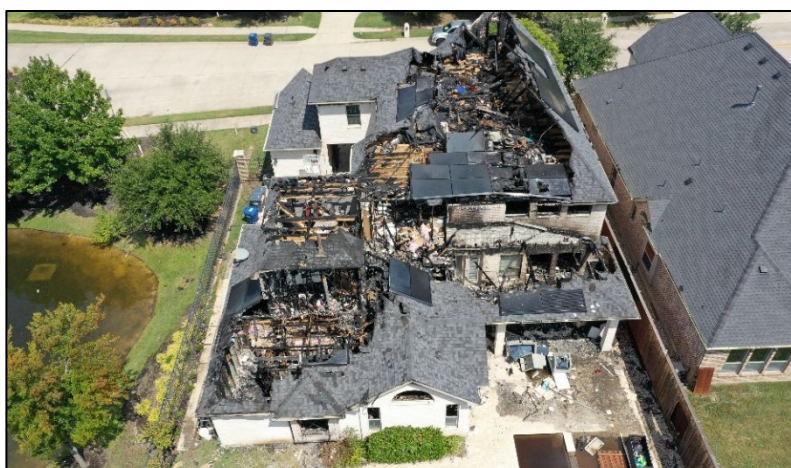
Photo 1: View of the rear of structure, post-fire.
(Courtesy of the fire department)

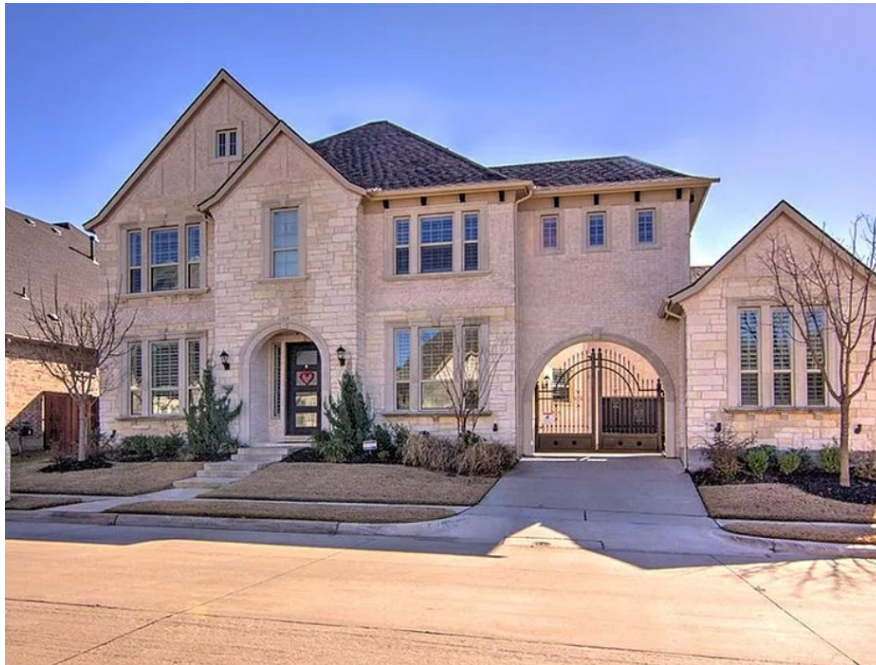
This incident involved a type V, large-area residential structure that was built in 2016 (see **Photo 2**). It was two stories, contained 4,450 sq ft of living space, and included a surrounding security fence. The structure contained high ceilings and a winding staircase to the second division (see **Photo 3**). The structure layout included five bedrooms and a raked (sloped floor) media (theater) room (see **Photo 4**).

Photo 2: View of structure, pre-incident.
(Courtesy of the fire department)

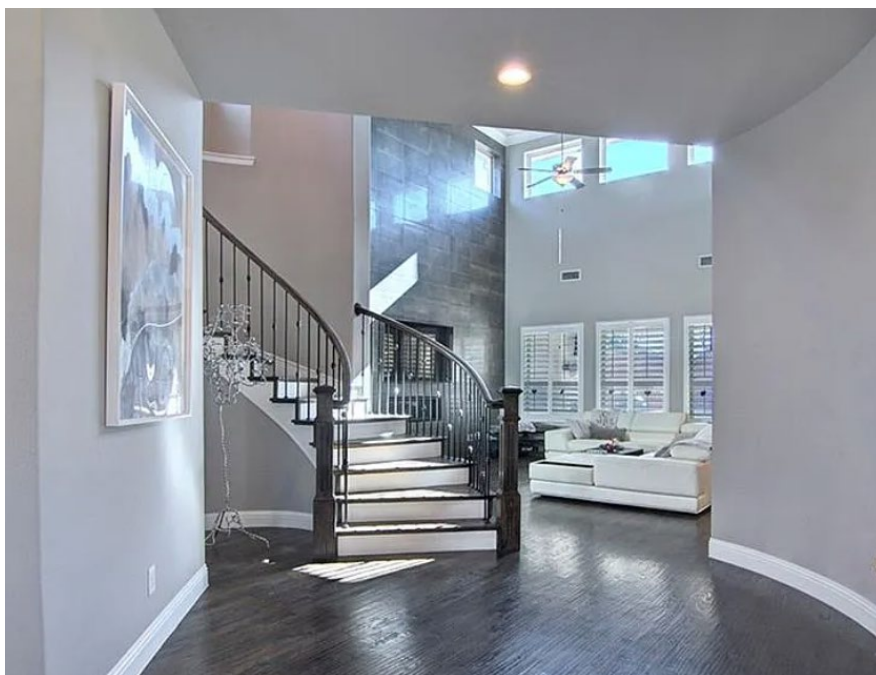
**Photo 3: Winding staircase, pre-incident.
(Courtesy of the fire department)**

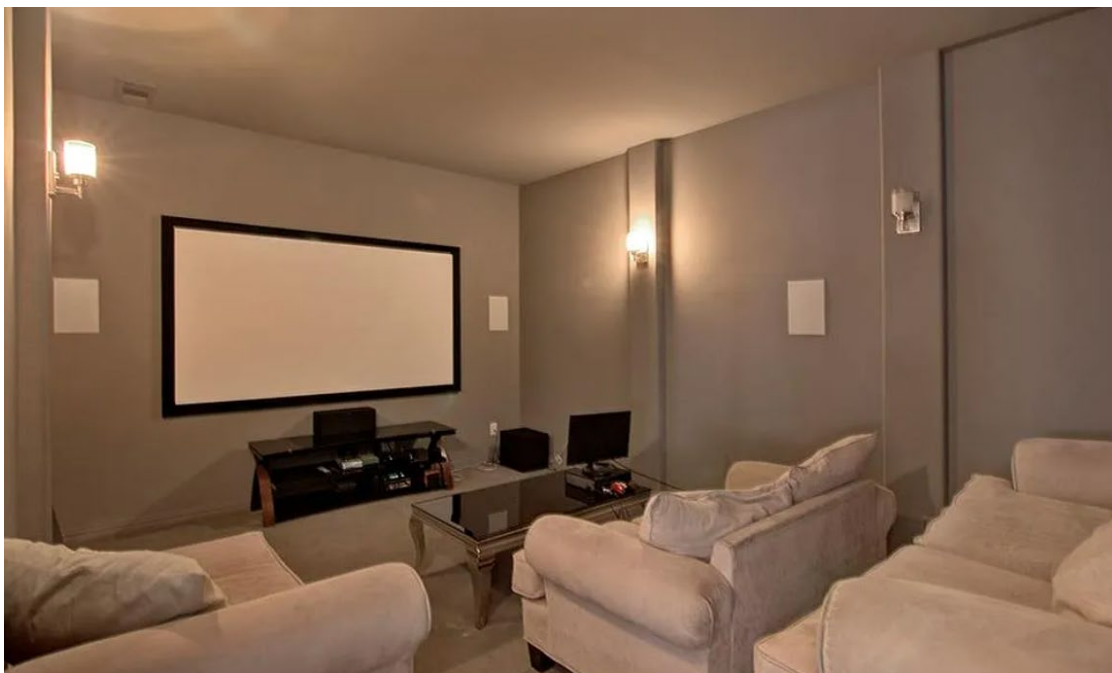
**Photo 4: Media room, pre-incident.
(Courtesy of the fire department)**

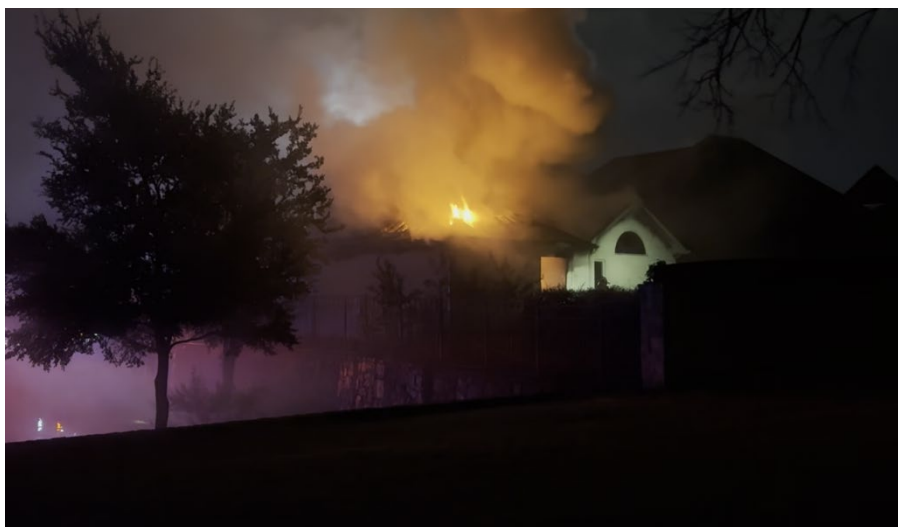
At 21:34 hours, Tiller 11 firefighter was told by a Medic 11 firefighter that his EOSTI was sounding and was running low on air. Captain 11 noticed Medic 11's EOSTIs sounding and radioed that Tiller 11 and Medic 11 were coming out to recycle. Captain 11 told the Medic 11 firefighters to wait at the stairs while he located the Tiller 11 firefighter. At 21:35 hours, Engine 7 reported two hoselines on the fire with conditions looking better and extension on the Side Charlie/Delta corner. Medic 3

Photo 5: Fire conditions on Side Charlie/Delta corner.
(Courtesy of the fire department)

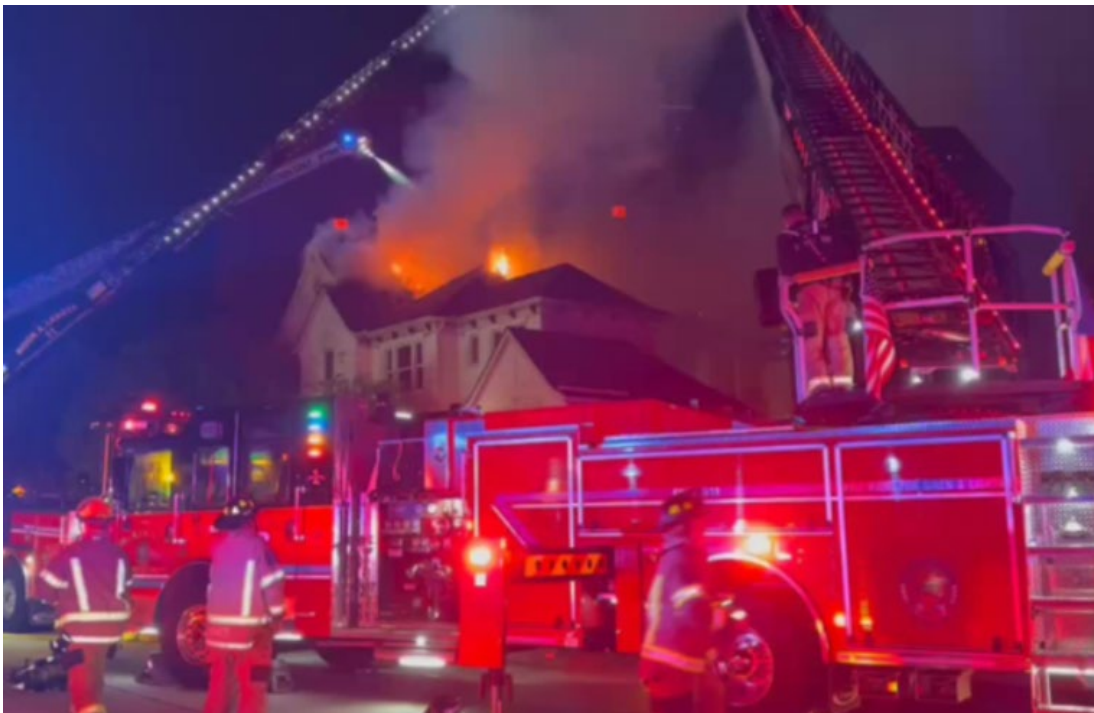
Photo 6: Defensive operations on Side Alpha, post-extrication.
(Courtesy of the fire department)
