**SERIOUS
INJURY REPORT**
REPORT SLIDES

F2025-08

**Nine Career Firefighters Injured
at Residential Structure Fire –
Texas**

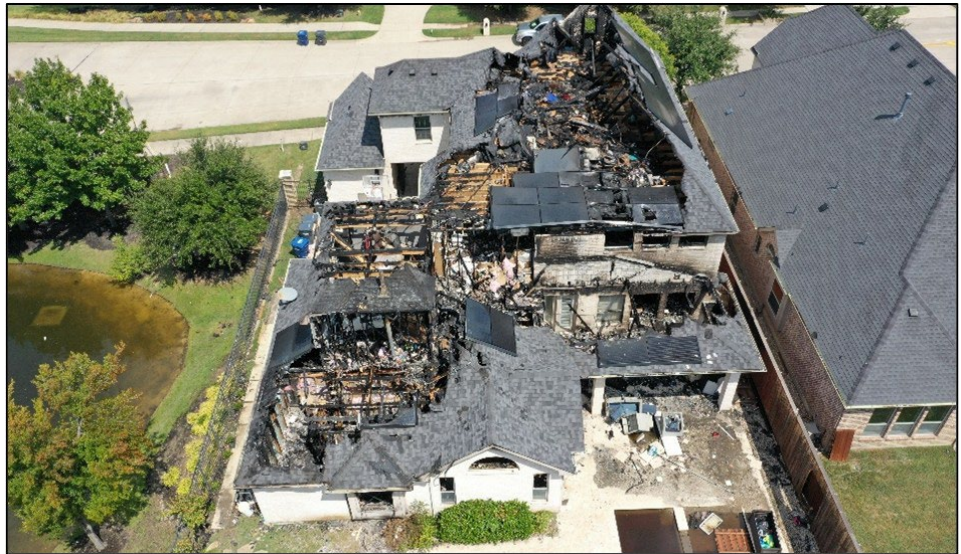
View of the rear of structure, post-fire. Photo courtesy of the fire department.

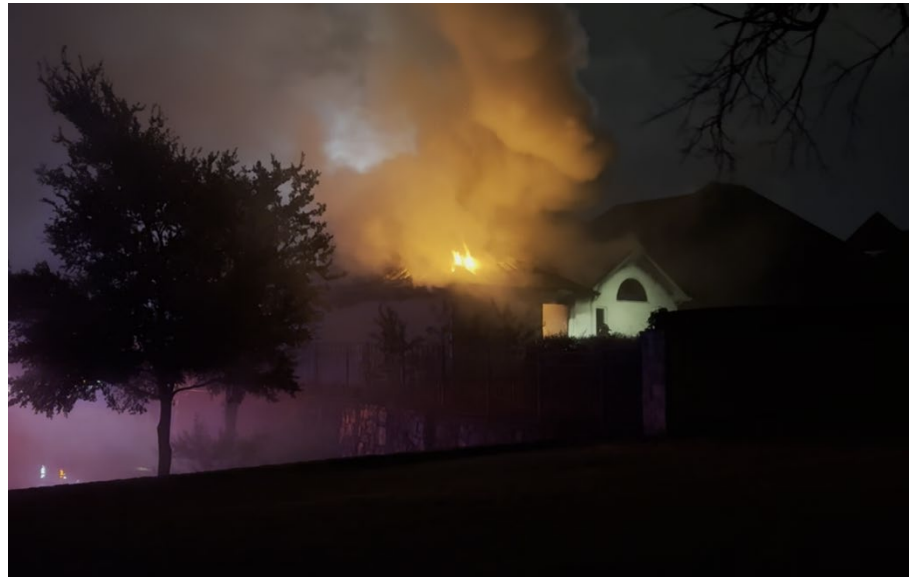
Fire conditions on Side Charlie/Delta corner. Photo courtesy of the fire department.

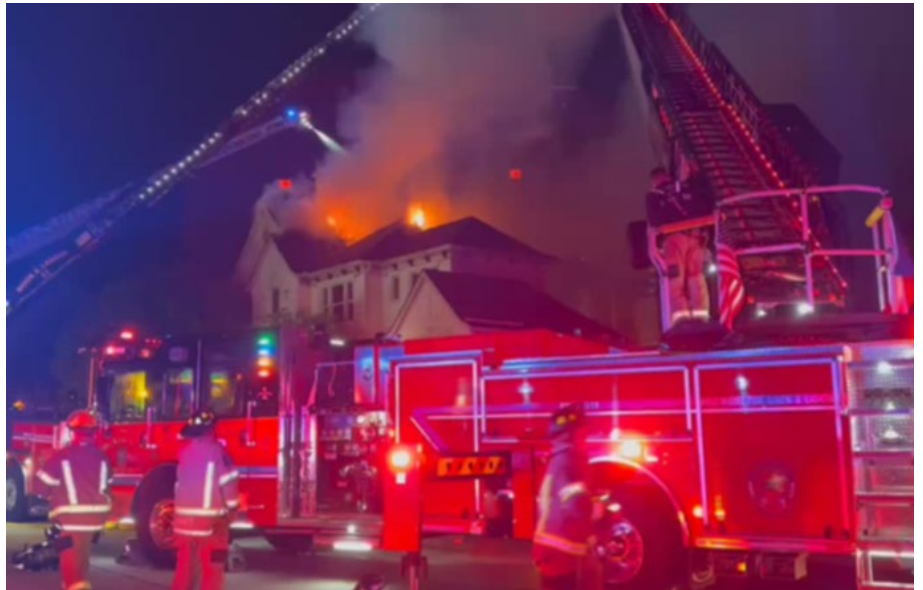
Defensive operations on Side Alpha, post-extrication.
Courtesy of the fire department.
