LINE OF DUTY DEATH REPORT

REPORT F2025-09 • March 2026

Career Firefighter Dies during Warehouse Fire at Unpermitted Film Studio – Georgia

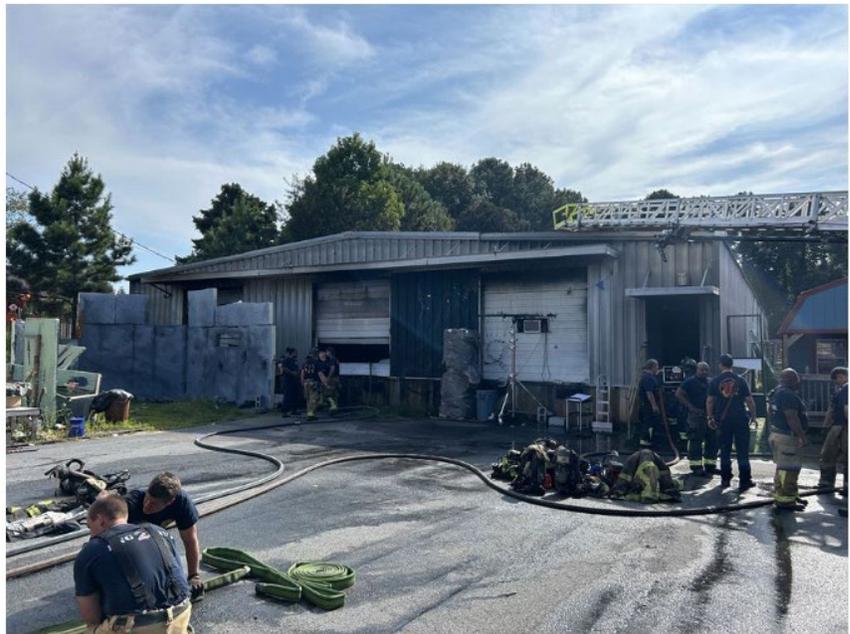
Photo 1: View of the warehouse, Side Alpha, post-fire.
(Courtesy of the fire department)

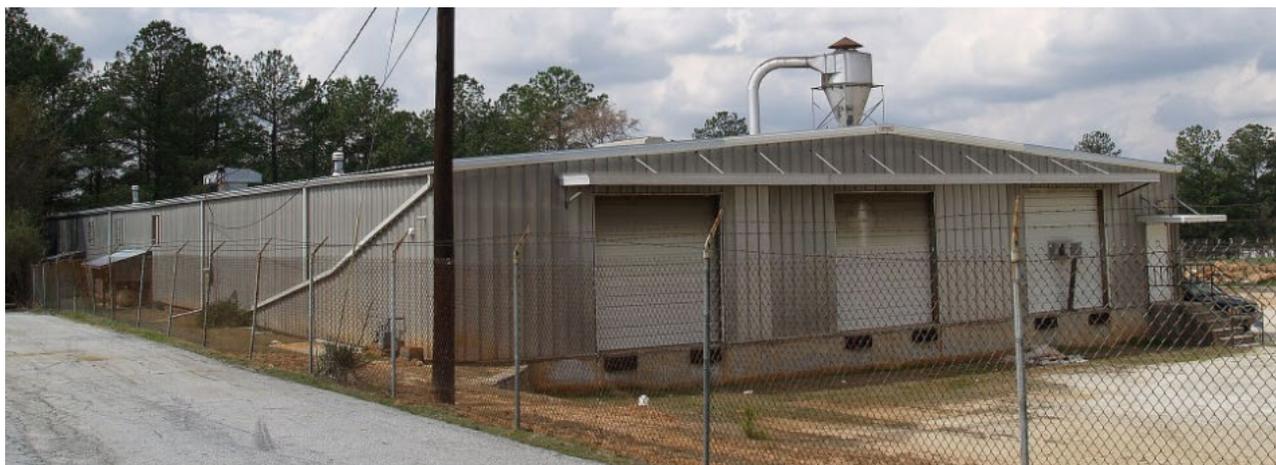
This incident involved a Type IIb, single-story industrial warehouse built in 1980 (see **Photo 2**). The warehouse was approximately 70 ft x 200 ft x 15 ft steel-frame design with a low-slope steel roof, steel exterior siding and 16 roof skylights. Two sides of the warehouse had 4 ft diameter vent holes with a mechanical fan that allowed continuous fresh air exchange. It contained 14,000 square ft of floor space, including 1,000 square ft of office area, and seven 14 ft garage doors with raised concrete foundations. The warehouse's office areas were partitioned on Side Alpha with the remaining area being open floor space. The warehouse was located on a two-acre lot with a surrounding security fence and gate.

Photo 2: View of warehouse, Side Alpha, pre-incident.
(Courtesy of the fire department)

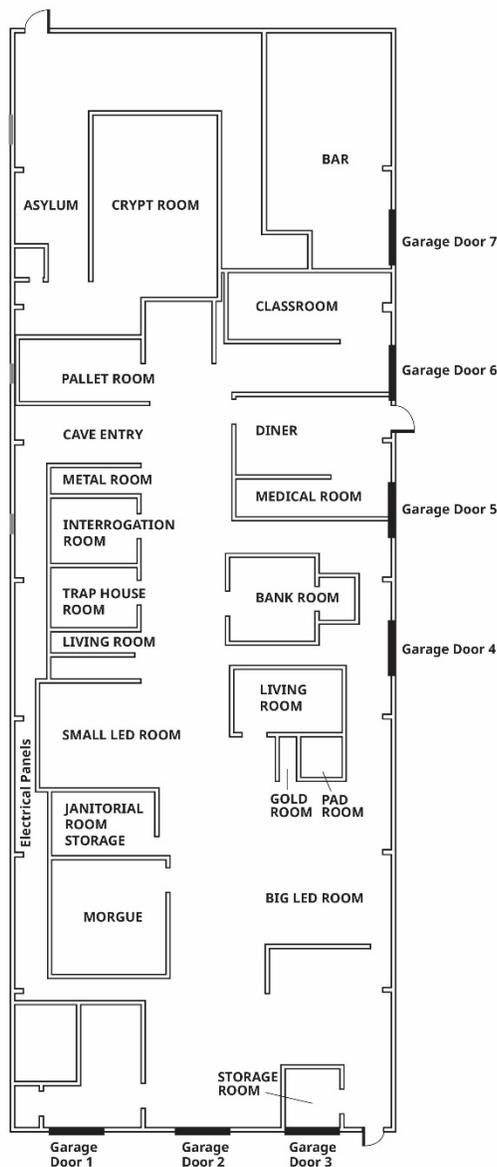
Figure 1: Floor plan of warehouse showing temporarily, theme-constructed rooms. (Courtesy of the fire department)

a Mayday.” At this time, the Quint 24 crew was in the big LED room (see **Figure 1**) and decided to stay in their location to avoid getting further lost. Quint 24 officer again called for Engine 14 to come back with their nozzle, get on the ground, and that his crew was in front of where they previously operated. Engine 14 officer and his firefighter checked their air supply and responded that they were re-entering to assist Quint 24. Engine 14 officer requested Quint 24 officer to activate his PASS. In response, Quint 24 tailboard manually activated his PASS.

At 14:10 hours, HR 24 officer radioed to Car 7 that they found tailboard 2 and were coming out. He was located about 20 feet into the structure, along the wall of the storage room that faced Side Bravo (see **Figure 1**). His PASS was in full alarm. HR 24 officer and Truck 16 officer began to drag him out, which became difficult with the debris and metal props in the area. At 14:13 hours, Car 7 announced that HR 24 tailboard 2 was out of the structure. Battalion 4 repeated the transmission and stated that operations would remain defensive. Multiple crews carried HR 24 tailboard 2 from the doorway and began to remove his SCBA and structural firefighting turnout gear. Crews doffing his PPE noted that his body felt extremely hot to the touch and had burns on his lower torso. Crews began treating him for cardiac arrest and he was transported to a local hospital where he was later pronounced deceased.

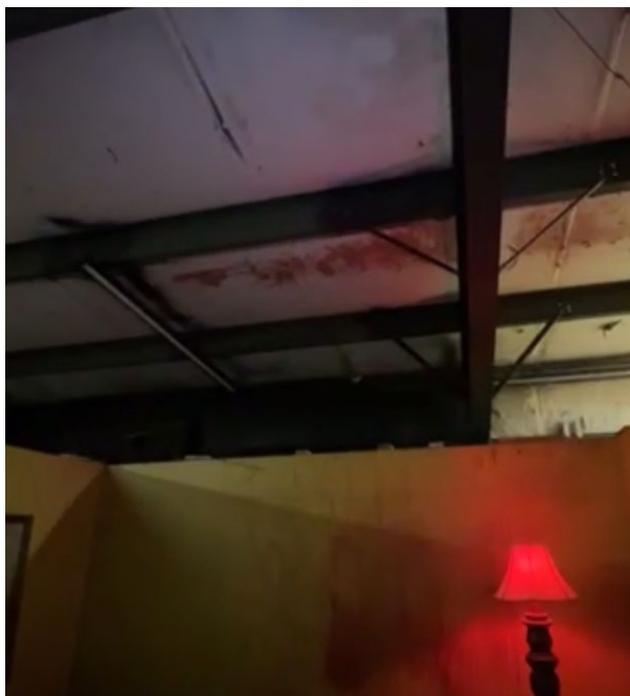
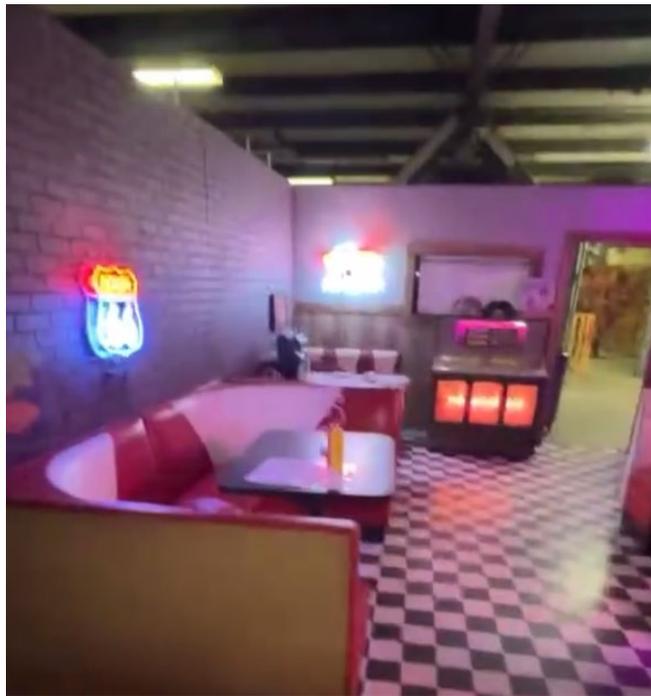
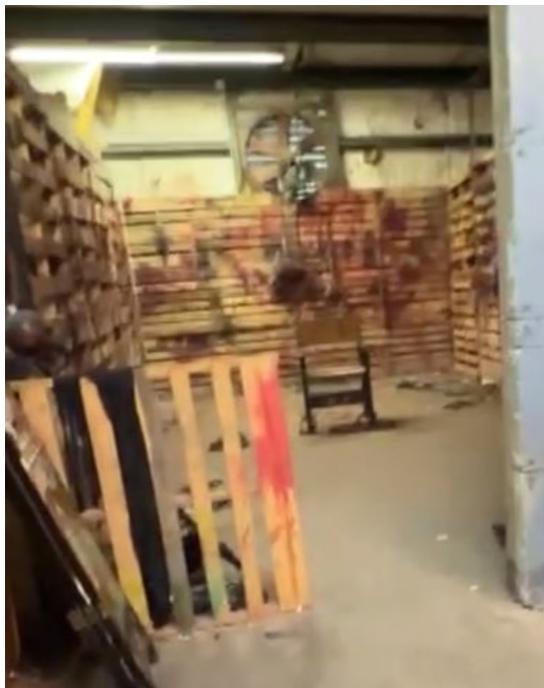
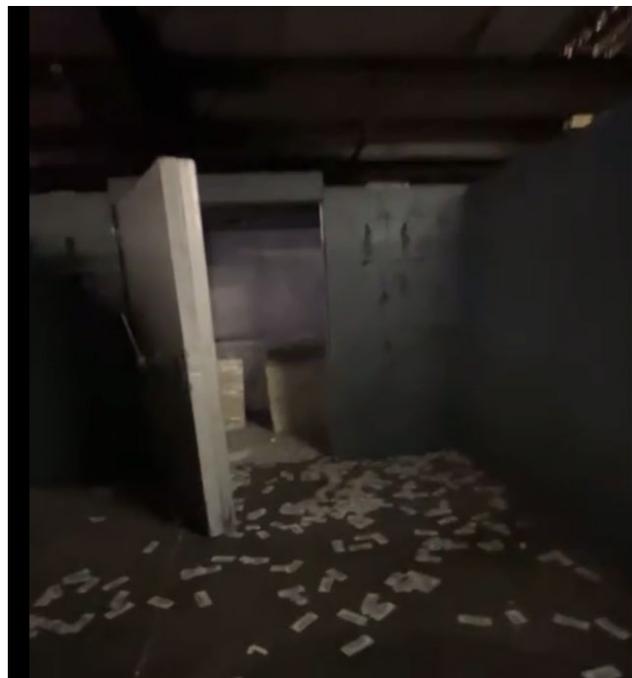
At the time of the incident, a film studio business operated the warehouse. The warehouse had multiple temporarily constructed rooms, which were made of rigid [expanded](#) and [extruded](#) polystyrene boards, ordinary construction materials, and plastics (see [Figure 1](#)). The rooms were not ceiling height, and each contained themed studio props, such as furniture, manikins, and other lightweight decorations (see [Photo 3, 4, 5, and 6](#)). The warehouse also had props on the exterior, such as a graveyard and a circus. The film studio business also used the warehouse for an annual Halloween party open to the public.

Photo 3, 4, 5, and 6: View of temporarily constructed rooms with themed studio props, pre-incident. Photos show rooms were not built to ceiling height.
(Courtesy of the fire department)

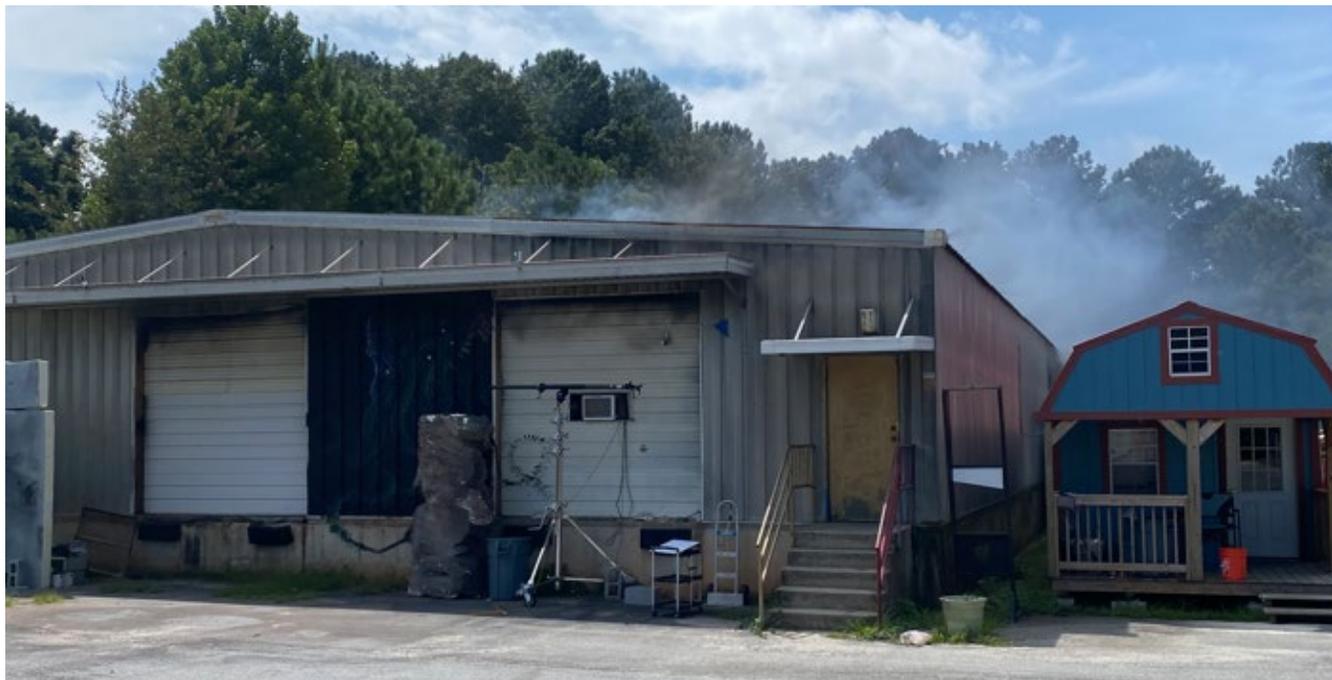
Photo 7: Smoke conditions upon arrival of Engine 14, Side Alpha.
(Courtesy of the fire department)

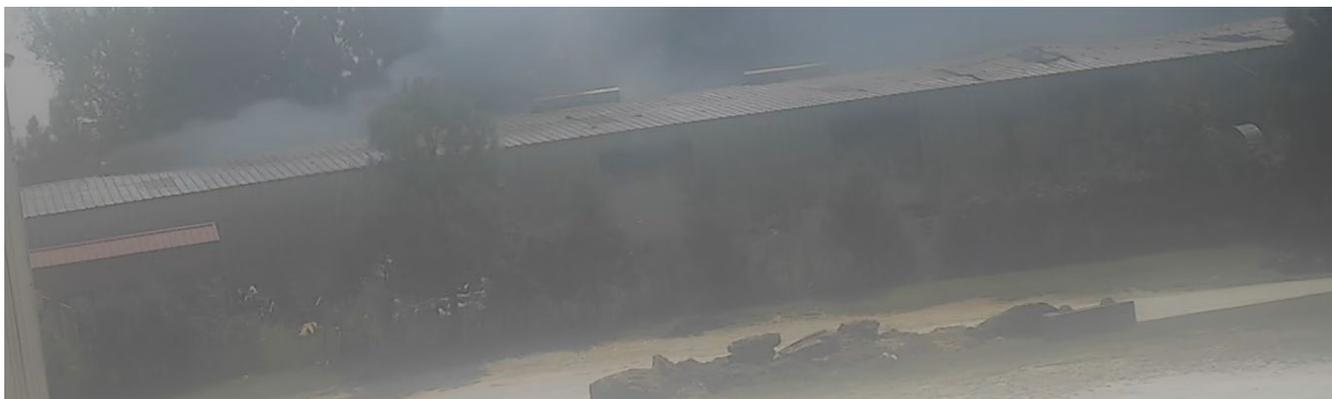
Photo 8: Smoke conditions upon arrival of Engine 14, Side Delta, showing buckling of roof.
(Courtesy of the fire department)

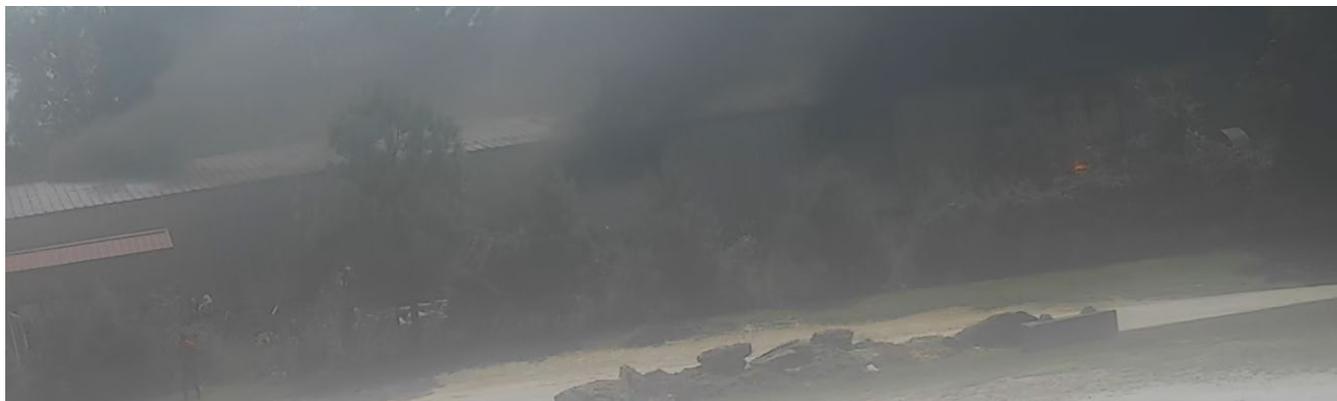
Photo 9: Smoke conditions at 13:50 hours, Side Delta, showing fire.
(Courtesy of the fire department)

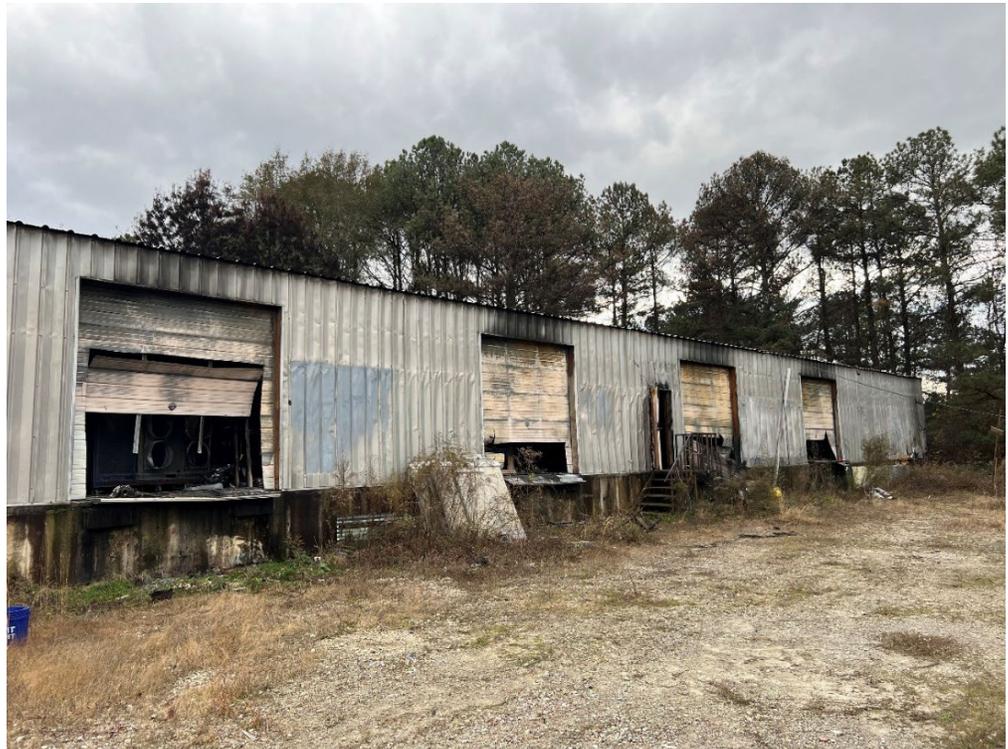
Photo 10: Garage door cuts, Side Delta, post-fire.
(Courtesy of the fire department)

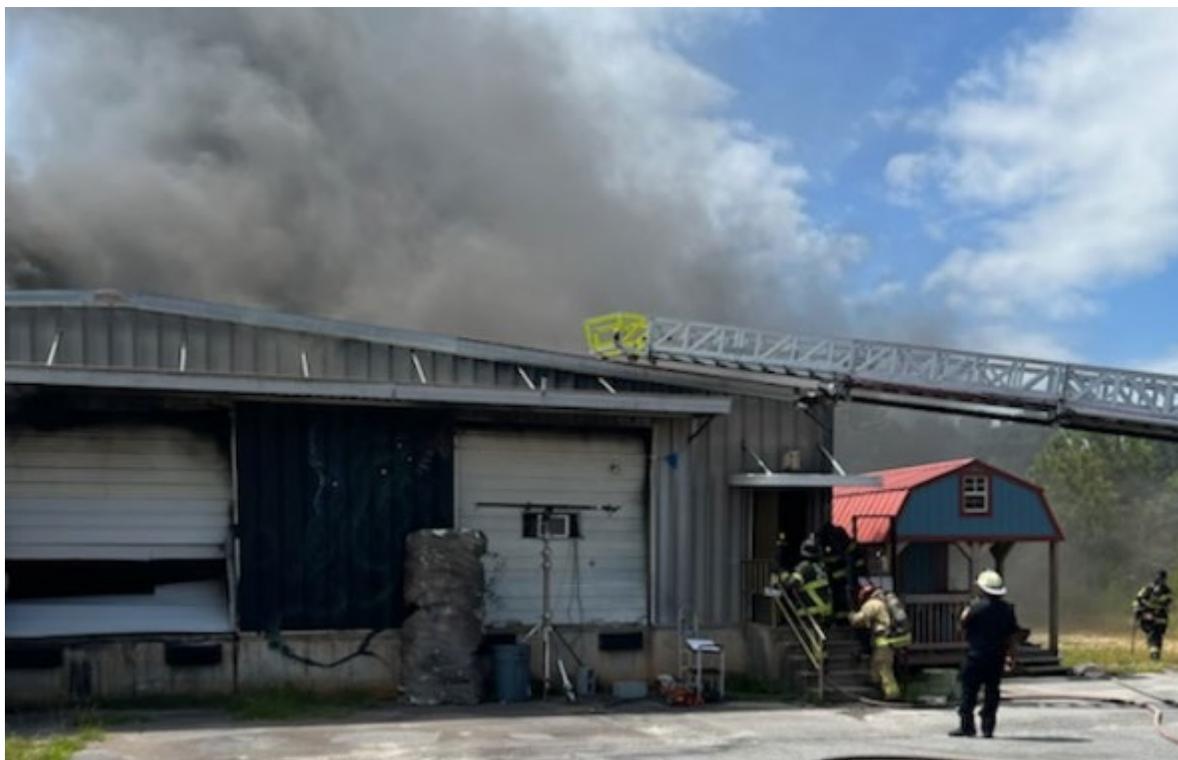
Photo 11: Crews entering to search for Quint 24, Side Alpha.
(Courtesy of the fire department)

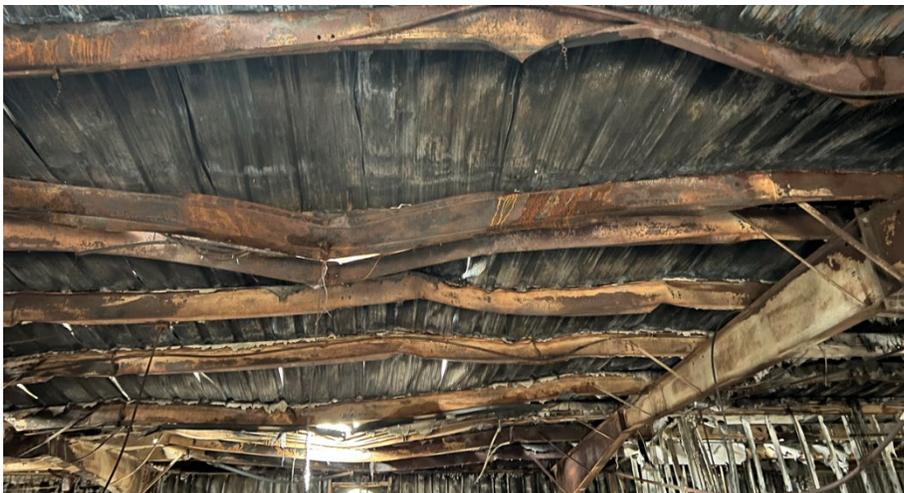
Alpha, crawling due to limited visibility and high heat conditions. During their search, they followed the hoseline and periodically heard the metal roof buckling (see **Photo 12**).

Photo 12: Ceiling condition, post-fire.
(Courtesy of the fire department)

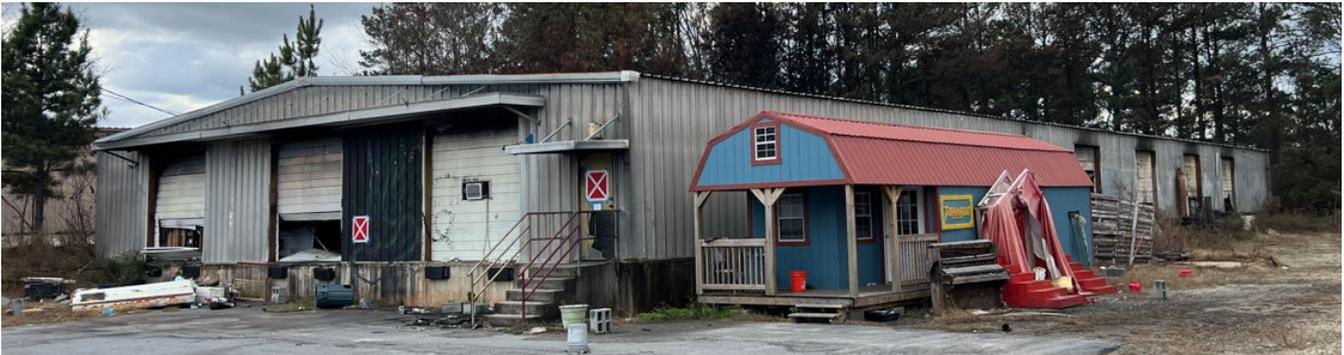
Between 14:14 and 15:03 hours, command was transferred to Battalion 5 and fire suppression operations continued with first alarm crews being rotated off the incident. All first alarm crews were given a debriefing outside the incident before they were released. The fire was declared under control at 15:04 hours with fire investigators taking control of the scene (see **Photo 13**).

Photo 13: Warehouse, Side Alpha/Delta corner, post-fire.
(Courtesy of the fire department)

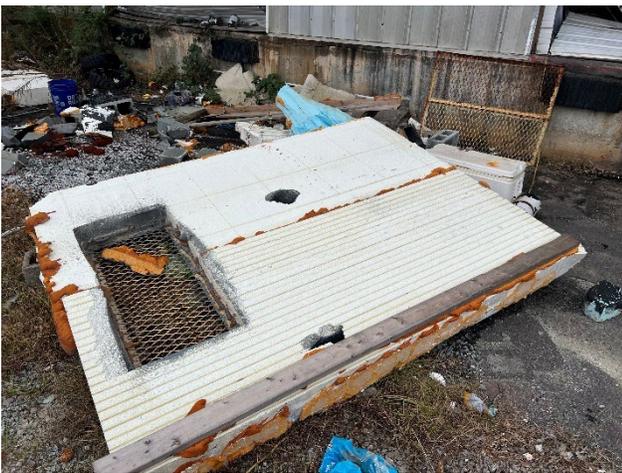
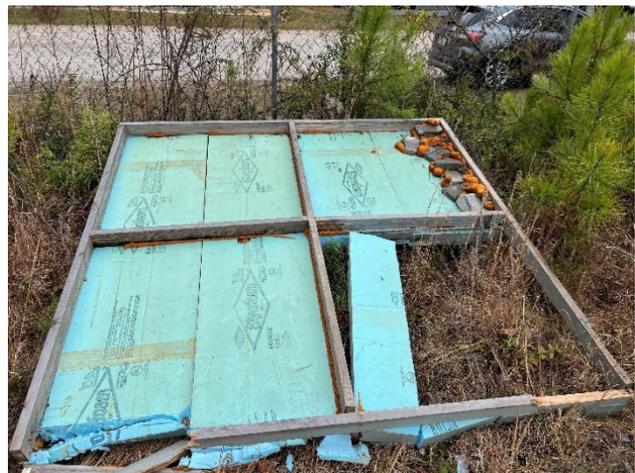
Upon arrival of the fire department, the fire in the warehouse was ventilation-limited. The heat release rate and growth were limited by the amount of oxygen available to the fire as the warehouse doors and openings were mostly closed with the exception of vent holes for mechanical fans. Upon opening doors for interior operations and cutting the garage doors for ventilation, the fire moved from decay to growth stage as it received fresh oxygen sources. This included the opening of Side Alpha from which the wind directly entered the warehouse. This uncontrolled ventilation, along with no fire suppression, facilitated full development of the fire and involvement of surrounding fuel sources such as the rigid expanded and extruded polystyrene boards (see **Photo 14 and 15**). According to Fire Safety Research Institute (FSRI), these materials have effective heats of combustion that are 50% to 100% higher than wood. In addition, the soot yield from these foam plastics are 10 to 20 times greater than the soot emissions of wood [FSRI 2023]. With increasing heat energy, the conditions became hotter with larger amounts of smoke limiting visibility.

Photo 14 and 15: Rigid extruded polystyrene boards used to make film studio rooms.
(Courtesy of the fire department)
