**LINE OF DUTY  
DEATH REPORT  
REPORT SLIDES**

**F2025-09**

Career Firefighter Dies during  
Warehouse Fire at Unpermitted  
Film Studio – Georgia

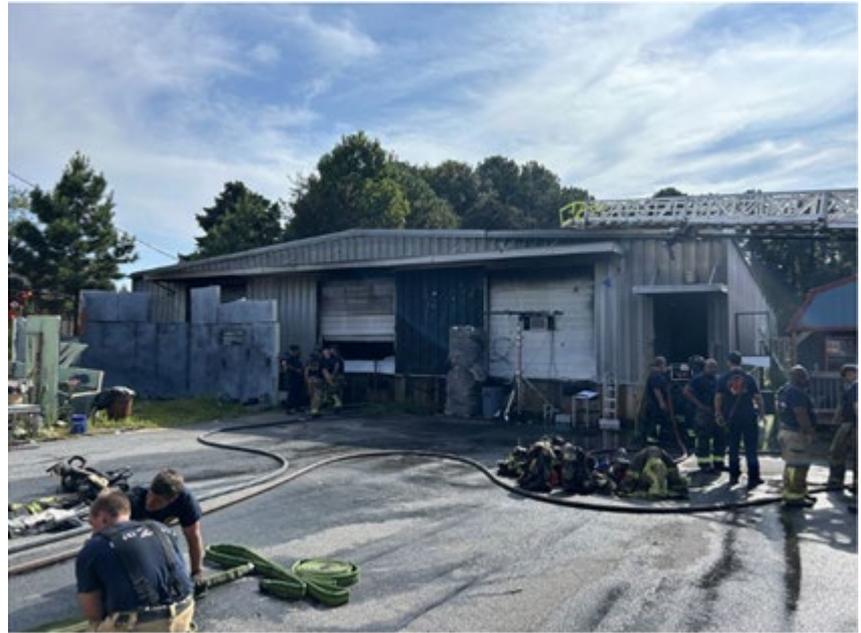
View of the warehouse, Side Alpha, post-fire.  
(Courtesy of the fire department)

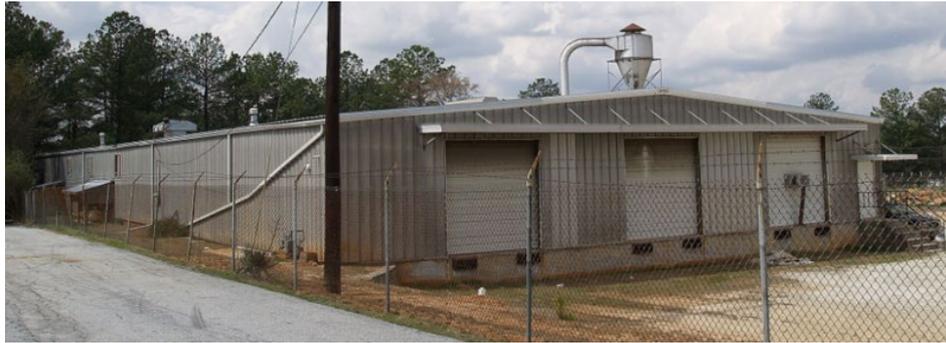
View of warehouse, Side Alpha, pre-incident.  
(Courtesy of the fire department)

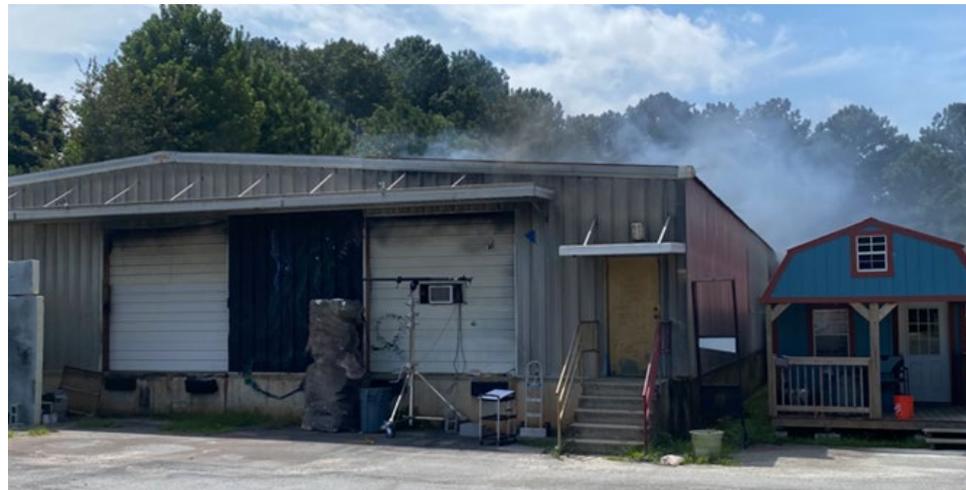
Smoke conditions upon arrival of Engine 14, Side Alpha.  
(Courtesy of the fire department)

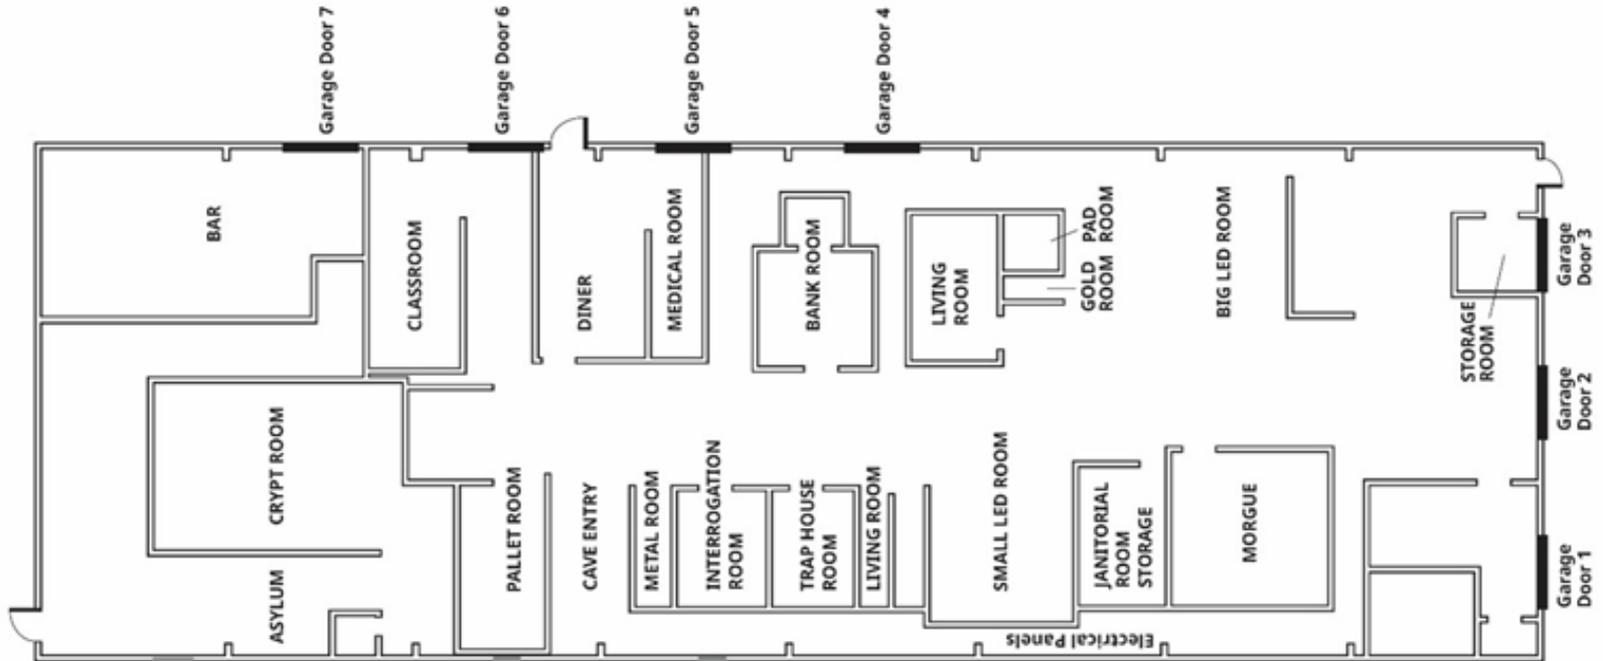
Floor plan of warehouse showing temporarily, theme-constructed rooms. (Courtesy of the fire department)

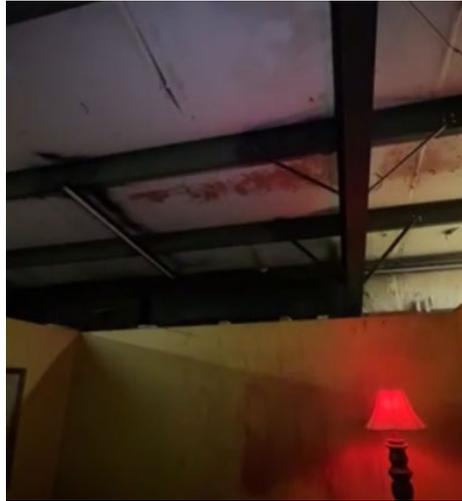
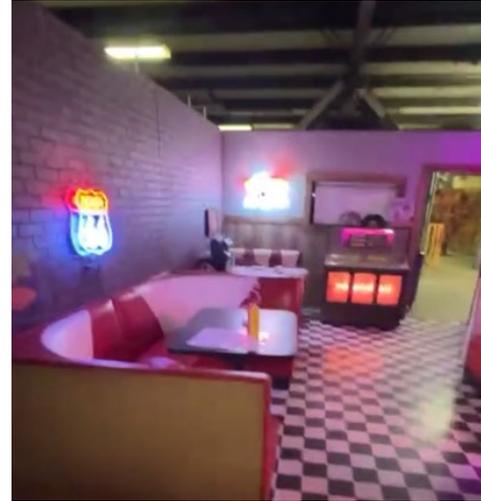
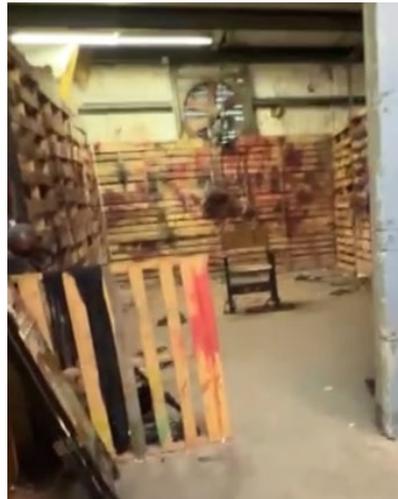
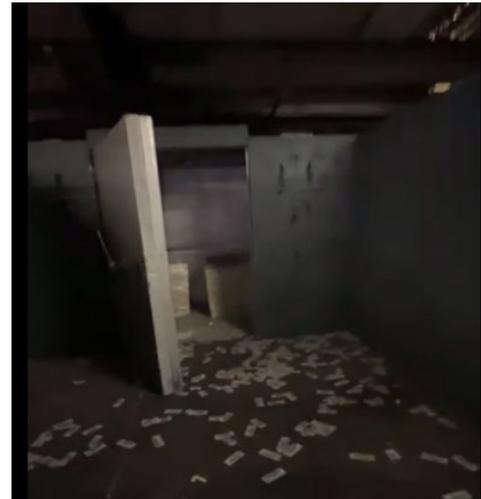
View of temporarily constructed rooms with themed studio props, pre-incident. Photos show rooms were not built to ceiling height.  
(Courtesy of the fire department)

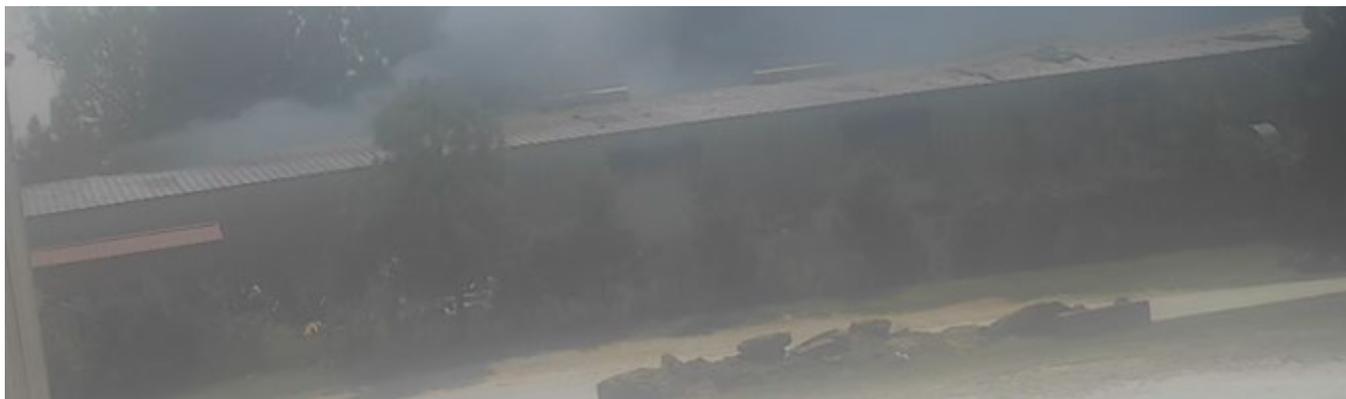
Smoke conditions upon arrival of Engine 14 at 13:37 hours, Side Delta, showing buckling of roof.  
(Courtesy of the fire department)

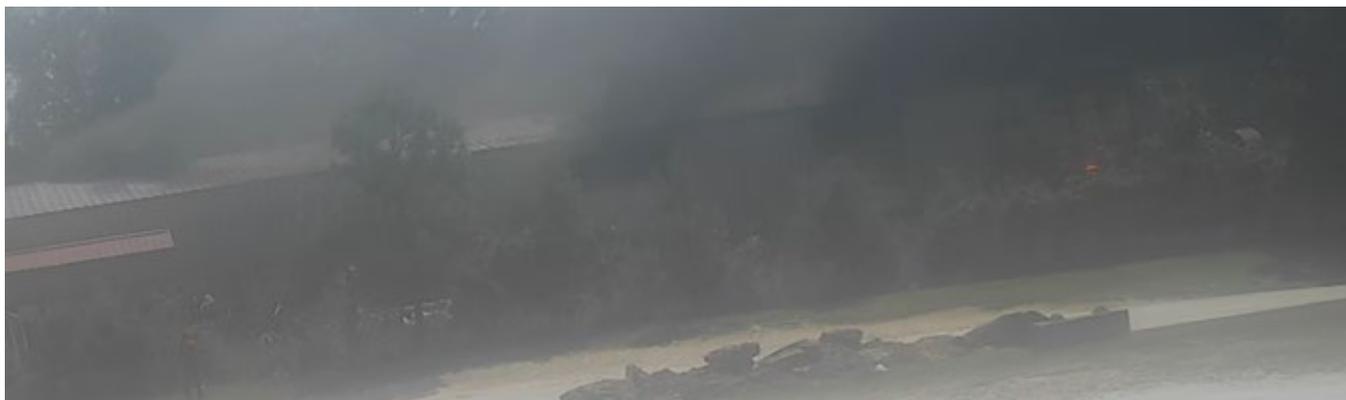
Smoke conditions at 13:50 hours, Side Delta, showing fire.  
(Courtesy of the fire department)

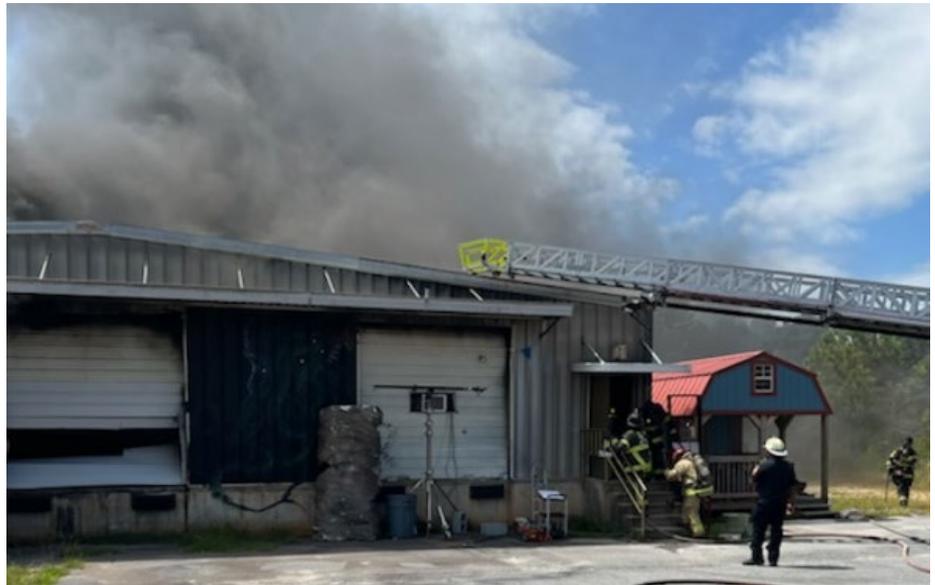
Crews entering to search for Quint 24, Side Alpha.  
(Courtesy of the fire department)

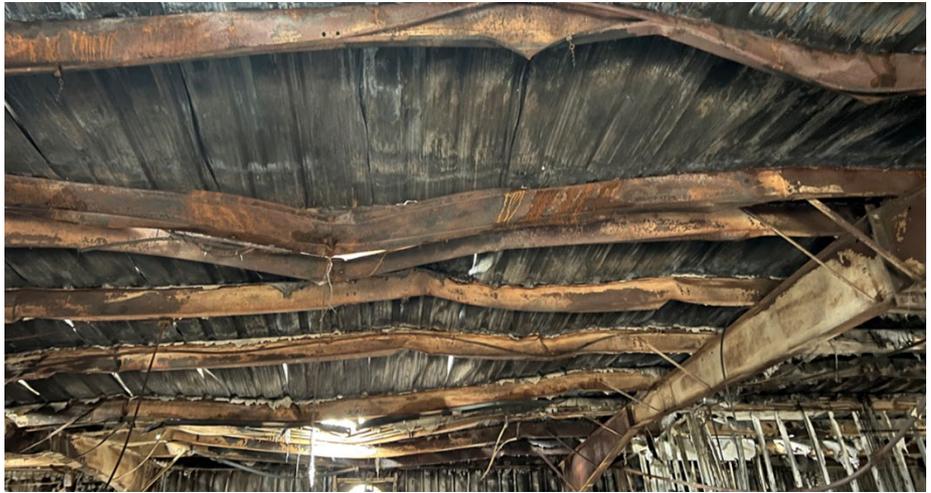
Ceiling condition, post-fire.  
(Courtesy of the fire department)
