# SERIOUS INJURY REPORT

REPORT F2025-10 • January 2026

## **Career Firefighter Sustains Serious Burns and Another Injured in Carport Collapse at Residential Structure Fire – Texas**

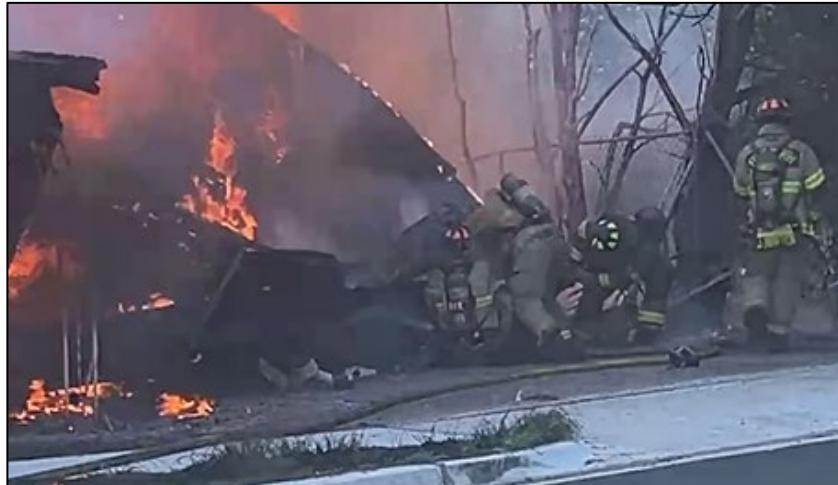
**Photo 1: View of Side Alpha, post-collapse.**  
*(Courtesy of the fire department)*

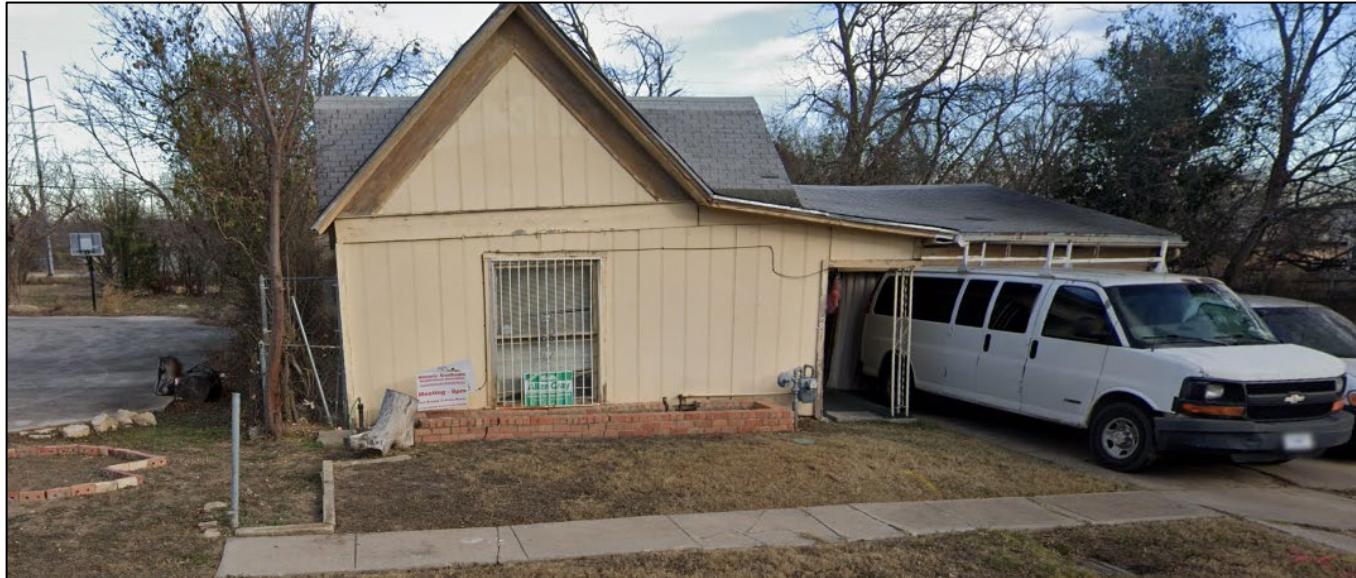
This incident involved a type V, wood-frame constructed, residential structure that was built in 1916 (see **Photo 2**). It was one-story with 1,020 sq ft of living space that was built on a 4,791 sq ft lot. The structure included an attached wood-frame carport with a roof supported by 3-inch steel support posts. To enclose the carport, there were 31 gauge corrugated galvanized steel panels surrounding the carport (see **Photo 3**). The structure had steel security coverings on all doors and windows (see **Photo 4**).

**Photo 2: View of Side Alpha, pre-incident**  
*(Courtesy of the fire department)*

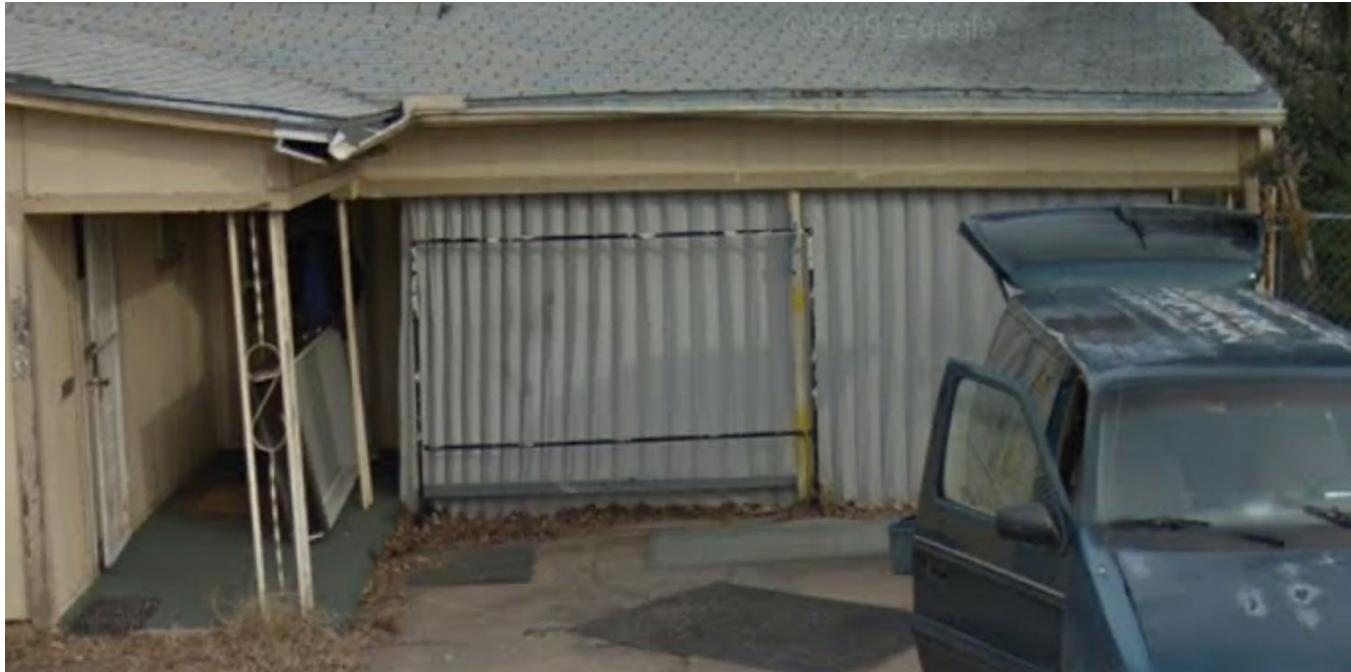
**Photo 3: View of Side Alpha, carport with corrugated steel panels.**  
*(Courtesy of the fire department)*

At this incident, the carport had a roof constructed with wood beams attached to the residence which was supported by 3-inch steel support posts. The lean-to-style collapse of the carport resulted in the roof at the Side Alpha/Delta corner falling directly onto Engine 11 firefighter.

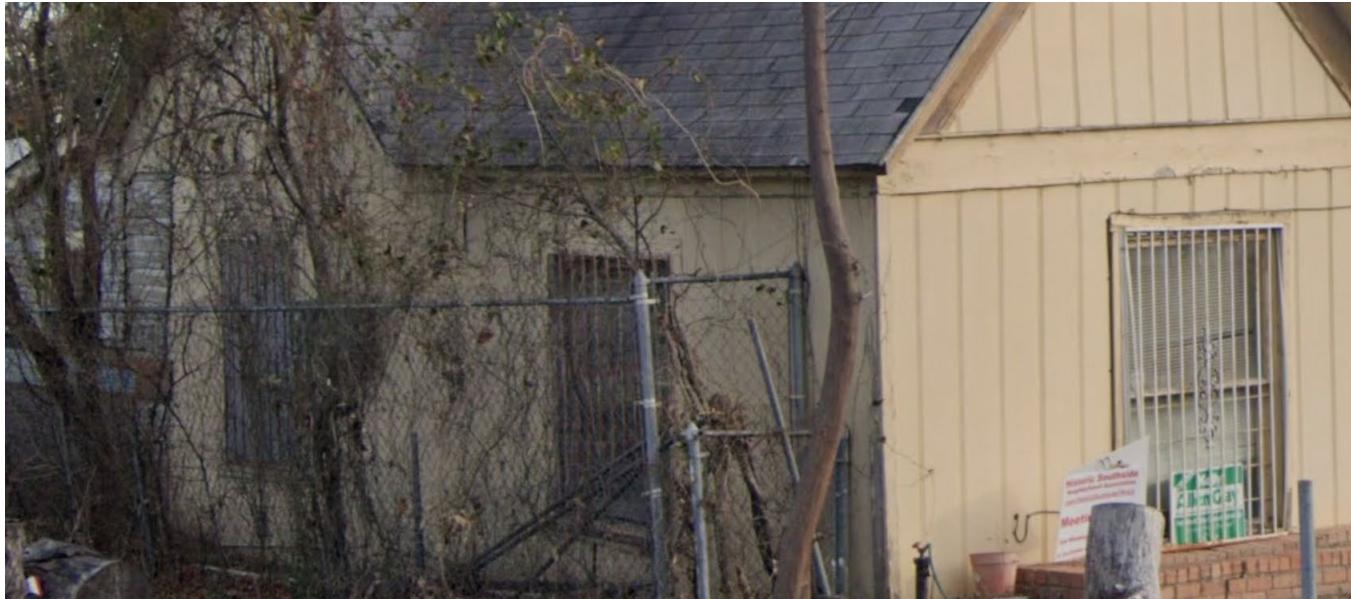
**Photo 4: View of security bars on windows, Side Alpha/Bravo corner.**  
*(Courtesy of the fire department)*

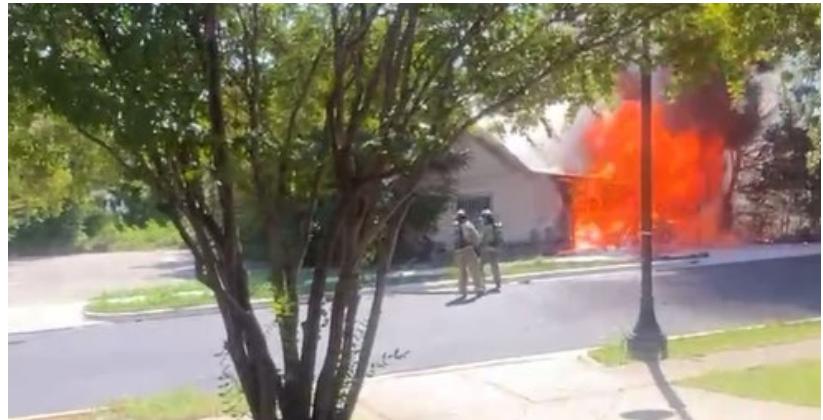
**Photo 5: Arrival conditions on Side Alpha.**  
*(Courtesy of the fire department)*

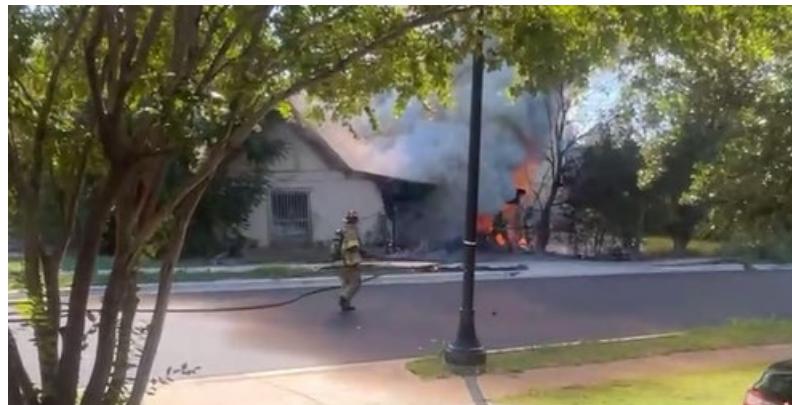
under the carport. Engine 11 firefighter took one step under the carport at the corner and started extinguishing the wood support beam (see **Photo 6**). Seconds later at 10:59 hours, the carport experienced a lean-to-style collapse with the roof remaining attached to the residence. This collapse trapped Engine 11 firefighter under the burning roof. His entire body was covered, except for one leg. He tried to reach for his radio mic but was unable to with his arms pinned.

**Photo 6: Engine 11 firefighter stepping under carport.**  
*(Courtesy of the fire department)*

At this incident, Engine 11 firefighter began a transitional attack with a 1 ¾-inch pre-connect, extinguishing fire under the carport by starting on the left side and moving right. Engine 11 officer then directed him to the Side Alpha/Delta corner to extinguish a burning car under the carport. Engine 11 firefighter took one step under the carport at the corner, extinguishing the wood support beam before it collapsed.

#### ***Recommendation #1a: Fire departments should ensure firefighters extinguish fires from a relative area of safety when performing exterior fire control as part of a transitional attack.***

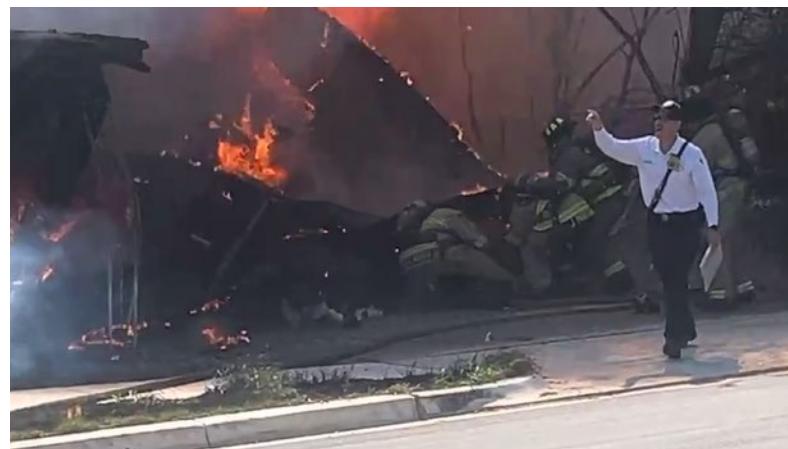
Engine 5 officer and firefighters from other units tried to extricate Engine 11 firefighter from the collapse (see **Photo 7**). They used hand tools and manually lifted the roof enough to pull the firefighter out. At 11:01 hours, Engine 11 firefighter was extricated and put onto a stretcher for treatment and transport. He was airlifted to a medical facility for treatment. Engine 11 officer was also transported for smoke inhalation injuries. After the extrication, multiple hoselines and a defensive strategy were used to bring the fire under control at 11:54 hours.

**Photo 7: Extrication operation.**  
*(Courtesy of the fire department)*

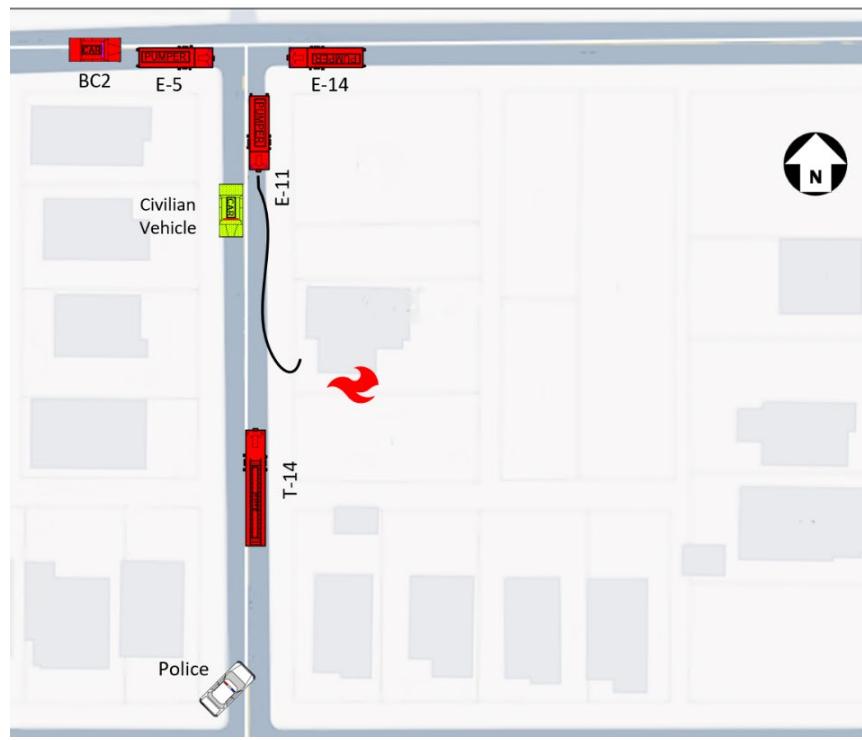
When conducting fire control, fire officers and firefighters should consider apparatus placement in context of water sources and distance from the fire. In this incident, Engine 11 positioned short of the structure on the Side Alpha/Bravo corner (see Diagram 1). Although Engine 11 firefighter deployed 200 ft of hoseline, the apparatus position may have limited their reach as the incident progressed. The position of Engine 11 did not allow for the potential use of a deck gun, which is an alternate technique used for exterior fire control [NFPA 1700 2026].

**Diagram 1: Apparatus placement on scene.**  
*(Courtesy of NIOSH)*
