F2025-10

**Career Firefighter Sustains
Serious Burns and Another
Injured in Carport Collapse at
Residential Structure Fire – Texas**

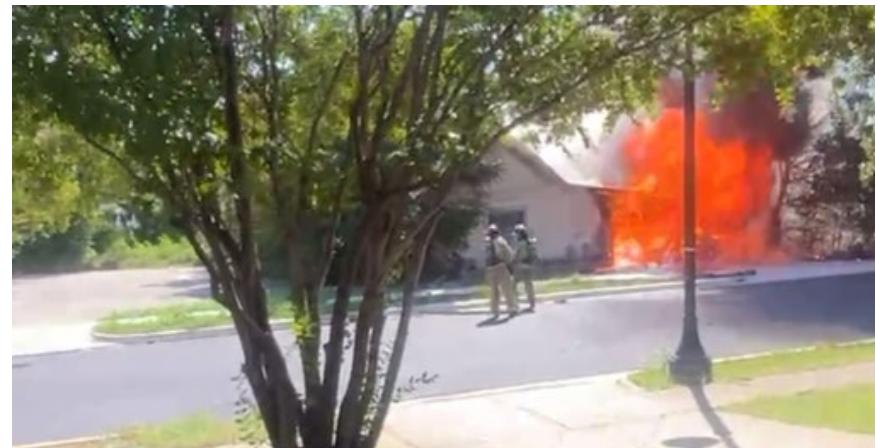
Arrival conditions on Side Alpha.
(Courtesy of the fire department)

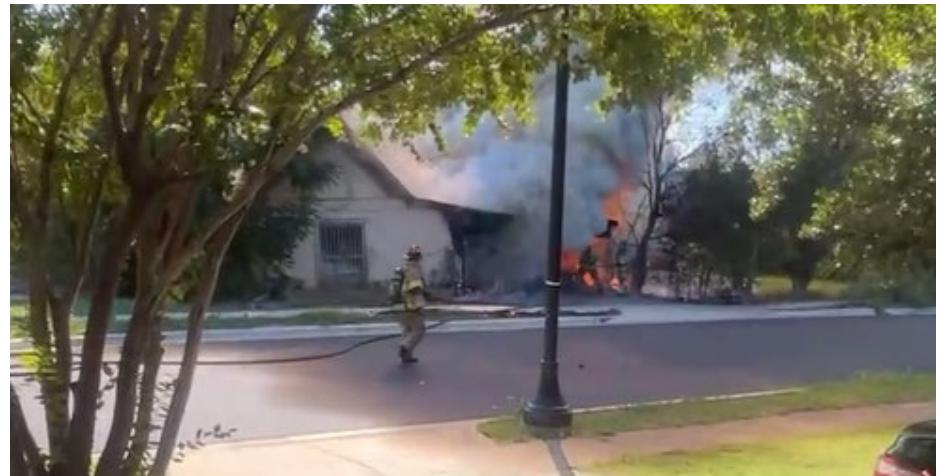
- Engine 11 firefighter deployed a 200 ft 1 3/4-inch pre-connect and began to extinguish fire under the carport by starting on the left side and moving right.
- Engine 11 officer directed him to the Side Alpha/Delta corner to extinguish a burning car under the carport.
- Engine 11 firefighter took one step under the carport at the corner and started extinguishing the wood support beam.

Engine 11 firefighter stepping under carport.
(Courtesy of the fire department)

- Fire departments should ensure firefighters extinguish fires from a relative area of safety when performing exterior fire control as part of a transitional attack.
- Fire departments should educate fire officers and firefighters in building performance under fire conditions and the potential for structural collapse.
- Fire departments should complete an initial scene size-up and risk assessment to inform a risk-benefit analysis.
- Fire departments should train incident commanders how to spot and correct task saturation to quickly refocus emergency response operations.
- Fire departments should coordinate with law enforcement agencies to overcome challenges of scene access for responding fire apparatus.

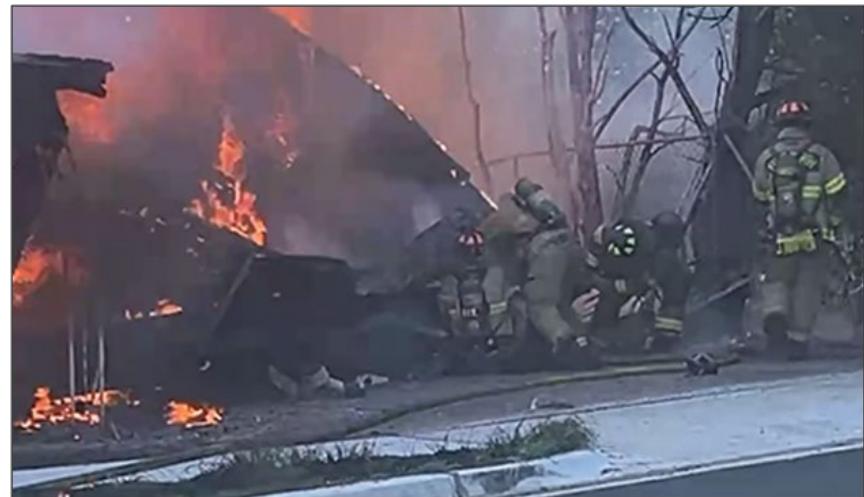
- Seconds later at 10:59 hours, the carport experienced a lean-to-style collapse with the roof remaining attached to the residence.
- This collapse trapped Engine 11 firefighter under the burning roof.
- Battalion 2 directed Engine 14 to send their crew to the scene immediately, then called a Mayday stating a firefighter was trapped under the partial collapse of the building on Side Alpha.

View of Side Alpha, post-collapse.
(Courtesy of the fire department)

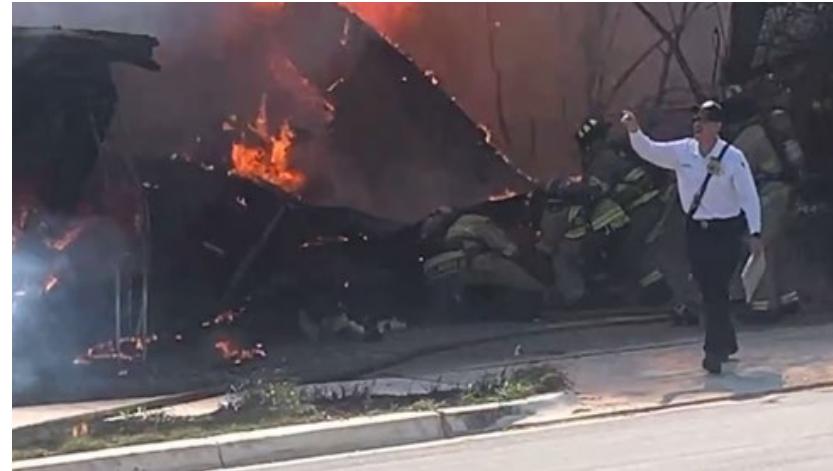
- Battalion 2 requested Truck 14 bring rescue tools and called for the PSAP to dispatch a second alarm.
- Engine 5 officer and firefighters from other units tried to extricate Engine 11 firefighter from the collapse.
- They used hand tools and manually lifted the roof enough to pull the firefighter out.

Extrication operation.
(Courtesy of the fire department)
