SERIOUS INJURY REPORT

REPORT F2026-01 • April 2026

Four Career Firefighters Injured from a Floor Collapse in an Abandoned Residential Structure Fire – Kansas

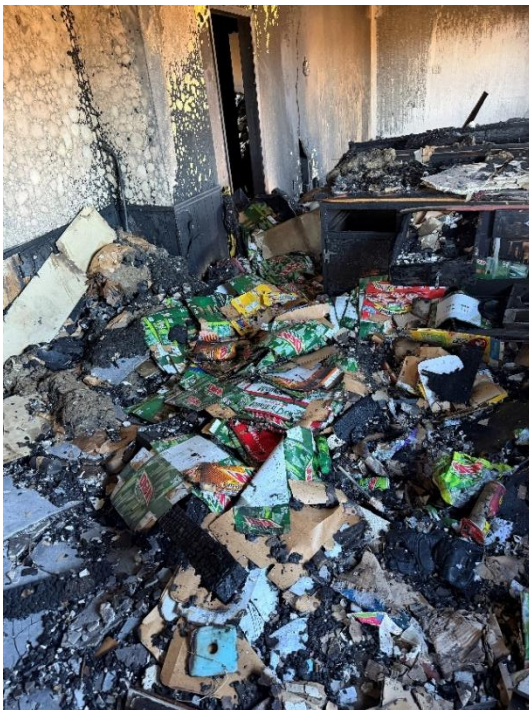
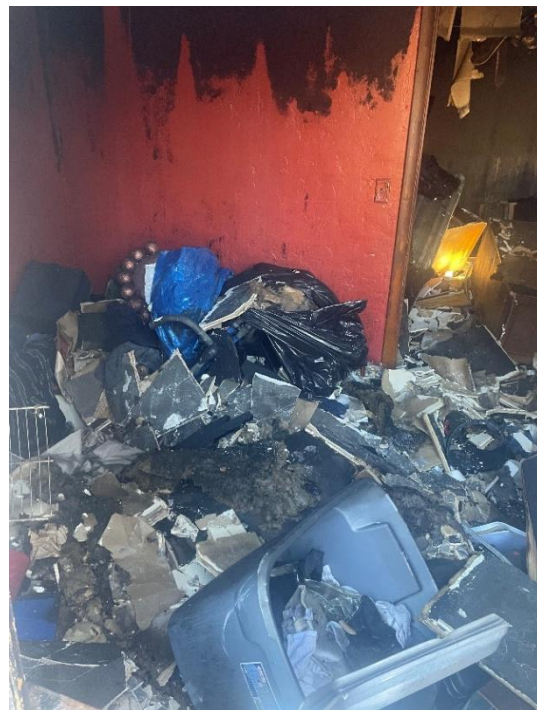
The structure was reported to be abandoned for 18 months, with a significant amount of furniture, trash, and debris spread throughout the interior (see **Photo 3 and 4**). Many of the structure openings were unprotected and consequently, there were reports of unauthorized people accessing and using the space.

Photo 3 and 4: View of trash on first floor.
(Courtesy of the fire department)

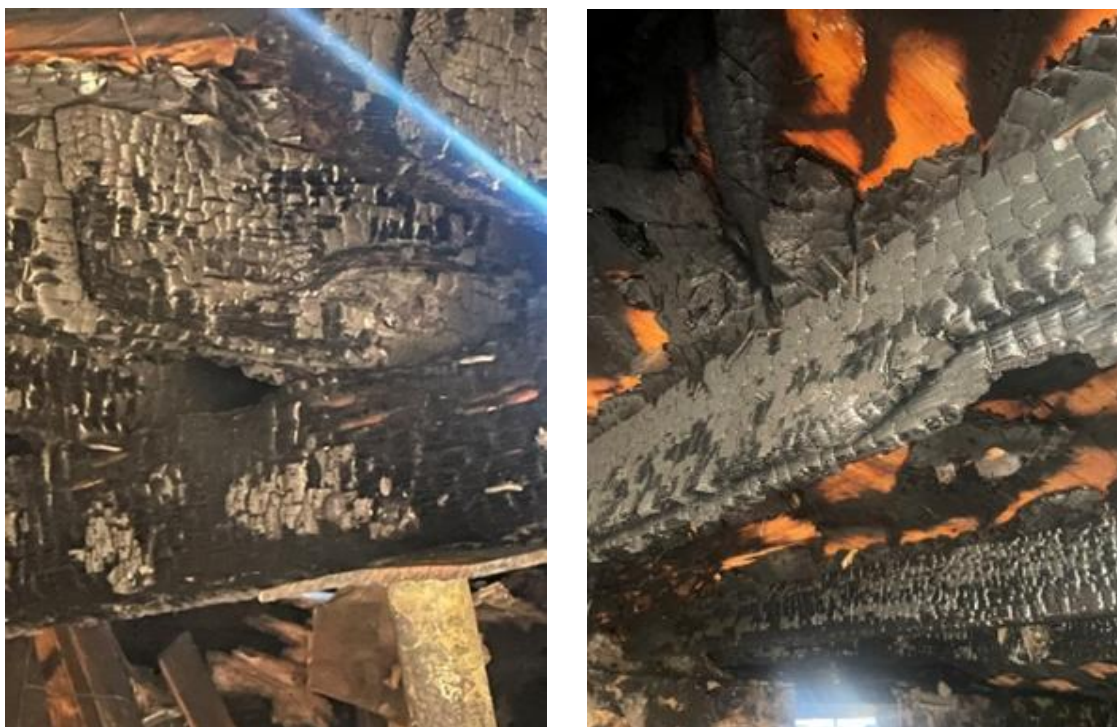
Solid-sawn lumber often exhibits predictable charring behavior when exposed to fire, with an average charring rate between 1.2 to 1.9 inches per hour when tested in ASTM E 119 fire resistance test furnace conditions [Babrauskas 2005]. As charring progressed, the effective cross-section of the joists decreased,

resulting in reduced load-bearing capacity and eventual structural failure (see **Photo 5**). The area of collapse was completely consumed by fire, while surrounding joists exhibited significant charring and thermal degradation (see **Photo 6**). Given the large fuel load in the basement and extended pre-detection burn time, floor joists were likely exposed to direct flame impingement and sustained high heat energy for a prolonged period prior to suppression operations. These conditions likely resulted in a significant reduction in structural cross-section of joists, loss of load-bearing capacity, weakening of joist connections, and progressive structural failure leading to collapse. The Fire Safety Research Institute conducted basement fire experiments to determine times to floor collapse. The collapse times for nominal dimensioned 2 x 12-inch lumber, exposed to the fire was less than 13 minutes after ignition of the fuel in the basement [Kerber et al. 2012].

Photo 5 and 6: View of joist charring.
(Courtesy of the fire department)

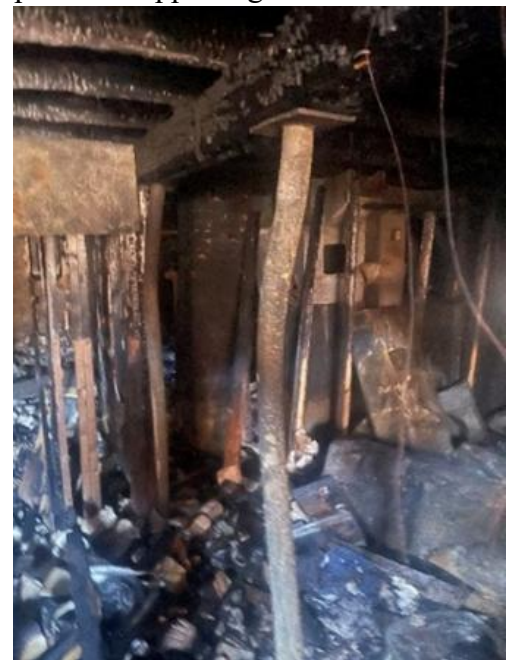
During the post-incident assessment of the structure, several steel lally columns located in the basement were observed to have significant bowing and twisting deformation (see **Photo 7**). These conditions are consistent with loss of compressive strength in structural steel due to prolonged exposure to elevated temperatures during the fire event. As temperatures approach approximately 1,000°F (538°C), structural steel can lose roughly 50 percent of its load-bearing capacity, and as temperatures continue to rise toward 1,100-1,200°F, the material begins to experience substantial reductions in both yield strength and modulus of elasticity [AISC 2011]. Based on the fire conditions present in the basement area, it is likely that the compartment experienced significant heat buildup due to limited ventilation and the presence of combustible contents, allowing temperatures to increase rapidly. Fire dynamics within a confined

As the fire progressed, the steel columns would have absorbed heat energy through convective and radiant heat from flame impingement and superheated gases, as well as conduction through connected structural elements. As the steel columns were exposed to elevated temperatures, the internal crystal structure of the metal began to change, causing thermal expansion followed by a progressive loss of tensile strength and stiffness. This weakening allowed the columns to deform under the existing structural loads they were designed to support. The observed bowing of the columns indicates compressive instability, where the steel members were no longer capable of supporting the vertical loads from the structure above. Additionally, the twisting deformation (**Photo 7**) suggests uneven heating and thermal expansion, likely caused by asymmetric fire exposure or varying heat intensities across the surface of the column. As portions of the steel heated more rapidly than others, differential expansion would have produced torsional stresses within the column, contributing to the twisting observed during the examination. These deformation patterns are consistent with heat-induced structural compromise, indicating that the basement compartment was subjected to temperatures sufficient to significantly reduce the load-bearing capacity of the steel support system. Once the tensile strength of the columns was reduced beyond their design limits, the structural members began to deform under load, leading to the visible bowing and twisting noted during the investigation. The condition of the lally columns provides important physical evidence supporting the conclusion that the basement fire produced sustained high-temperature conditions capable of impacting structural stability, and that the failure of these support elements was the result of thermal degradation of the steel rather than mechanical impact or pre-existing structural deficiencies.

Photo 7: Twisting of steel column.
(Courtesy of the fire department)

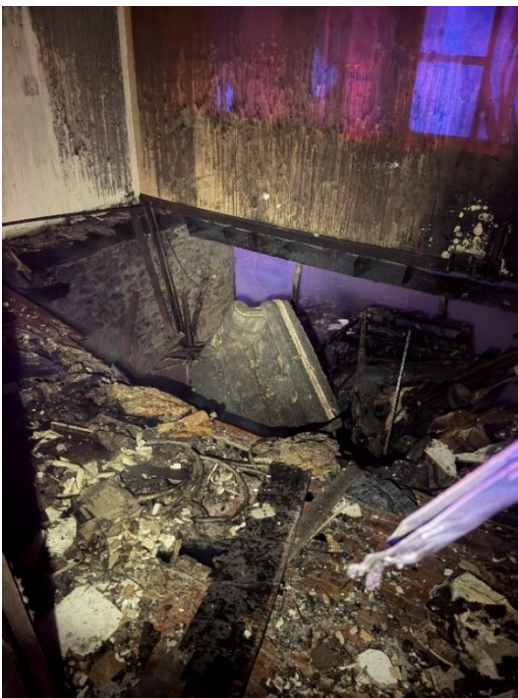
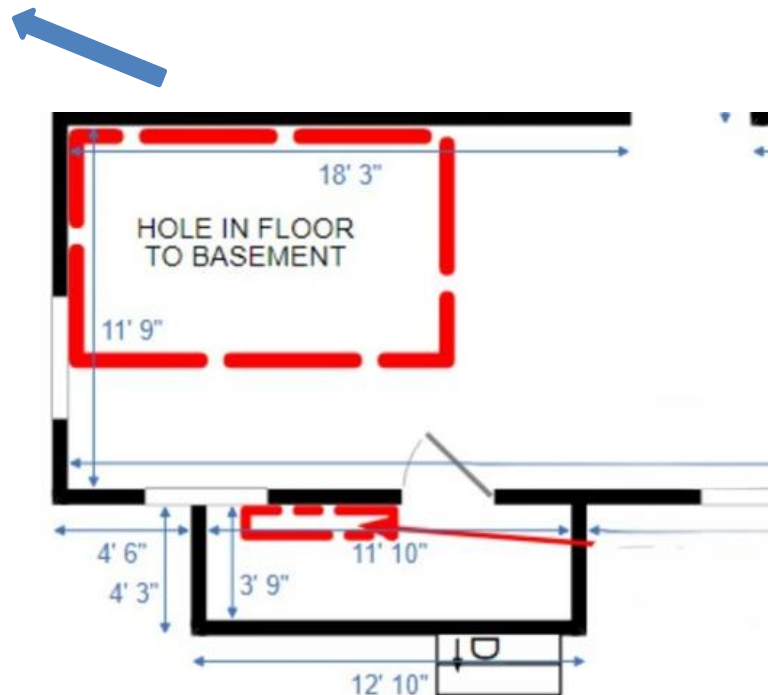
Photo 10 and Diagram 2: View of first floor collapse.
(Courtesy of the fire department)

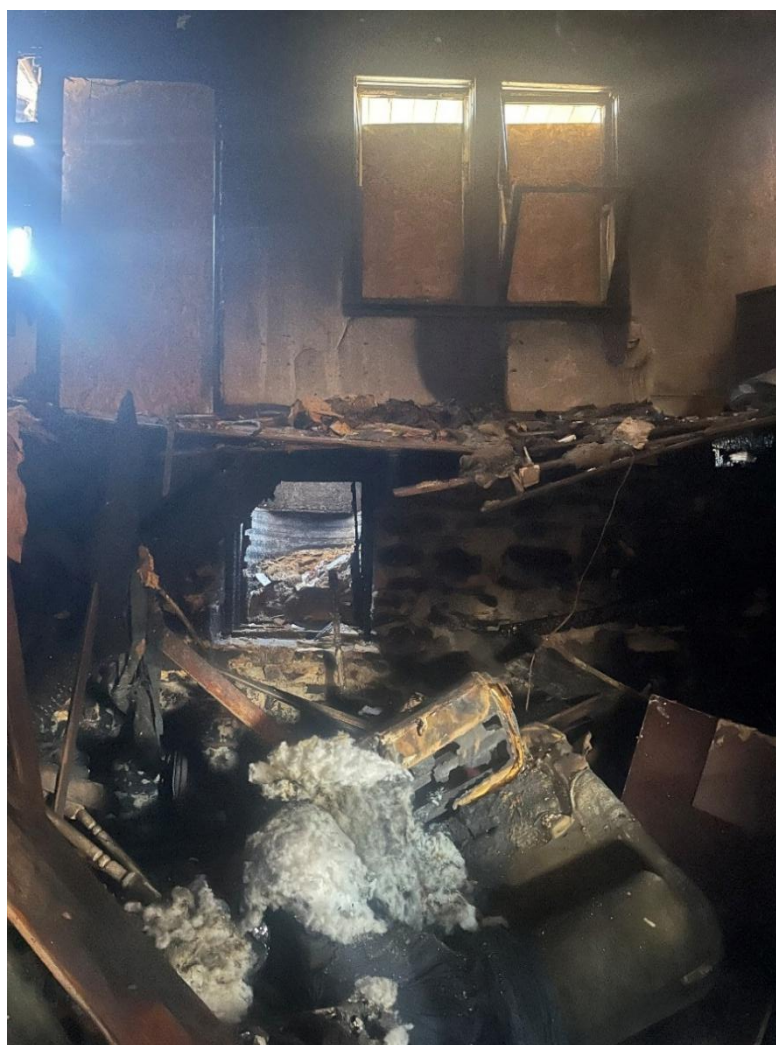
Photo 11: View of area of collapse with debris.
(Courtesy of the fire department)

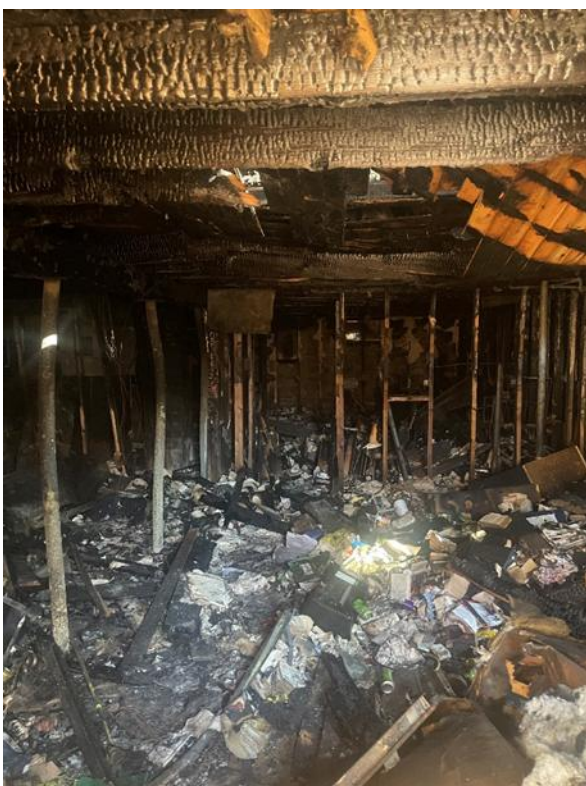
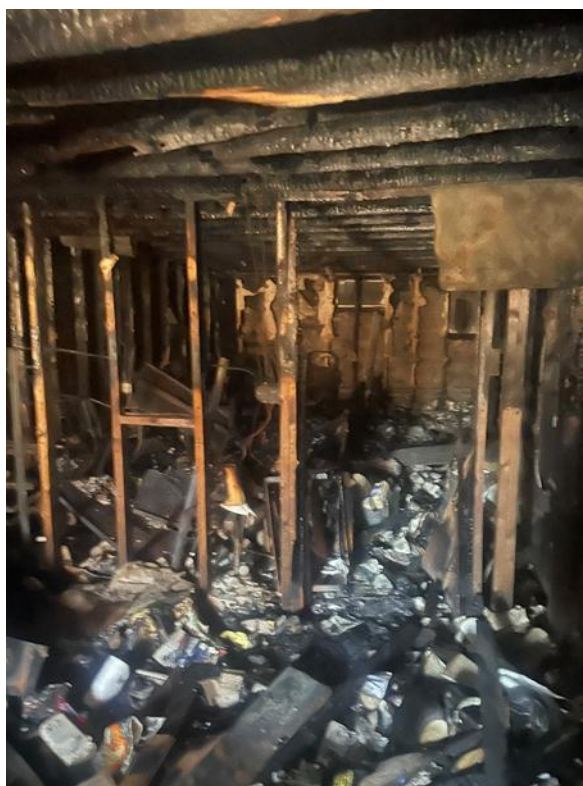
Photo 12 and 13: Basement with debris, post-fire.
(Courtesy of the fire department)
