**SERIOUS
INJURY REPORT**
REPORT SLIDES

F2026-01

Four Career Firefighters Injured
from a Floor Collapse in an
Abandoned Residential Structure
Fire – Kansas

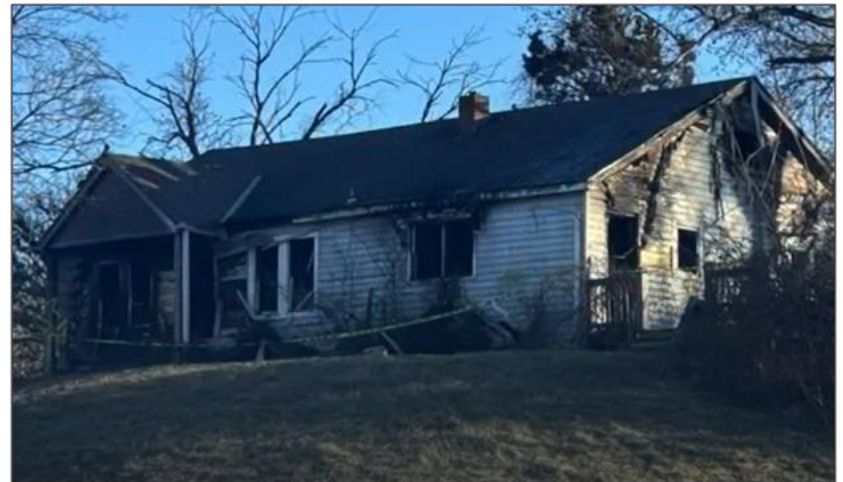
View of Side Alpha of structure, post-fire.
(Courtesy of the fire department)

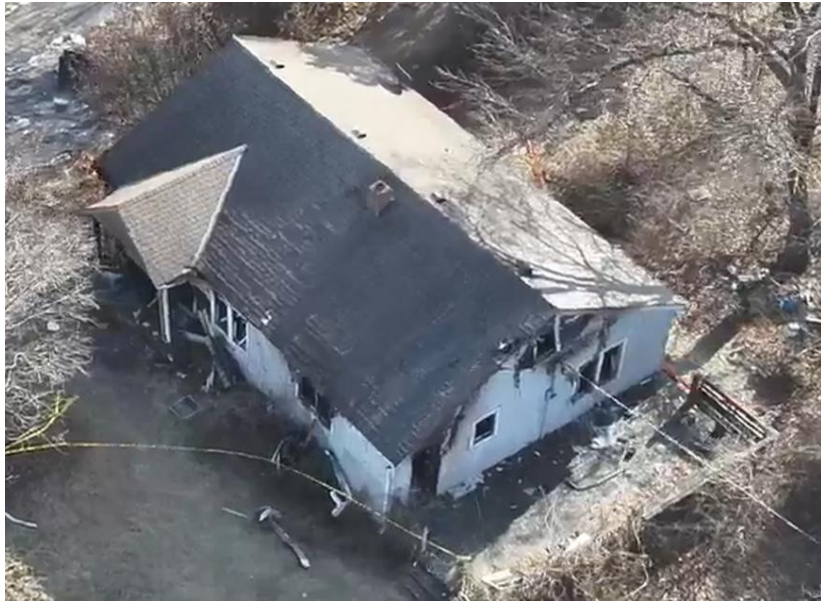
Aerial view of structure, post-fire.
(Courtesy of the fire department)

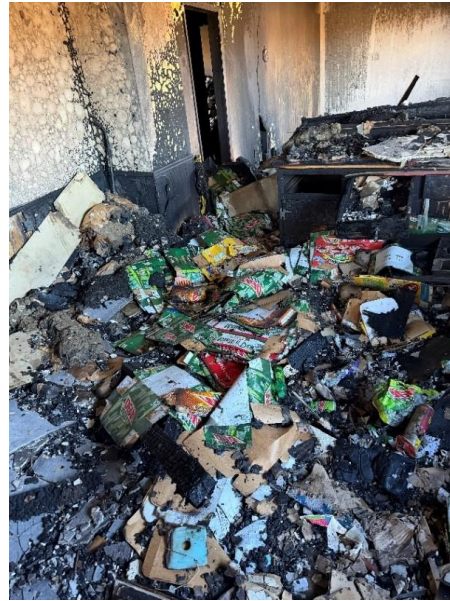
View of trash on first floor.
(Courtesy of the fire department)

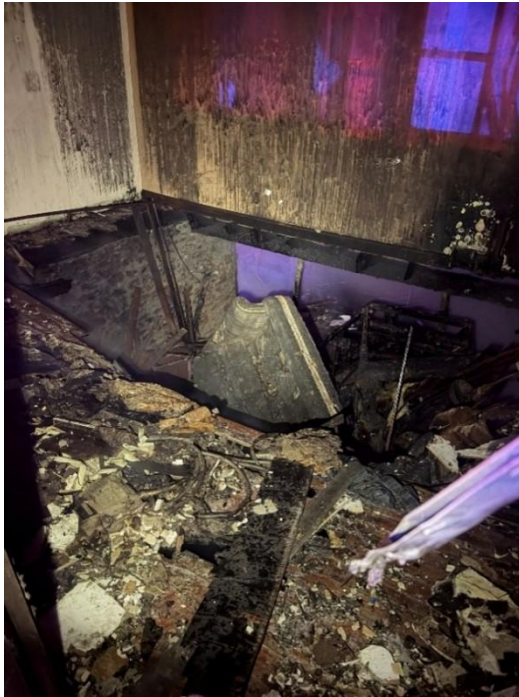
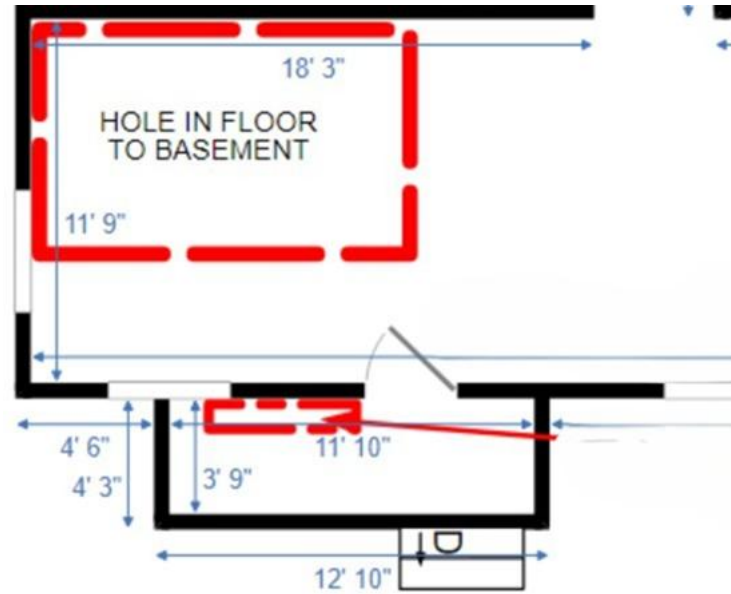
- Pumper 18 crew encountered heavy smoke conditions, no visibility, with no elevated heat.
- The crew of Quint 2 followed Pumper 18's crew and noticed flames coming through the floor.
- At 03:53 hours, the Shift Commander arrived on scene and assumed incident command (IC).
- Around the same time, there was a partial collapse of the living room floor.
- This caused Pumper 18 firefighter, Pumper 18 officer, and one Medic 18 firefighter to fall into the basement.

View of first floor collapse. (Courtesy of the fire department)

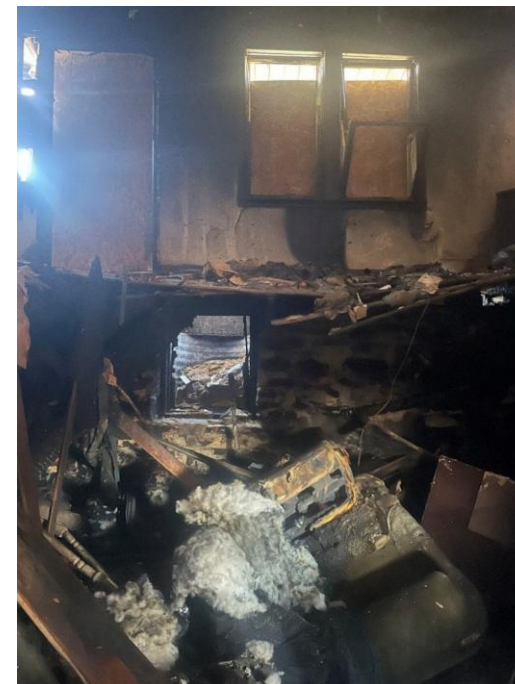
View of area of collapse with debris.
(Courtesy of the fire department)
