# SERIOUS INJURY REPORT

REPORT F2026-02 • April 2026

## ***Career Firefighter Injured after Falling from Ladder while Self-Extricating from Boarding House Fire – Pennsylvania***

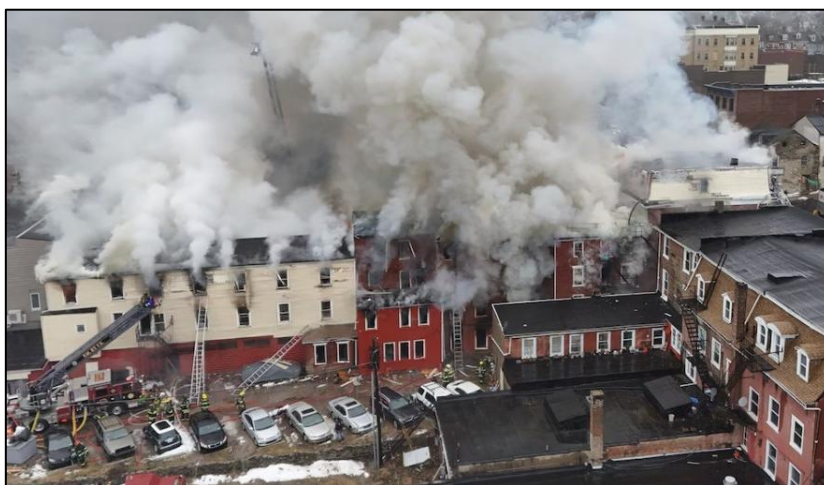
**Photo 1: View of structure, Side Bravo.  
(Courtesy of the fire department)**

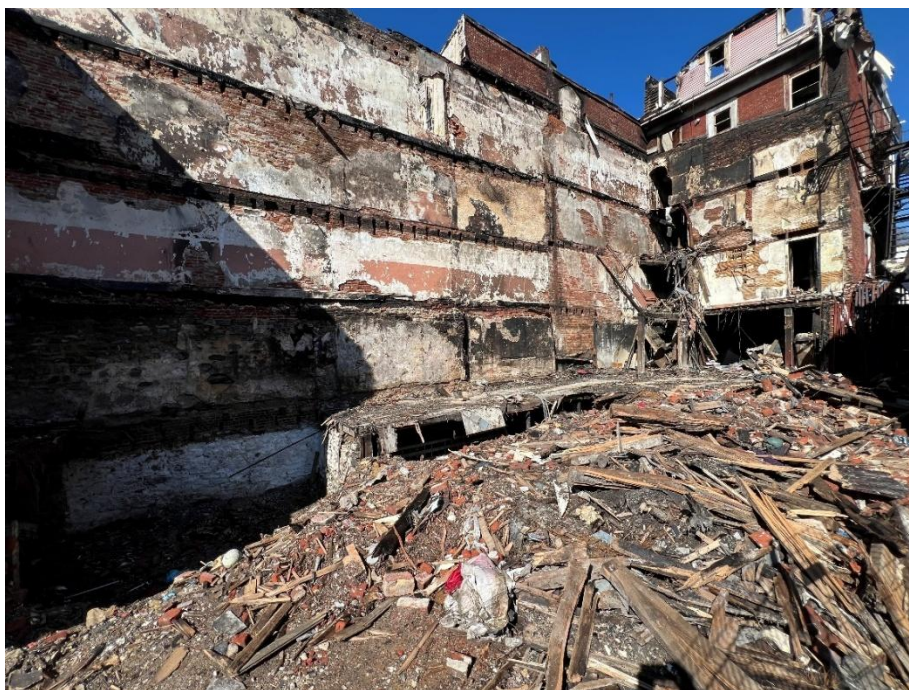
**Photo 2: View of pockets for floor and roof joists, post-fire.**  
*(Courtesy of the fire department)*

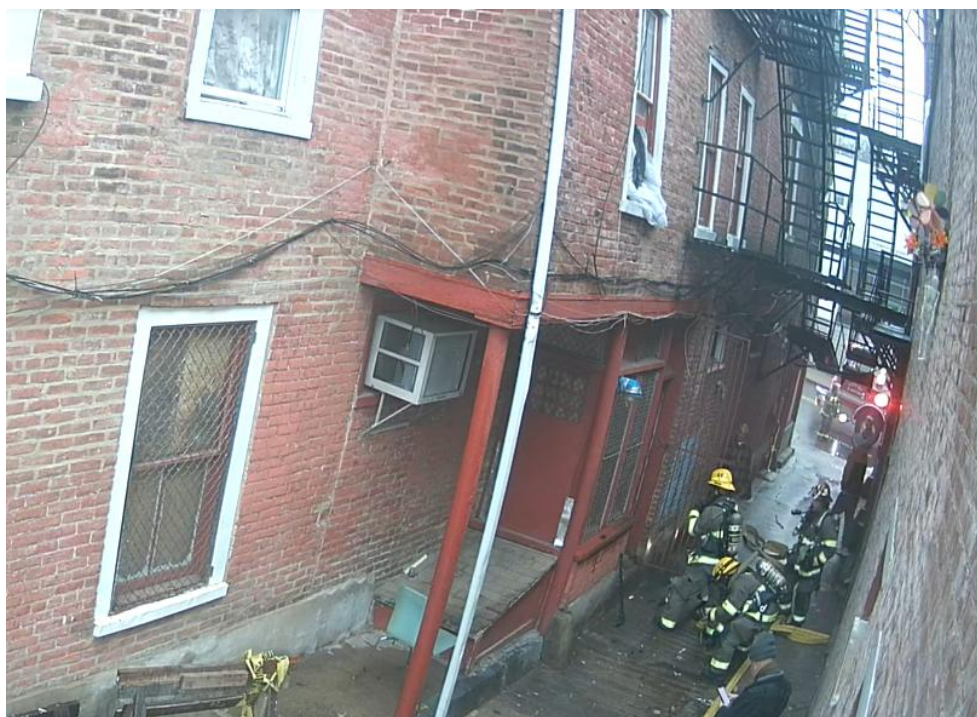
**Photo 3: Firefighters preparing to enter the basement, Side Bravo.**  
*(Courtesy of the fire department)*

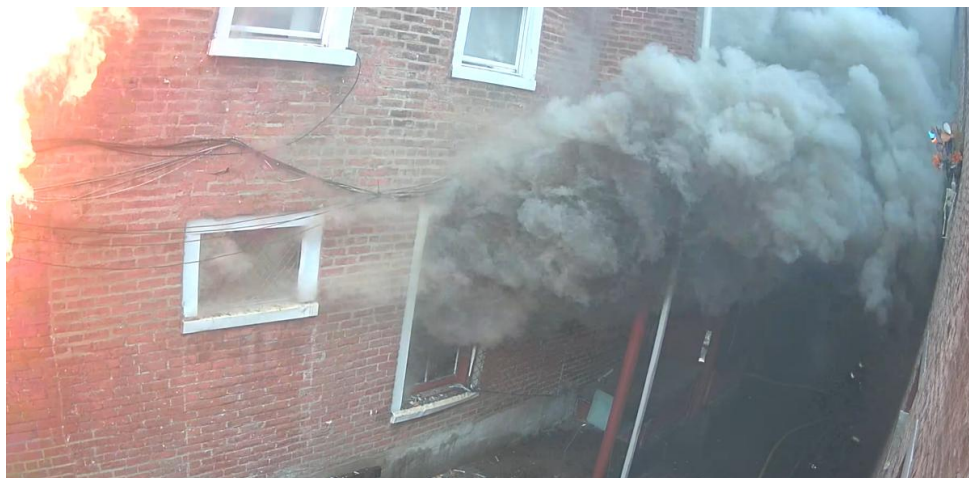
At 10:55 hours, the PSAP dispatched the second alarm assignment and an all-call for station 20. Captain 20 walked down the alley on Side Bravo and reported active fire from windows on the first division. He requested the firefighters in the basement to evacuate as they had fire above them. The firefighters exited the basement and took the hoseline back into the alley. Engine 20-4 firefighters and Utility 20 firefighter removed the metal security grilles and plywood off the first division windows. As the windows were opened, smoke became more turbulent with flames (see Photo 4).

**Photo 4: Post-ventilation conditions, Side Bravo.**  
(Courtesy of the fire department)

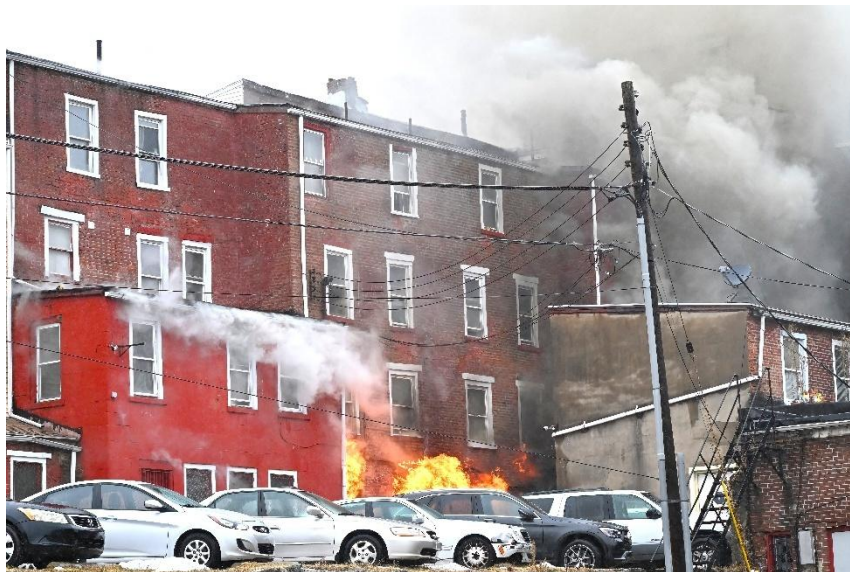
**Photo 5: Fire conditions, Side Bravo.**  
*(Courtesy of the fire department)*

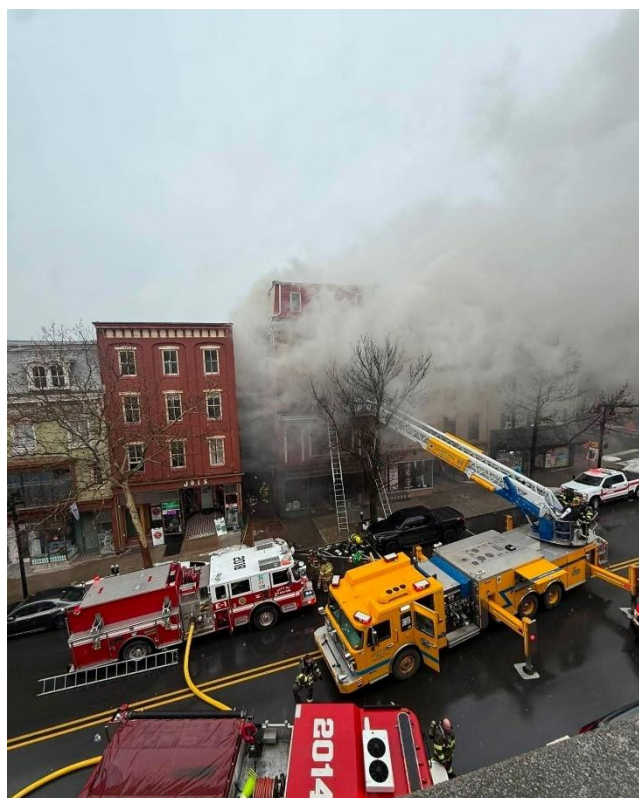
**Photo 6).** Chief 20-1 again directed Tiller 27 to stage on Side Charlie for rescues. Lieutenant 20 reported another victim on the third division and no victims visible on Side Charlie from the ground.

**Photo 6: Apparatus placement, Side Alpha.**  
(Courtesy of the fire department)

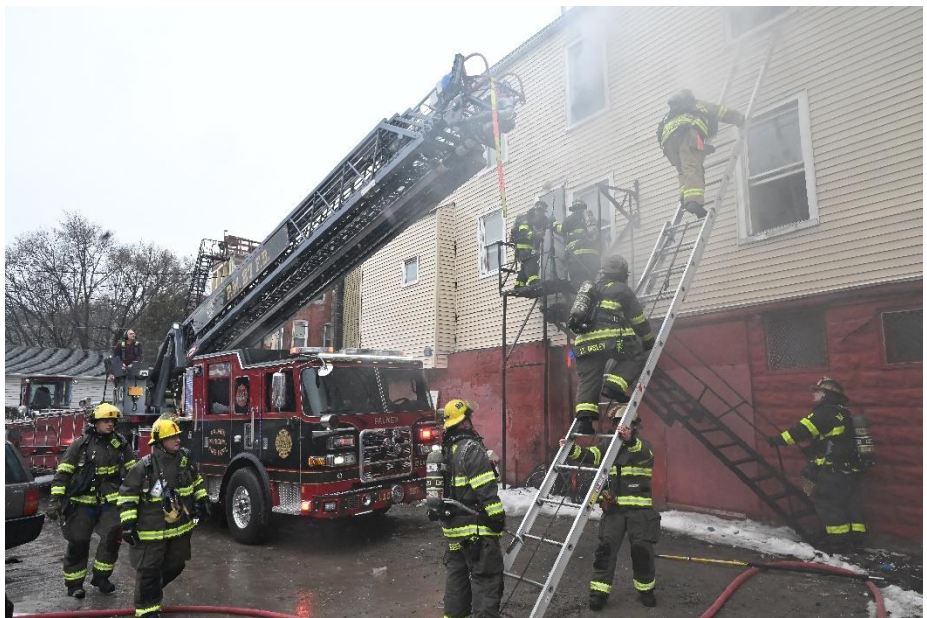
**Photo 7: Lieutenants 20 and 24 climbing ladder, Side Bravo.**  
*(Courtesy of the fire department)*

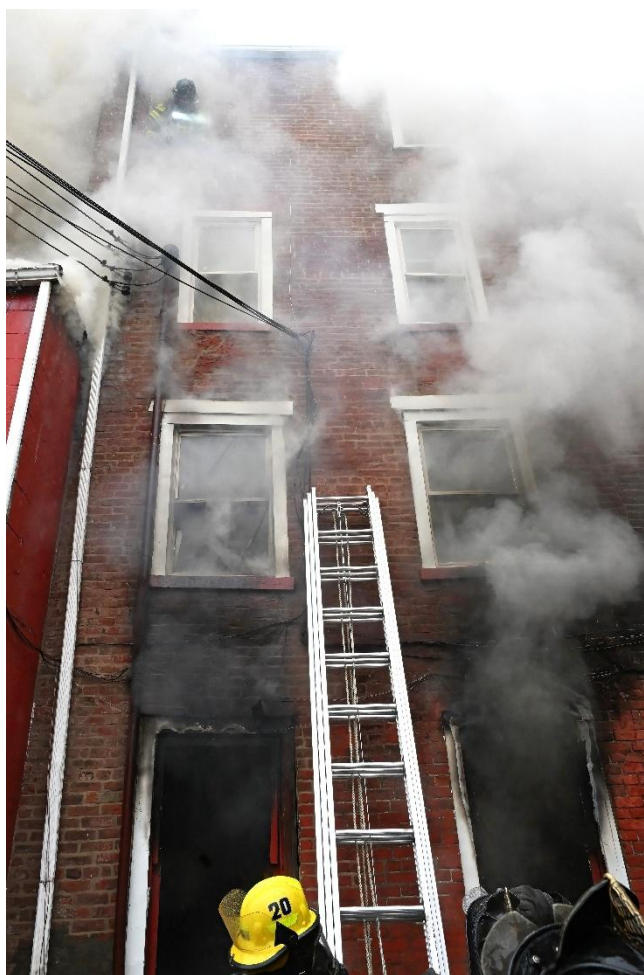
At 11:19 hours, Chief 20 requested the PSAP announce to all units to evacuate the structure. Not being able to hear the radio and transmit clearly, Ladder 24 firefighter deactivated his PASS. Ladder 24 firefighter again reported he couldn't get out or breathe. He stated he needed a ladder and could see one below. As the wind blew the smoke periodically from the windows, firefighters on the ground saw Ladder 24 firefighter for a moment. They started to raise a 35 ft ladder to his location (see Photo 8).

**Photo 8: Ladder 24 firefighter in window, Side Bravo.**  
*(Courtesy of the fire department)*

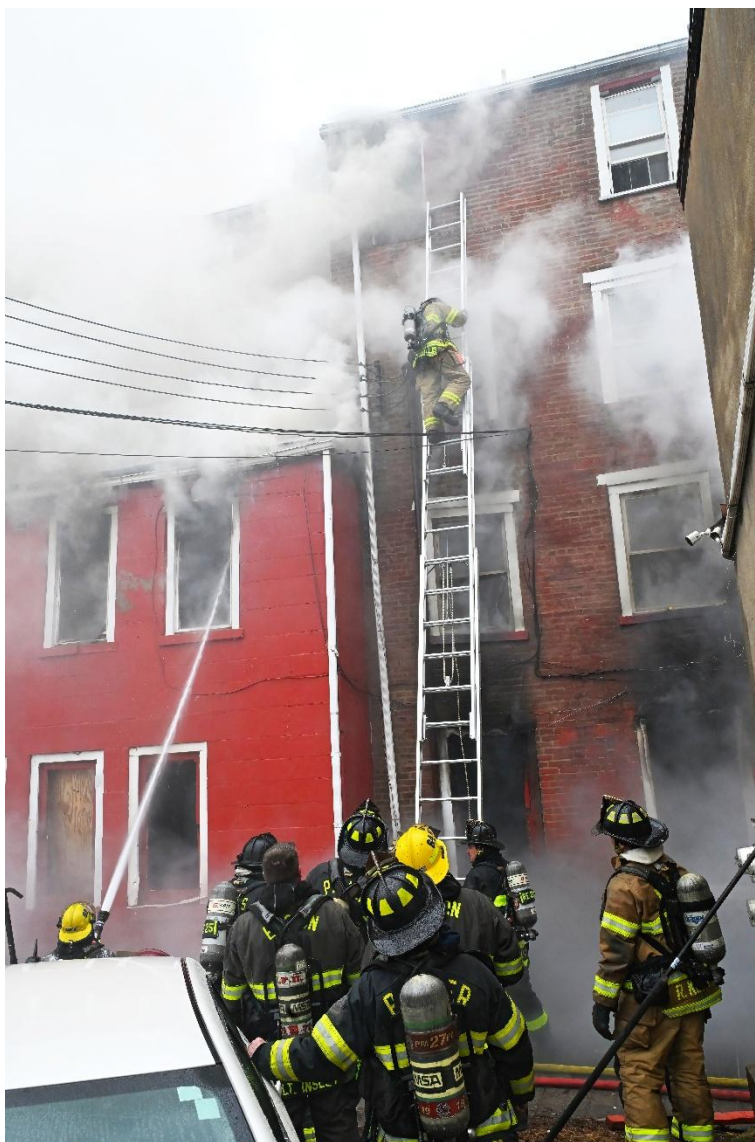
**Photo 9: Ladder 24 firefighter descending ladder, Side Bravo.**  
*(Courtesy of the fire department)*

Ladder 24 firefighter was out of air and spent over 10 minutes inhaling smoke and byproducts of combustion while he waited for a ladder. Halfway down, he stepped off the ladder after losing consciousness and fell about 20 ft to the ground. He sustained a broken back and ankle, injured shoulder, and respiratory injuries from smoke inhalation. His treatment included oxygen therapy while at the hospital due to low oxygen levels and carbon monoxide saturation.

***Recommendation #1: Fire departments should assist Mayday firefighters down ground ladders during self-extrication when their medical status is unknown.***

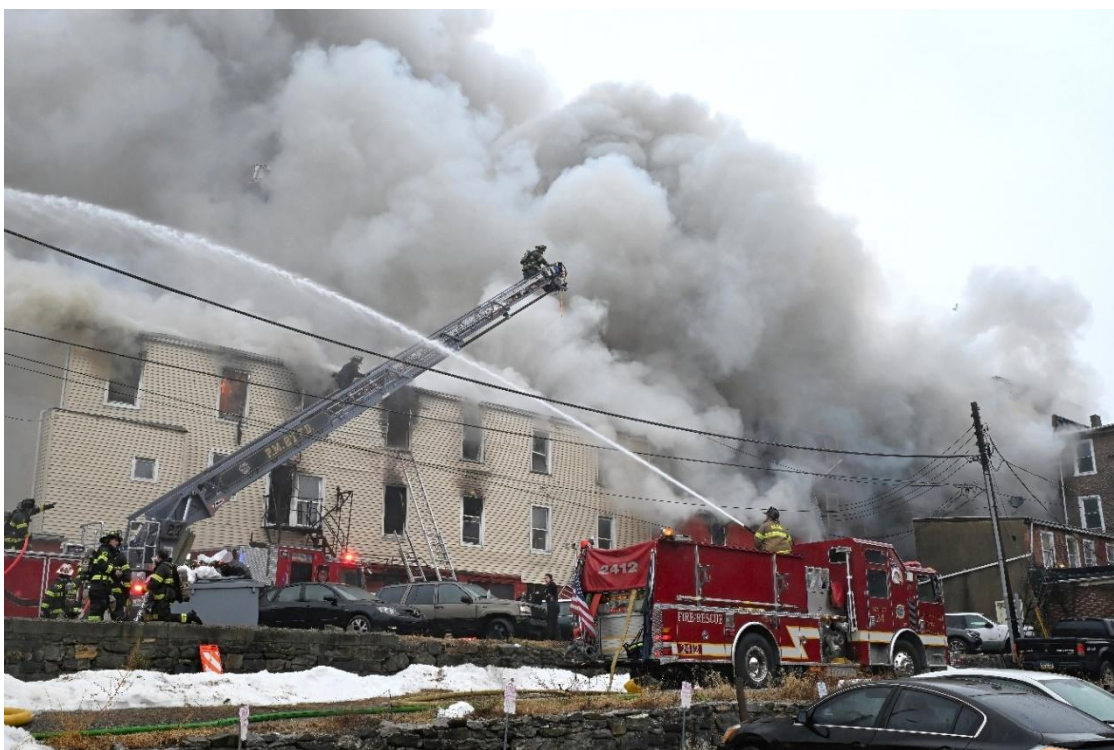
At 11:37 hours, Chief 20 reported that all operations were defensive. Multiple hoselines, ground monitors, and aerial devices were placed into service to flow water into the building (**see Photo 10**).

**Photo 10: Defensive operations, Side Bravo.**  
*(Courtesy of the fire department)*
