# NIOSH FIRE FIGHTER FATALITY INVESTIGATION AND PREVENTION PROGRAM

## SERIOUS INJURY REPORT

### Career firefighter sustains serious burns at residential structure fire with hoarding conditions – Virginia

F2026-05 VA · July 2026

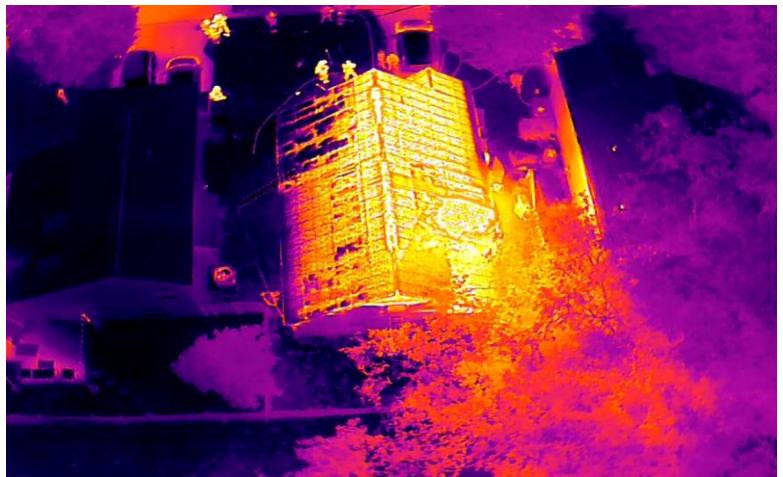
Image 1. Thermal imager reading from Fire Drone, view from above Side Charlie. (Source: Fire department)

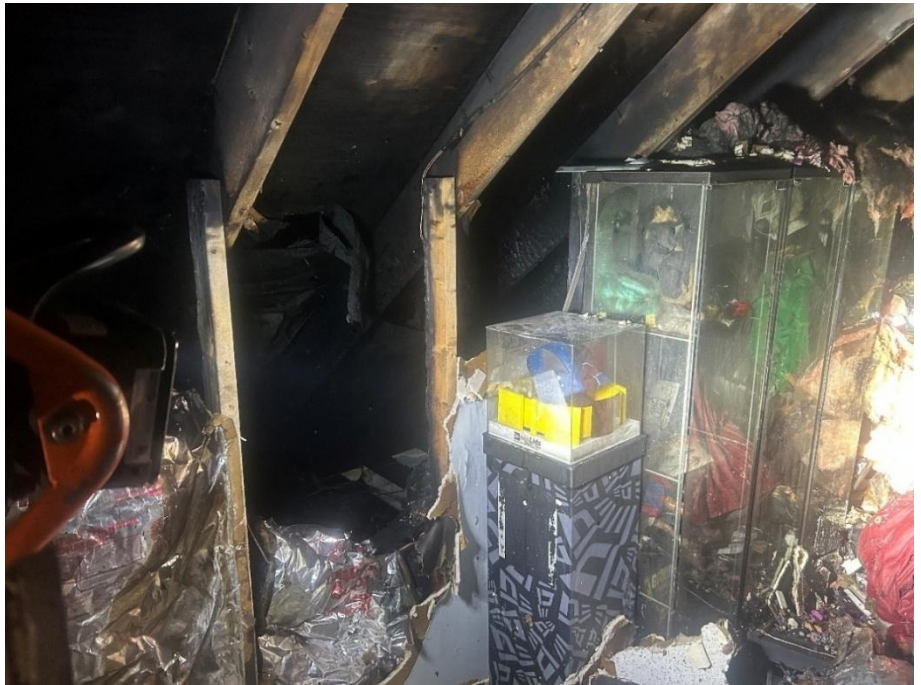
The fire department cause-and-origin investigation classified the fire as accidental. It indicated that the area of origin was a first-division hallway bathroom due to exhaust fan failure. The fire subsequently traveled vertically into the knee wall space above.

Image 3. View of knee wall, Side Bravo, post-incident. (Source: Fire department)

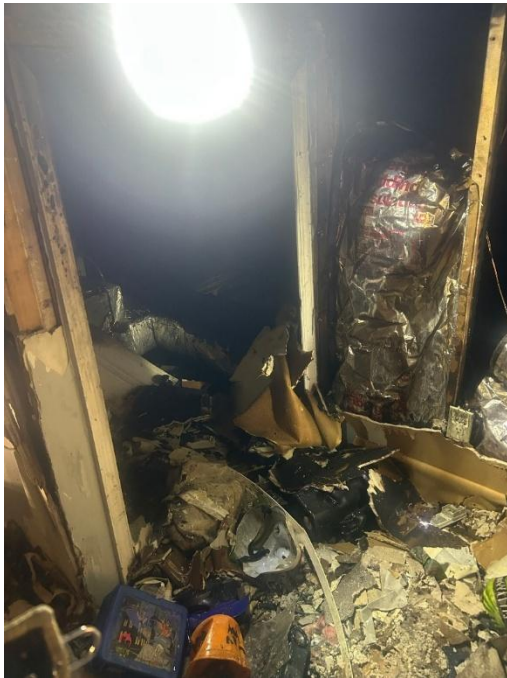
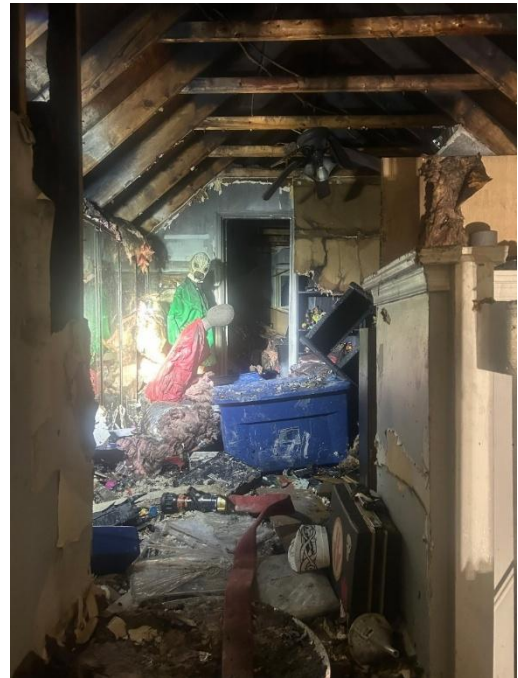
Image 5 and 6. Knee wall door (left) and hoarding conditions on second division (right), post-overhaul. (Source: Fire department)

- BC5 requested a crew with a hoseline on Side Delta. BC3 assigned Engine 9 to Side Delta after a water supply was established.
- Engine 18 officer saw a glow around a knee wall door towards Side Alpha. He pushed the door with his hook, the door fell flat onto the floor and was followed by sheet rock falling from above.
- Engine 18 officer called the Engine 16 crew, stating the fire was behind them. Engine 16 crew attempted to turn the hoseline around with major difficulty due to the hoarding conditions in the attic.

**Prevention action** · Consider exterior fire suppression when hoarding conditions are present and delay reaching the seat of fire in a knee wall and attic.

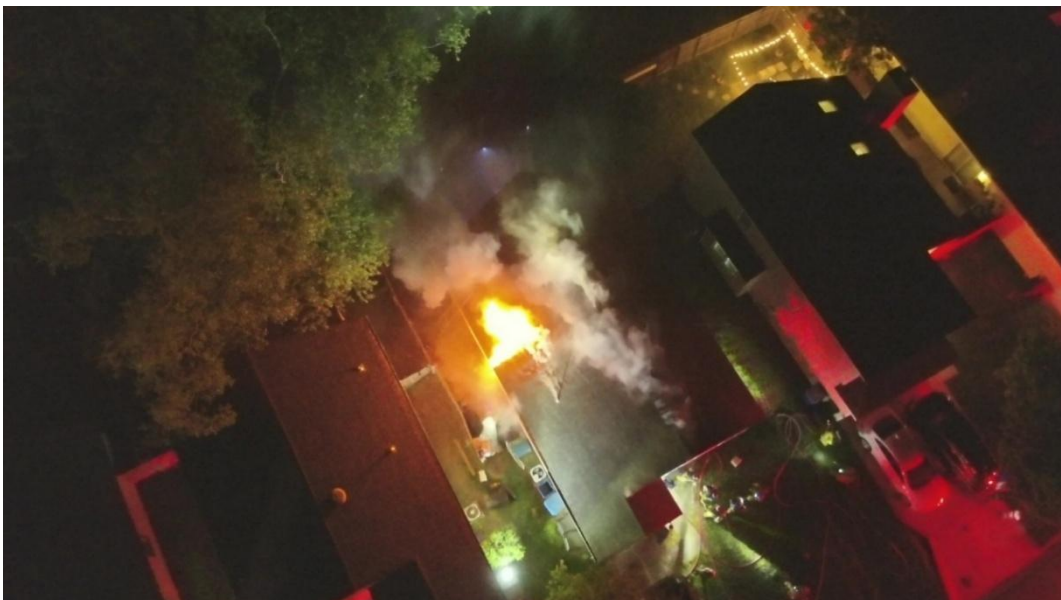
- Rescue 1 requested BC3 to assign an available crew to roof ventilation. Ladder 16 driver/operator reported to BC3 that the fire was venting from the roof on Side Bravo.
- BC3 acknowledged Ladder 16's update and requested Engine 16 to report if they had access to the attic. Engine 16 officer responded that they were making their way to the attic.
- Part of the ceiling collapsed onto the Engine 16 crew, and conditions rapidly deteriorated with high heat. Engine 16 officer was burned through the interface of his coat and gloves.
- As conditions became hotter, all interior crews in the attic began to evacuate down the stairs.

Image 7. Fire venting from Side Bravo roof. (Source: Fire department)

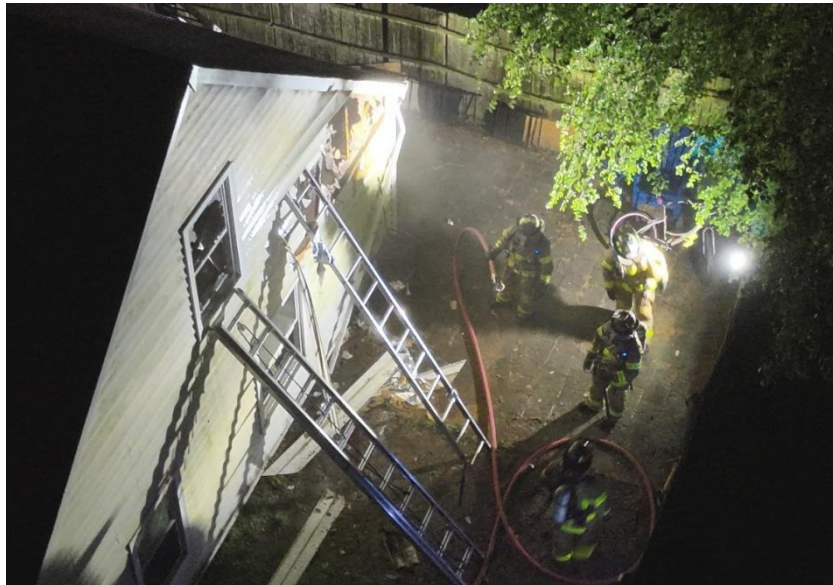
Image 8. Exterior fire control into knee wall, Side Charlie. (Source: Fire department)

This incident involved an attic fire in the space behind the knee walls. When Engine 16 arrived in the attic, their officer reported the presence of hoarding conditions. Although they began to flow water, they could not reach the source behind the knee wall. Hoarding conditions made it difficult to reach the source fire and navigate with the hoseline. This delayed applying water at the source fire and allowed a flow path to be established when the knee wall was breached. This caused the fire to rapidly grow. As heat increased, the ceiling collapsed. Interior crews exited the attic and opened the exterior siding to suppress the knee wall fire before reentering for interior operations.

The most effective method for interior operations on knee wall fires is to control the source fire, cool the gases prior to making large breaches in the barrier, and then aggressively opening the knee walls to complete extinguishment. Water should be applied at the source of a knee wall fire and toward the direction of spread before committing to the attic. Search for fire should be coordinated with suppression capabilities for quick extinguishment while limiting fire growth. Water application will not be effective until the source is controlled with direct water application [NFPA 1700 2026; NIOSH 2025]. When hoarding conditions are present, special consideration should be given to exterior fire control in knee walls and attics. When source fire control is delayed, anticipate rapid transition to untenable interior conditions. Exterior fire control can be completed by removing the exterior soffit and applying water along the eave line or through an exterior soffit using a piercing nozzle [NIOSH 2025]. This approach may control the fire enough to permit firefighting crews to transition back inside the structure to complete searches, suppression, and overhaul [NFPA 1700 2026; Kerber and Zevotek 2014]. *More about hoarding and knee walls and be found under [more information](#).*
