LINE OF DUTY DEATH REPORT

REPORT 2021-09 • May 2025

A Military Firefighter Killed and Two Firefighters Injured by a Wall Collapse at a Barn Fire – West Virginia

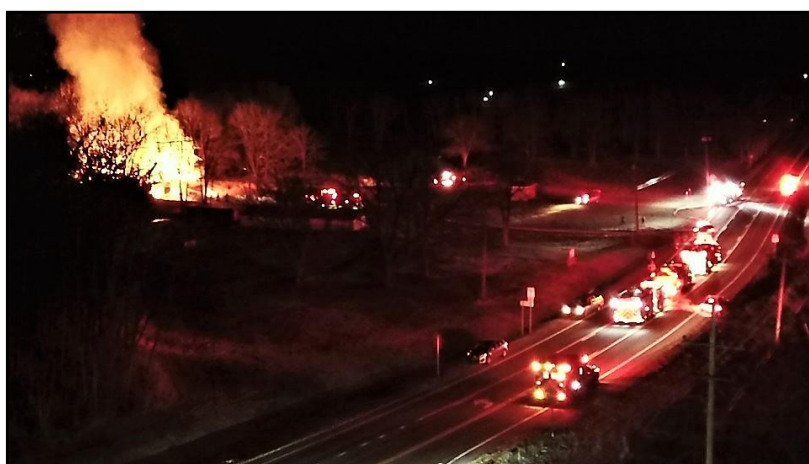
Photo 1: The barn fire that killed a military firefighter and injured two other firefighters.
(Courtesy of Statter911.com)

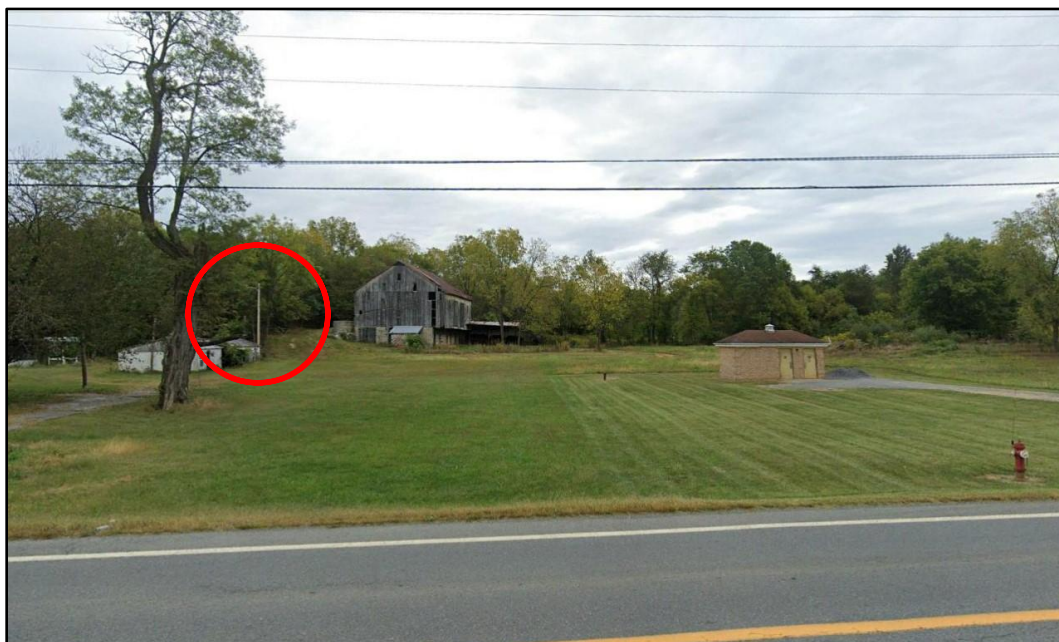
The structure was a three-story barn, built in the civil war era (see **Photo 2**). The barn was built on an angle on the property, into the ground on Side Bravo and Side Charlie, and had a non-porous foundation. The size of the barn was approximately 50-ft wide and 100-ft long. The construction of the

barn was heavy timber. There was a barbed wire fence on Side Delta of the barn. The beam that struck RE16 firefighter 4 was a 53-ft long, 10-inch x 12-inch, heavy timber that weighed approximately 1,000 pounds. The barn was unused/vacant and in poor condition. It was destroyed by the fire.

Photo 2: The location of the three-story barn, prior to the fire. Note the power pole on the left that provided electrical service to the barn.
