**LINE OF DUTY
DEATH REPORT
REPORT SLIDES**

F2021-09

A Military Firefighter Killed and
Two Firefighters Injured by a Wall
Collapse at a Barn Fire – West
Virginia

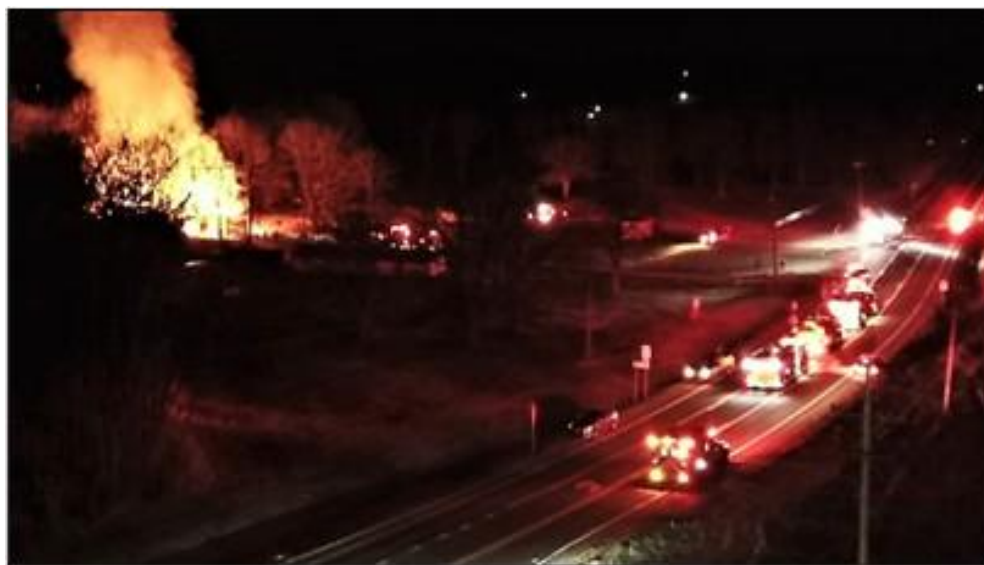
- On December 27, 2020, a 30-year-old military firefighter was struck on the head and killed by a falling structural support beam while fighting a barn fire.
- The heavy timber beam fell on the firefighter during the collapse of the barn.

The barn fire that killed a military firefighter and injured two other firefighters. (Courtesy of Statter911.com)

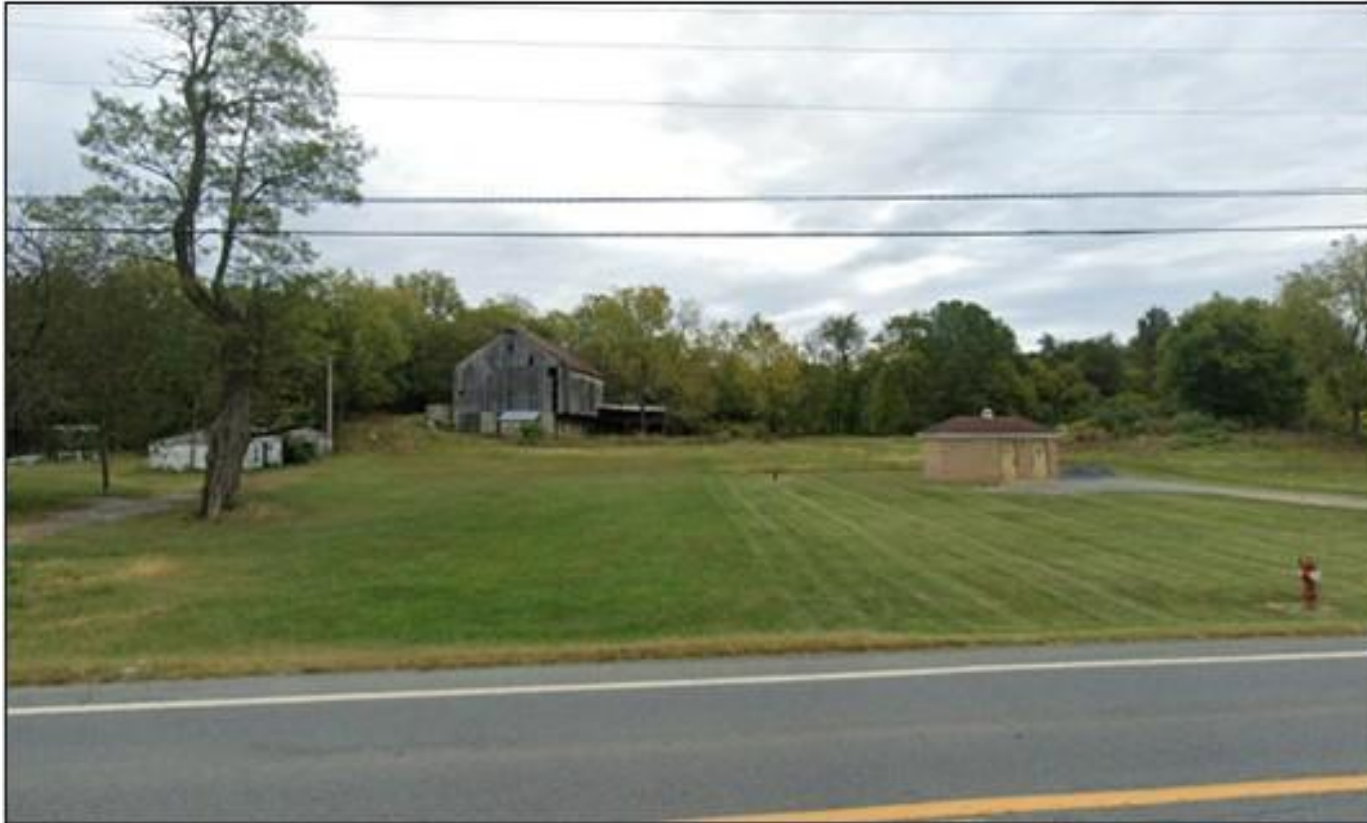
The location of the three-story barn prior to the fire. Note the power pole on the left that provided electrical service to the barn.
(Courtesy of Goggle Earth)
