**LINE OF DUTY
DEATH REPORT
REPORT SLIDES**

F2021-11

Firefighter Dies and Lieutenant
Seriously Injured at a Multi-
Family Residential Structure Fire
– Connecticut

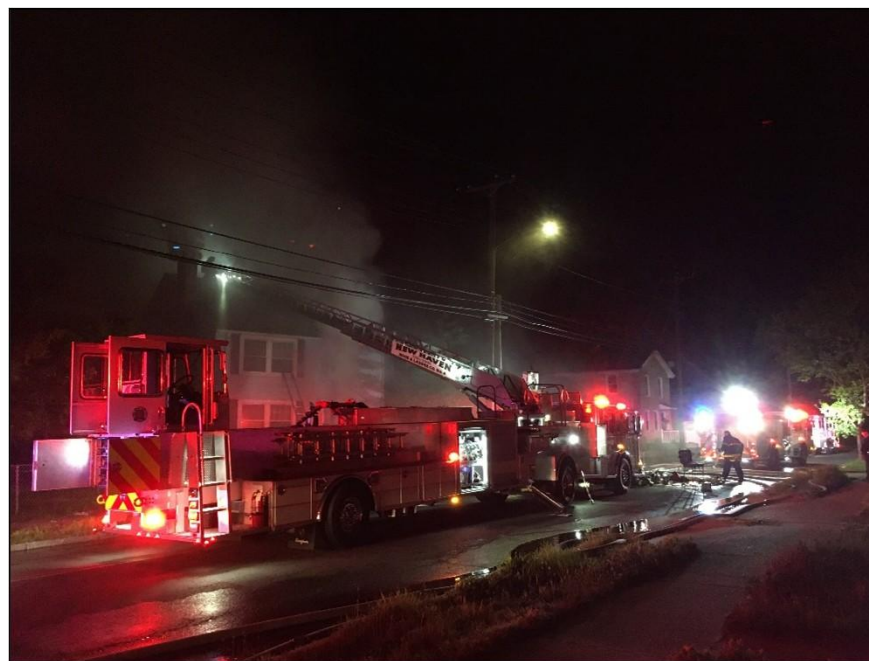
Truck 4 conducting roof ventilation at Box 1501.
(Courtesy of the fire department)

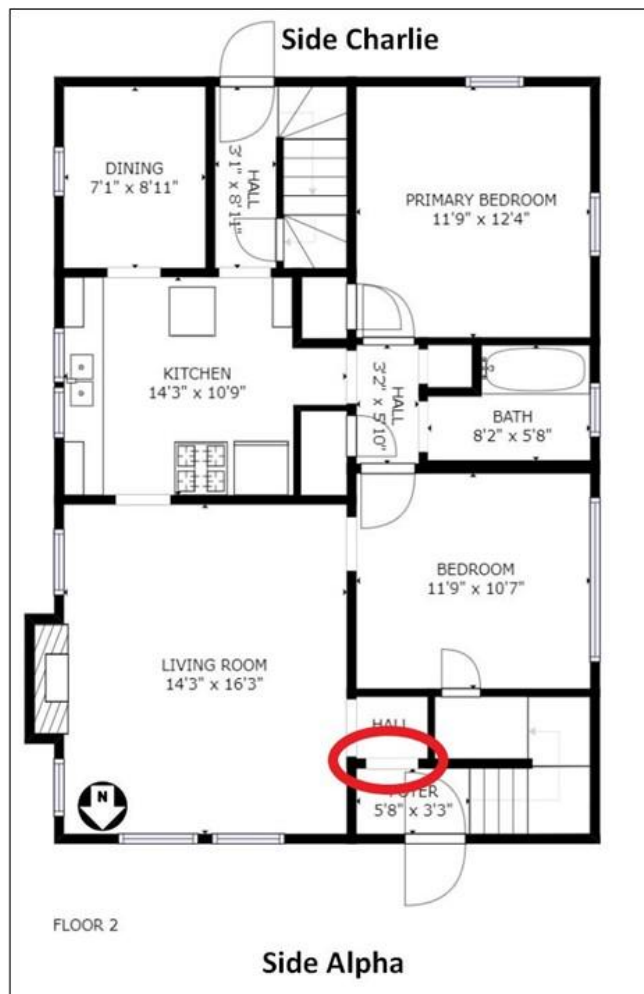
The floor plan of the 1st floor apartment. The red circle indicates the doorway that was blocked with a bookcase for security reasons. The only access into this apartment was through Side Charlie. Note: Diagram provided by Envision Forensics labeled this Floor 2.

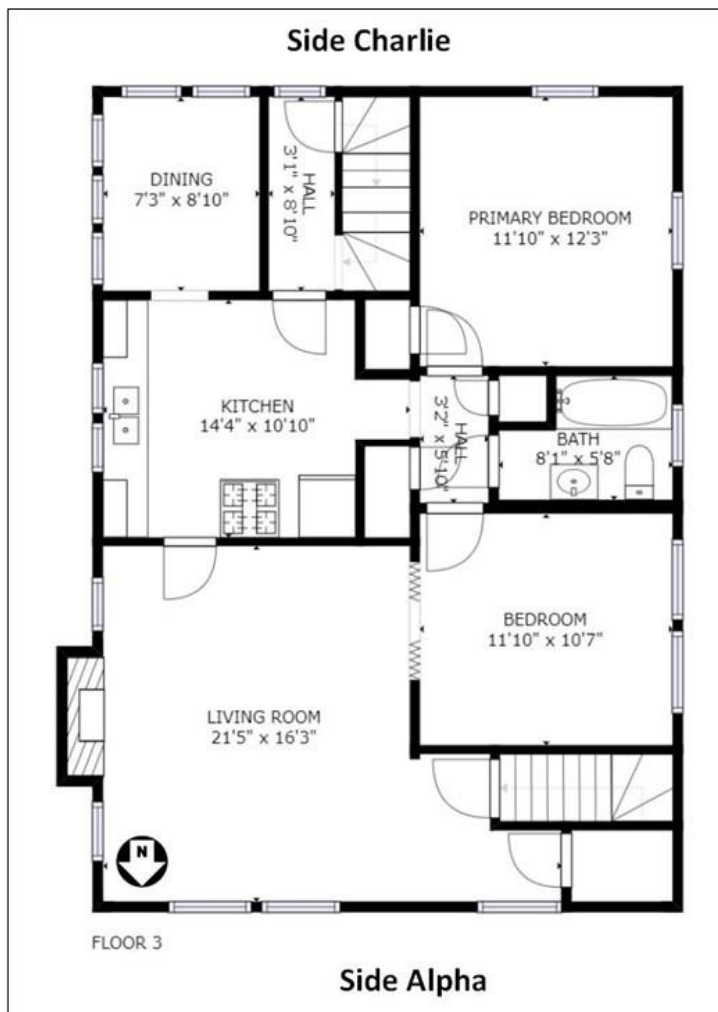
The floor plan of the 2nd floor apartment. Note: Diagram provided by
Envision Forensics labeled this Floor 3.

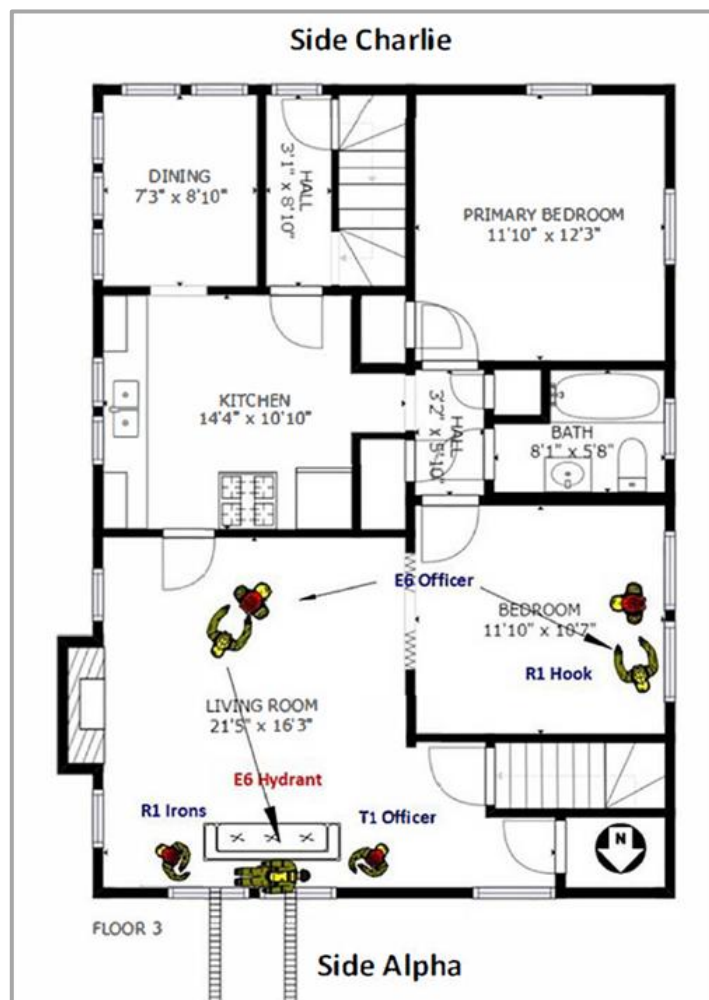
On the 2nd floor, the location of Engine 6 Hydrant and the Engine 6 Lieutenant (labeled as officer) after the Mayday occurred. The arrows indicate the paths of Engine 6 Officer took to the bedroom and Engine 6 Hydrant to the front window. (Prepared by NIOSH)

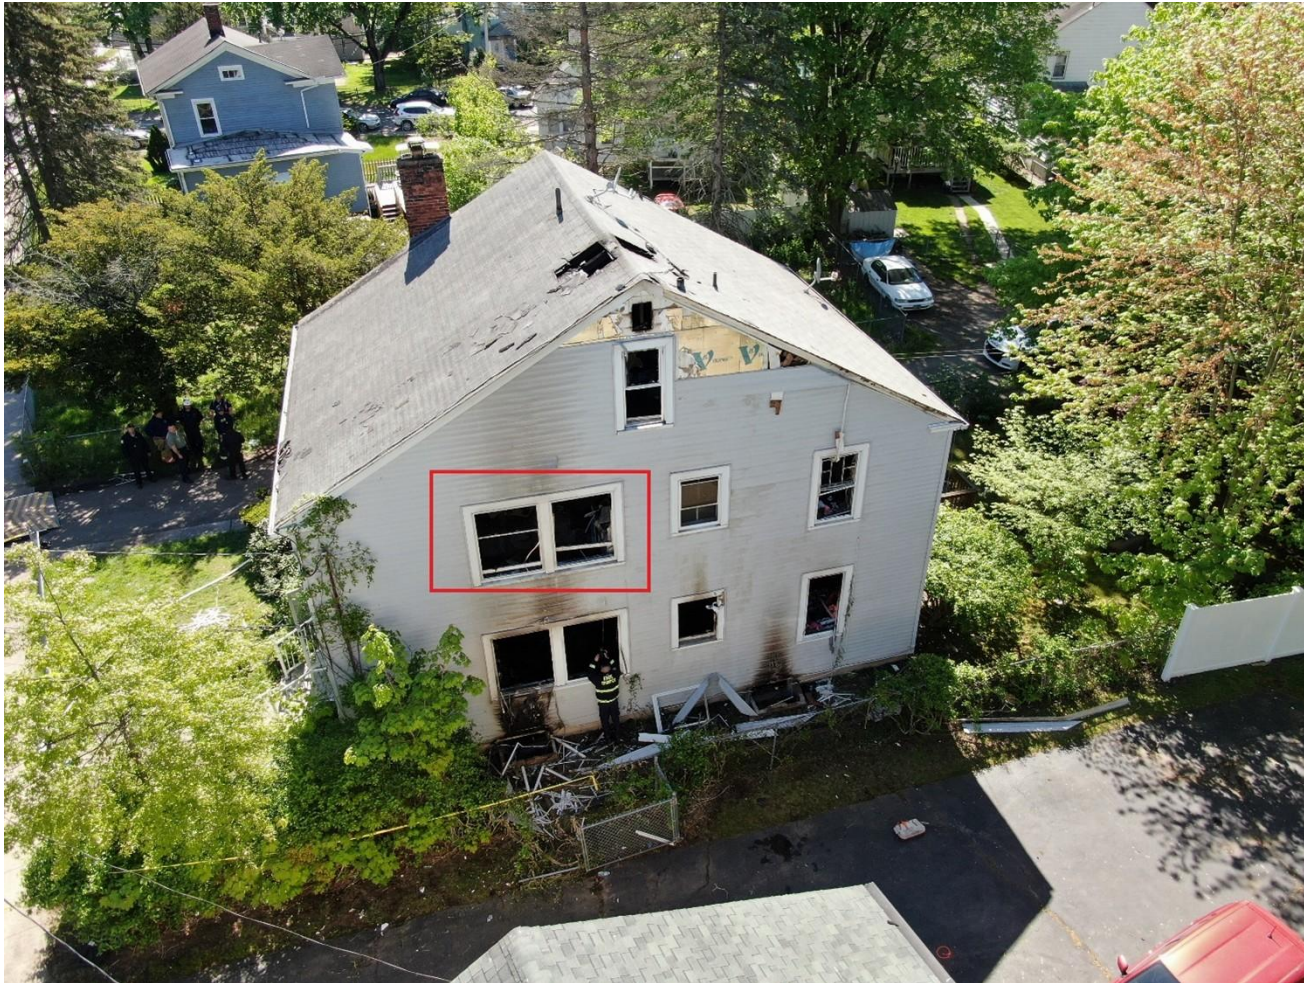
The 2nd floor window on Side Delta where Engine 6 Lieutenant was rescued from by Engine 4 and Engine 9. *(Courtesy of the fire department)*
