LINE OF DUTY DEATH REPORT

REPORT F2021-12 • May 2025

Volunteer Firefighter Dies after Becoming Lost during a Residential Structure Fire – Pennsylvania

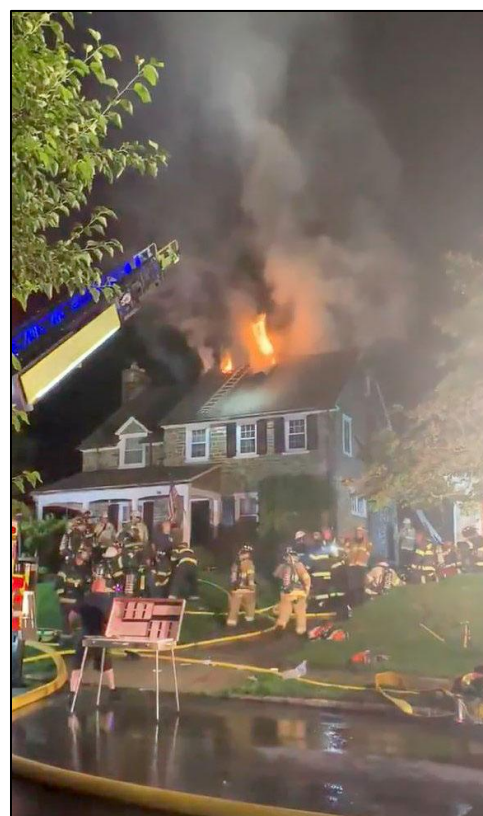
Photo 1: Fire venting along the roofline.
(Courtesy of the fire department)

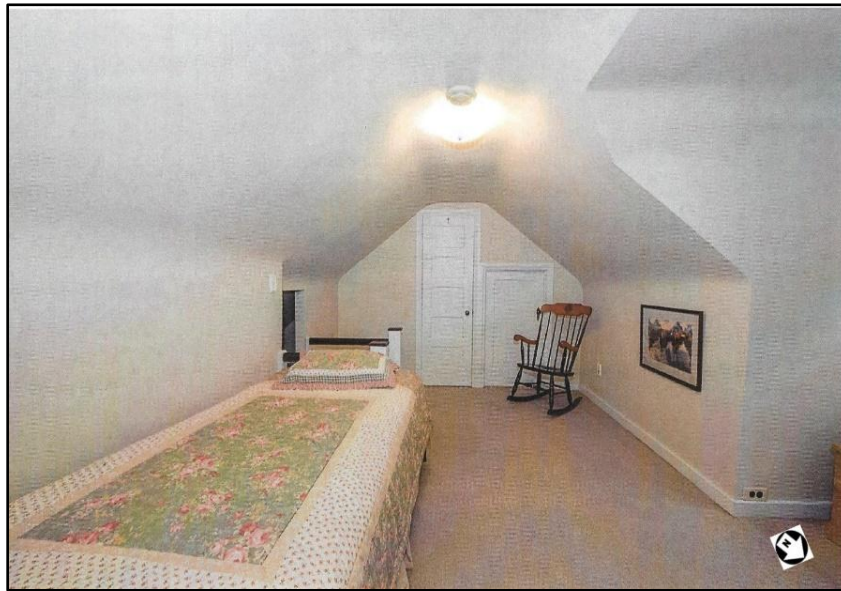
The attic had been converted into a bedroom with a full bath. An unfinished part of the attic on Side Bravo separated the room by a finished stud wall and half door. There was a closet beside the half door, which was accessed by a full door. A bedroom with a full bathroom was at the northern end (Side Delta) of the structure. The bedroom in the attic was accessed via a “U-shaped staircase (see **Photo 2 and Diagram 3**).

Photo 2. The small bedroom in the attic facing Side Bravo.
(Courtesy of the fire department)

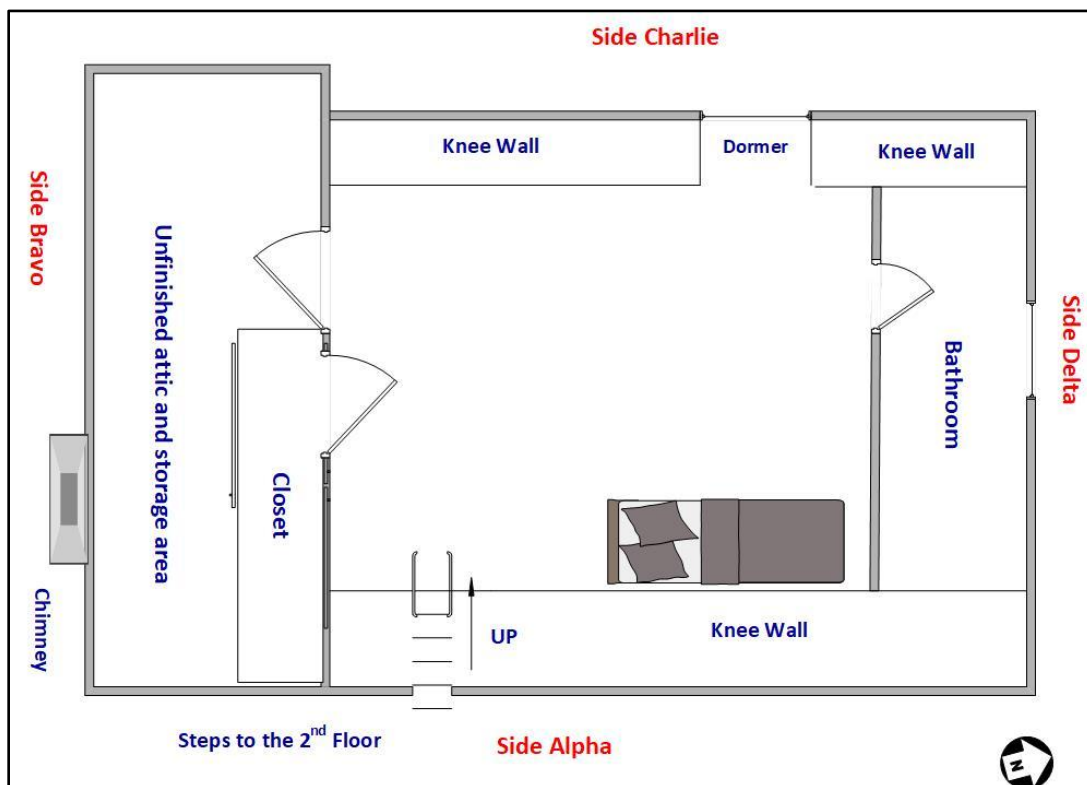
Diagram 3. The floor plan of the attic of the fire building.
(Prepared by NIOSH)

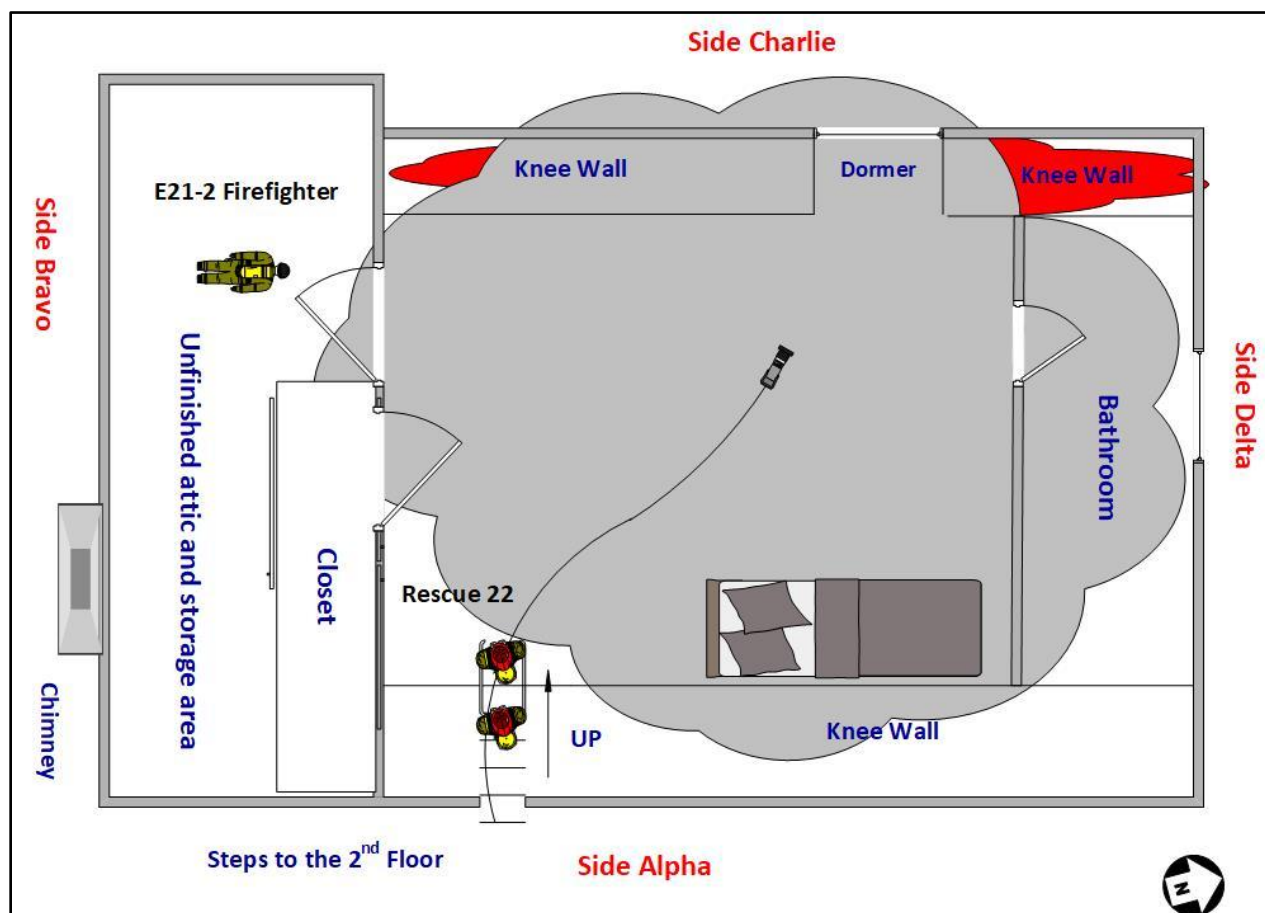
At approximately 22:55 hours, Engine 21-2 plus two firefighters from Ladder 26 started to enter the house through the front door and go to the attic. One firefighter from Ladder 26 had an issue with his SCBA and never entered the house. The two firefighters took the hoseline on the 2nd floor to the attic. At 22:57 hours, Engine 21-1 exited the structure. Ladder 26 firefighter walked down the steps to fix his hood before they went into the unfinished attic space. He realized he had an issue with his hood the moment he got onto the third floor, walked back downstairs, fixed it and reentered the third floor. At 22:58 hours, Engine 21-2 radioed IC that there was heavy thick smoke and high heat in the attic. At this time, Engine 21-2 and Ladder 26 firefighter crawled into the unfinished area of the attic. At 22:59 hours, Rescue 22 was split with a captain and two firefighters going to the 2nd floor and an assistant chief and lieutenant going to the attic (see **Diagram 4**).

Diagram 4. Location of Engine 21-2 in the unfinished area of the attic.
(Prepared by NIOSH)
