**LINE OF DUTY  
DEATH REPORT  
REPORT SLIDES**

**F2021-12**

**Volunteer Firefighter Dies after  
Becoming Lost during a  
Residential Structure Fire –  
Pennsylvania**

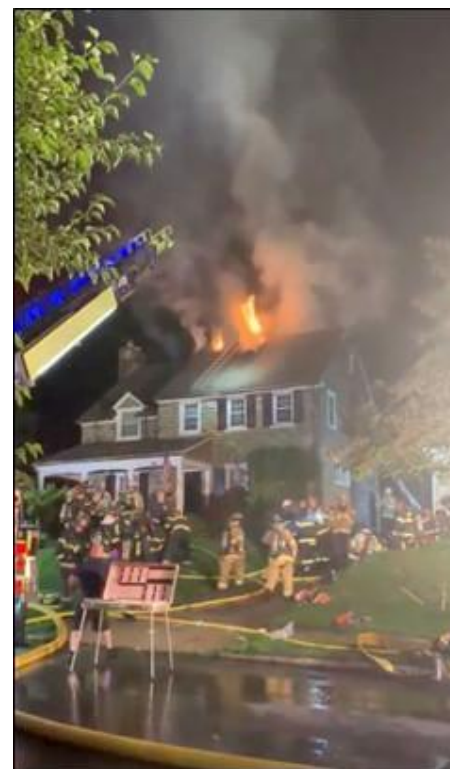
Fire venting along the roofline.  
(Courtesy of the fire department)

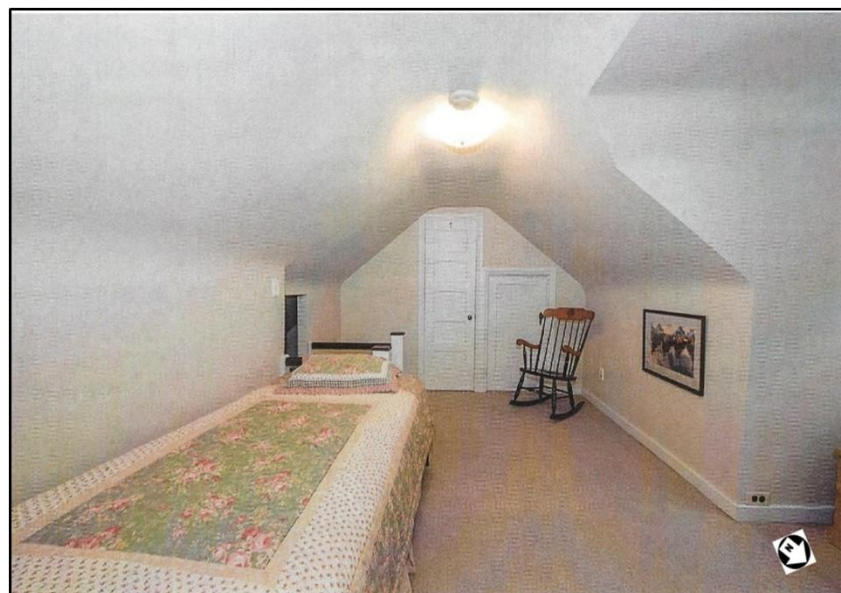
- At this time, a Rescue 22 crew was almost to the top of the attic steps.
- There was high heat and zero visibility but no fire in the finished section of the attic.
- There was fire showing in the unfinished section of the attic, where Rescue 22 found Engine 21-2.

The small bedroom in the attic facing Side Bravo.  
(Courtesy of the fire department)
