LINE OF DUTY
DEATH REPORT

REPORT F2021-14 • June 2025

Captain Falls into the Basement and Dies While Fighting a Fire in a Large Residential Structure - Maryland**Executive Summary**

On August 11, 2021, a 46-year-old career captain died after falling into a basement while fighting a large area residential structure fire.

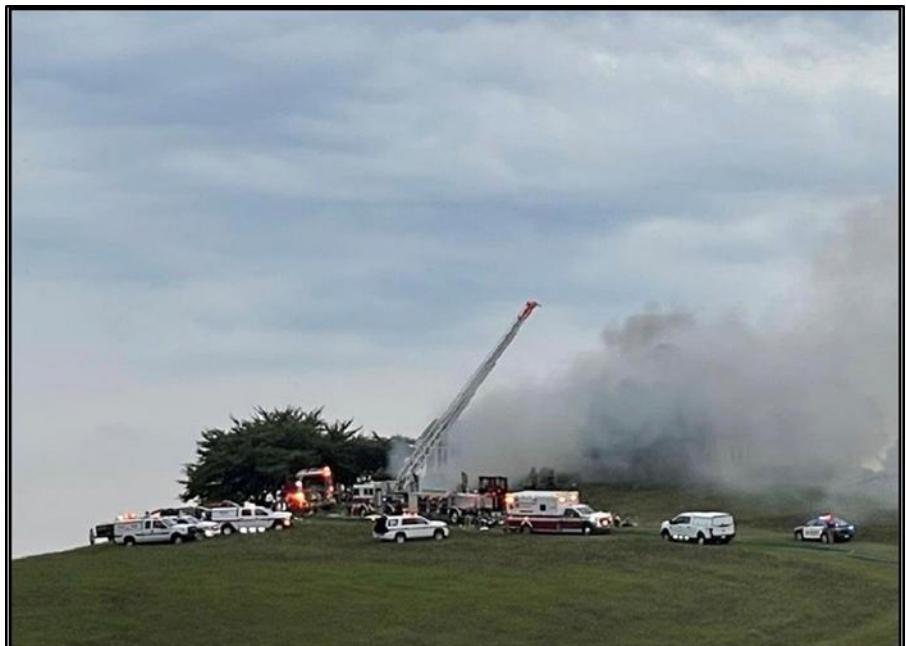
The working fire at Box 23-11 in the large area residential structure looking at Side Alpha of the structure.
(Courtesy of the Division of Fire and Rescue Services)

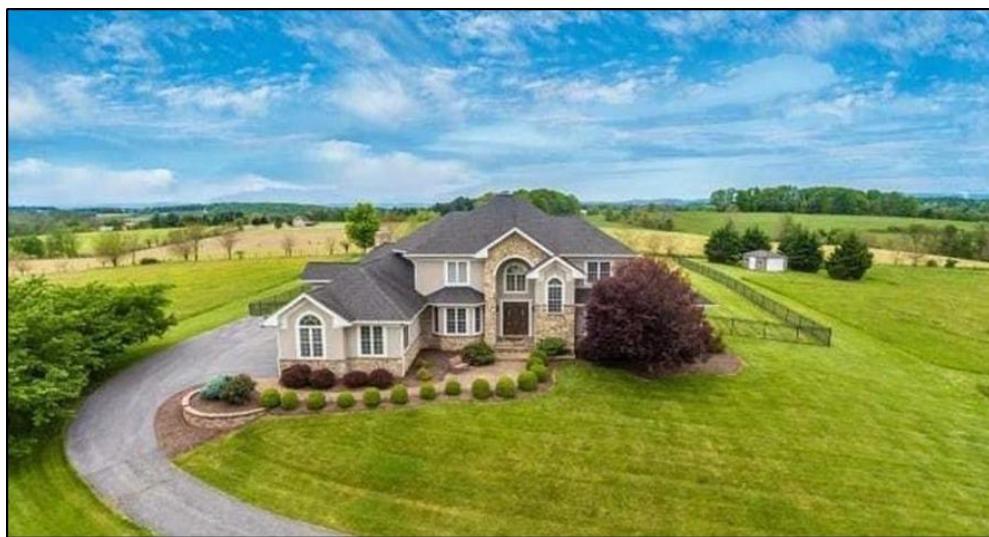
Photo 1. Side Alpha of the fire structure. (Courtesy of the Division of Fire and Rescue Services)

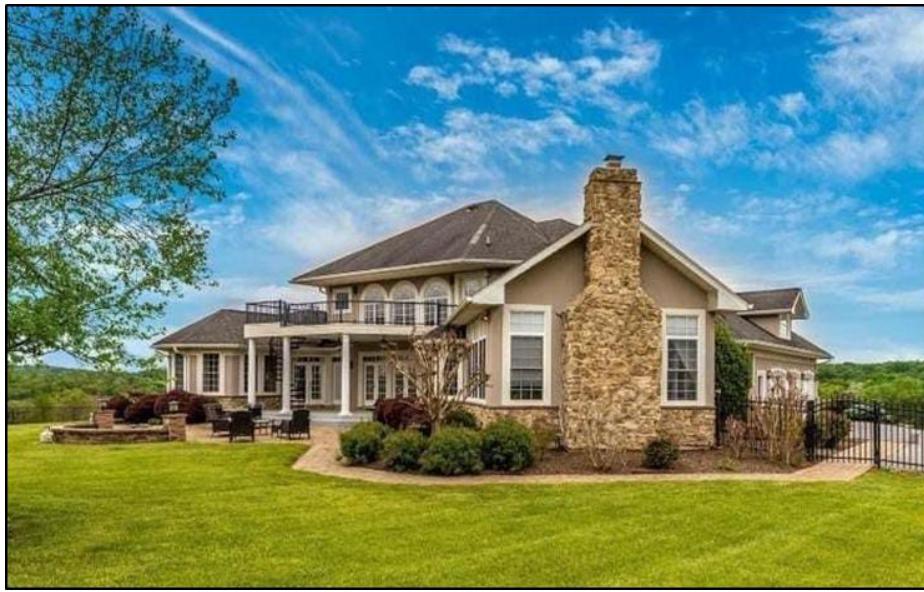
Photo 2. Side Bravo of the fire structure. The 100-gallon propane tank was located on the Side Bravo/Side Charlie corner in the flower bed. The propane was not installed at the time of this photograph.

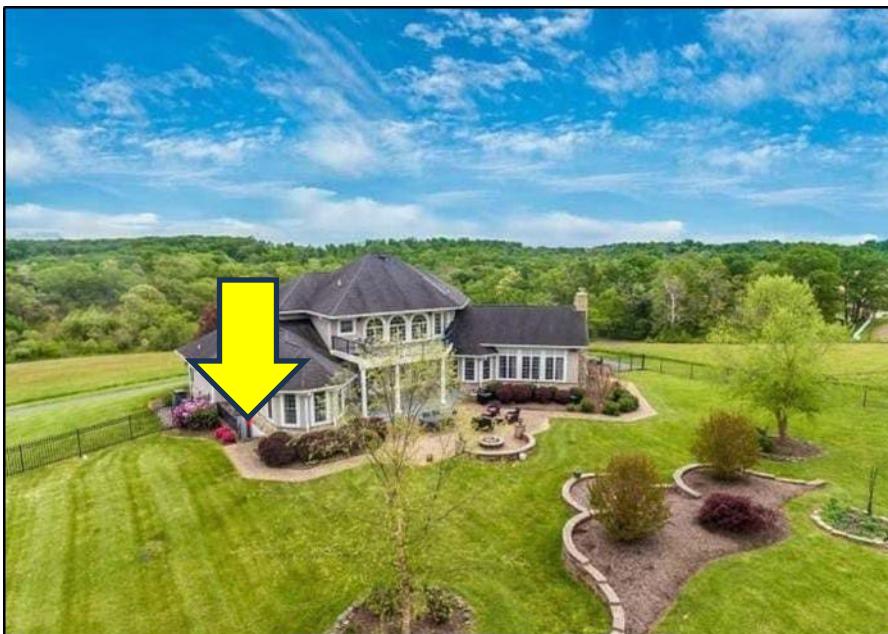
Photo 3. Side Charlie and Side Delta of the fire structure. The exterior steps to the basement were located on Side Charlie/Side Delta corner, as indicated by the yellow arrow. (Courtesy of the Division of Fire and Rescue Services)

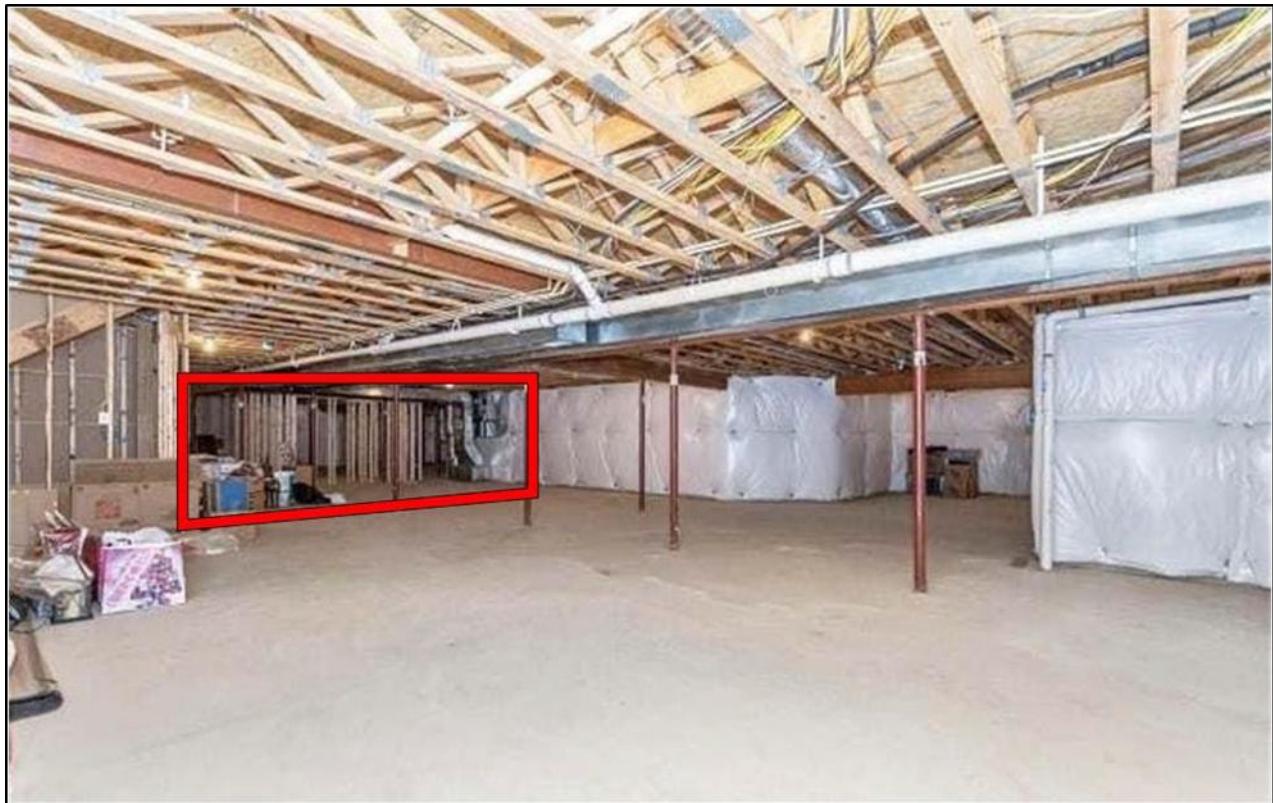
Photo 4. The unfinished basement. The framed stud wall that divided the basement had not been installed at the time of this picture. The red outline shows the approximate location of the framed stud wall.
(Courtesy of the Division of Fire and Rescue Services)

Near the center of the basement, just south of the interior basement stairs, was a wood-framed dividing wall that extended from Side Alpha to Side Charlie. The wall was finished with gypsum board on both sides. The dividing wall had two doors, one on Side Alpha and the other on Side Charlie. Both doors were closed at the time of the incident.

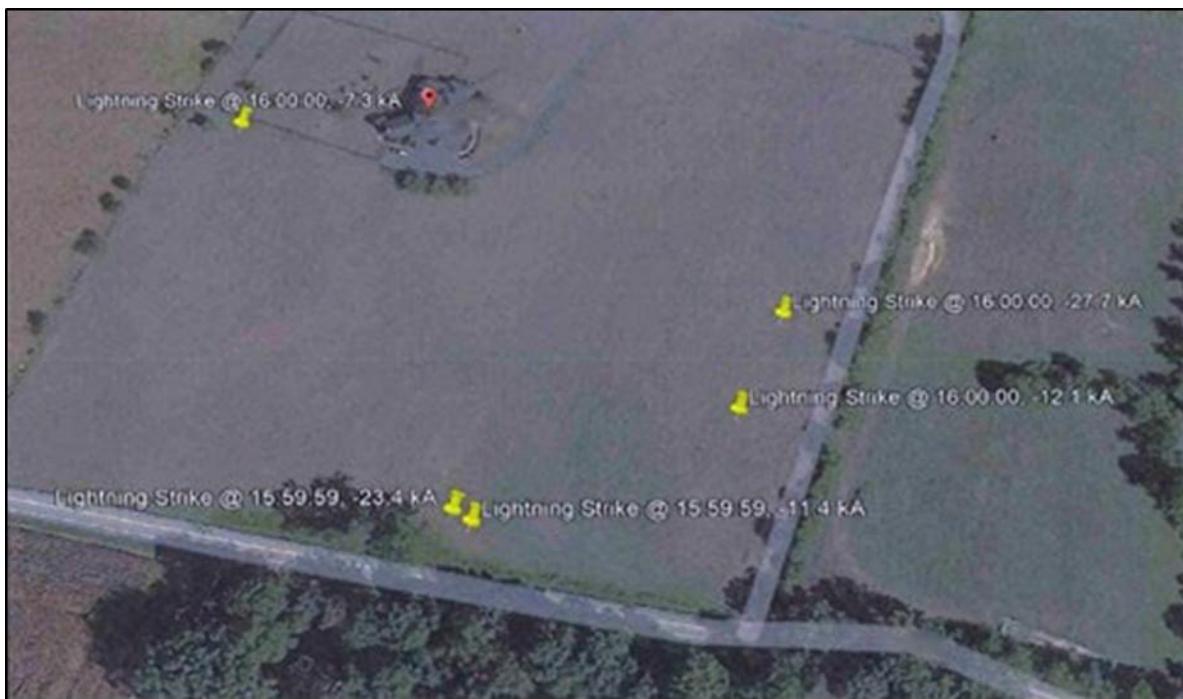
Sixty-three lightning strikes were reported within a five-mile radius of the structure (see Photo 5). An exterior security camera at the residence recorded a lightning strike at 16:00 hours (i.e., a large flash with concurrent thunder immediately afterwards). Small pieces of debris were heard falling and hitting the roof and siding. Around 16:14 hours, a power or internet service failure stopped the camera recording.

Photo 5. Visual representation of the lightning strikes (yellow tacks) in and around the area of the fire structure (red dot) between 15:59 and 16:00 hours on August 11, 2021.

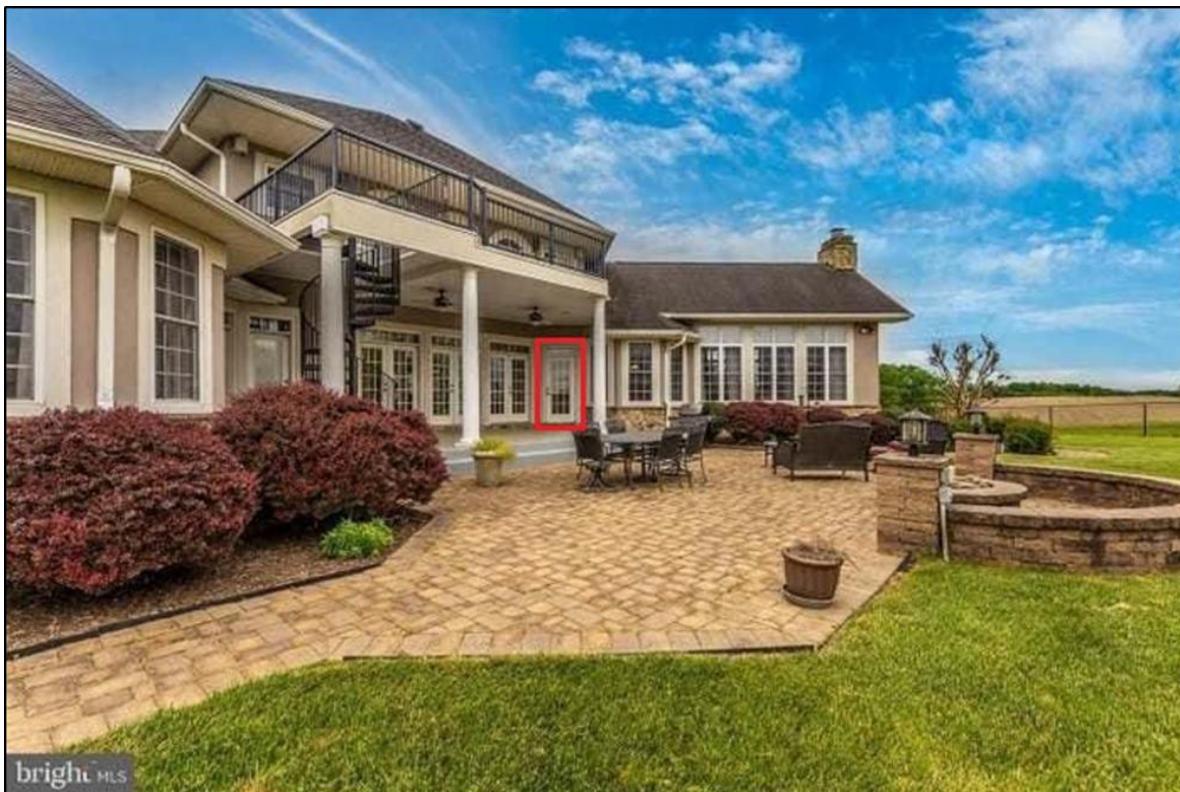
At 17:00 hours, OPSAC900 called Command with the following message, "Myself and Engine 251 have two lines in service, trying to knock the bulk of the fire. The next hoseline line needs to go to the inside and hold the interior." E251A entered the kitchen/breakfast nook area through the doorway on Side Charlie. After making the transmission, OPSAC900 observed E251A standing inside of the structure in the breakfast nook area adjacent to the family room and kitchen, just inside the bay windows. Engine 251A entered the kitchen/breakfast nook area through the doorway on Side Charlie (see **Photo 6**).

Photo 6. The doorway outlined in red was used by Engine 251A to enter the kitchen/breakfast nook area.
