**LINE OF DUTY
DEATH REPORT
REPORT SLIDES**

F2021-14

Captain Falls into the Basement
and Dies While Fighting a Fire in
a Large Residential Structure -
Maryland

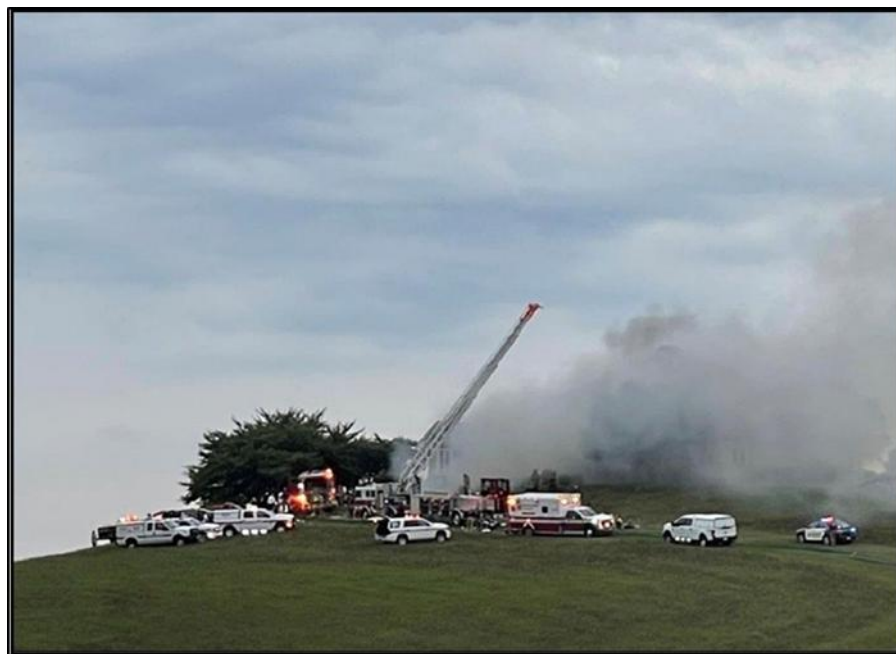
The working fire at Box 23-11 in the large area residential structure looking at Side Alpha of the structure.
(Courtesy of the Division of Fire and Rescue Services)

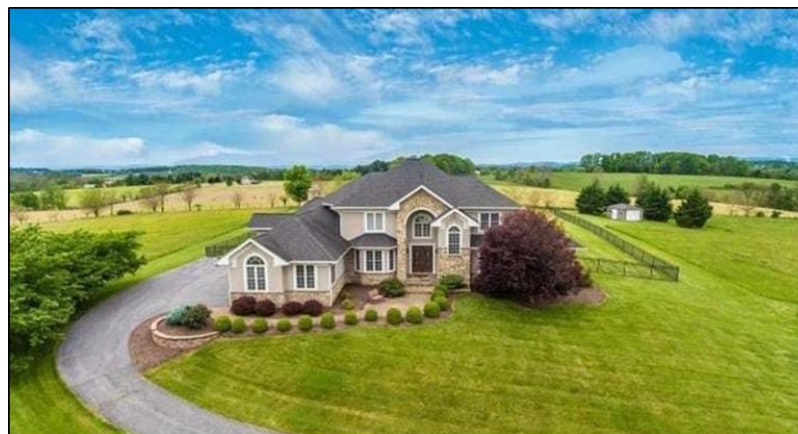
Side Alpha of the fire structure. (Courtesy of the Division of Fire and Rescue Services)

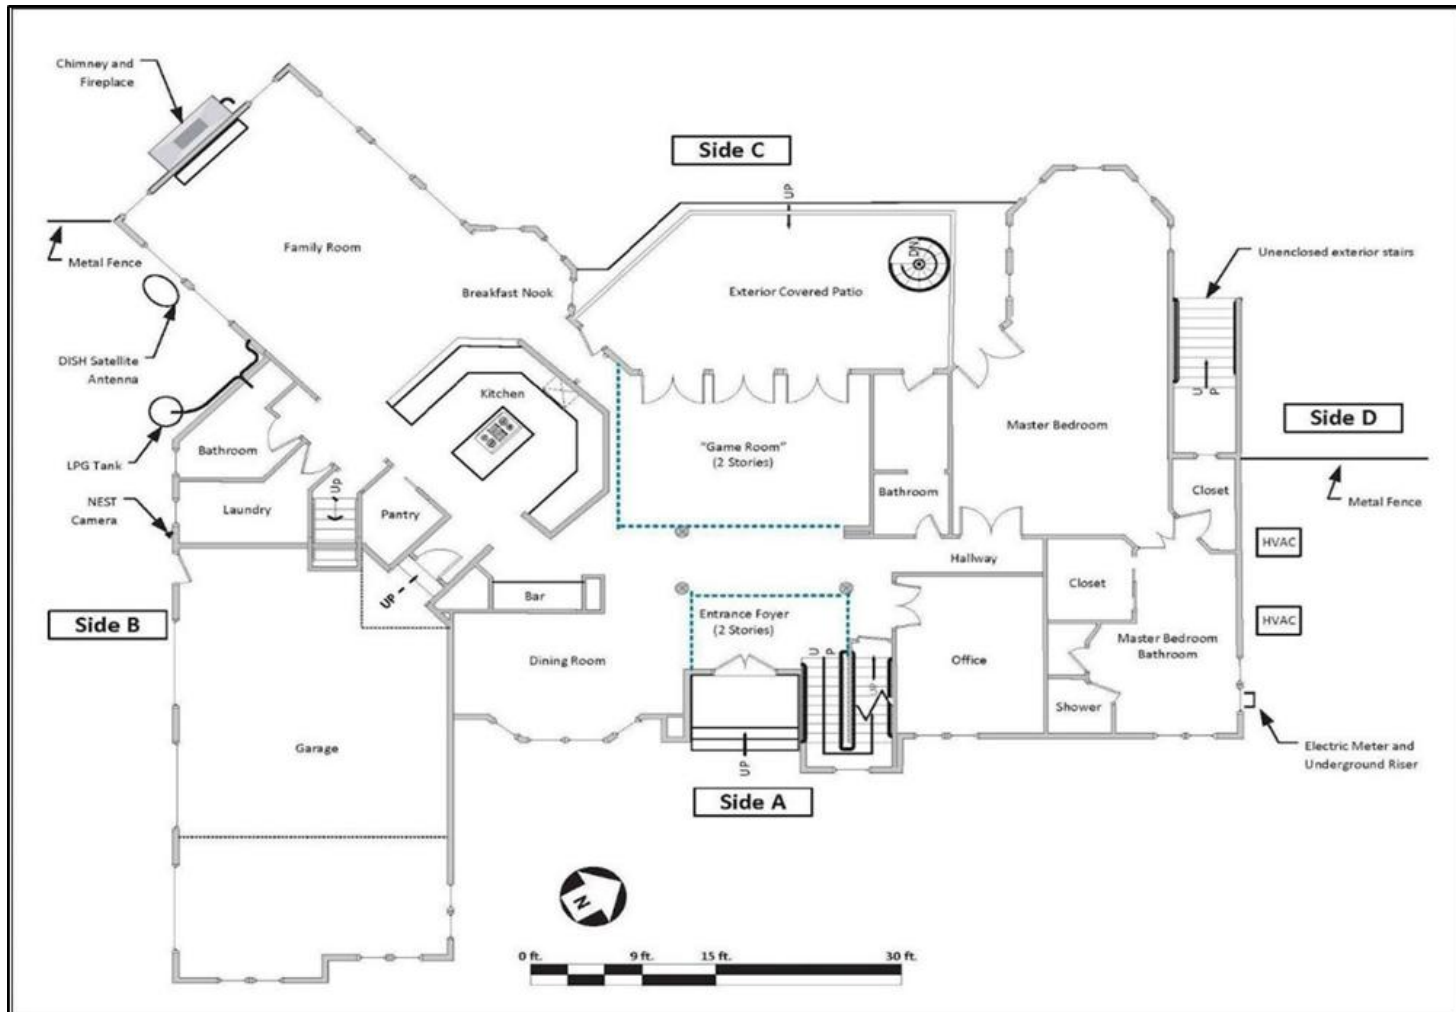
First floor house plan.
(Courtesy of the ATF)

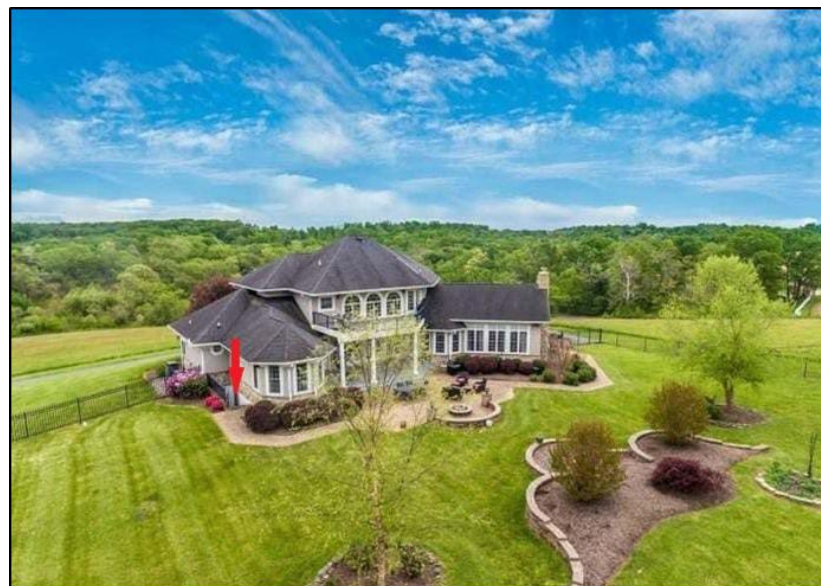
Side Charlie and Side Delta of the fire structure. The exterior steps to the basement were located on Side Charlie/Side Delta corner, as indicated by the red arrow.
(Courtesy of the Division of Fire and Rescue Services)
