LINE OF DUTY DEATH REPORT

REPORT 2022-01 • April 2025

Three Firefighters Die and another Seriously Injured During the Collapse of an Abandoned, Derelict, 3-story Row House Fire – Maryland

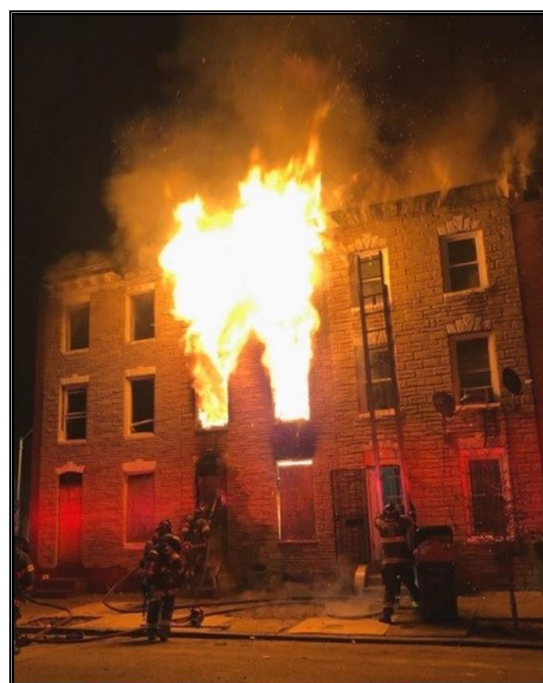
Photo 1. Initial fire conditions on arrival of Engine 14.
(Courtesy of the fire department)

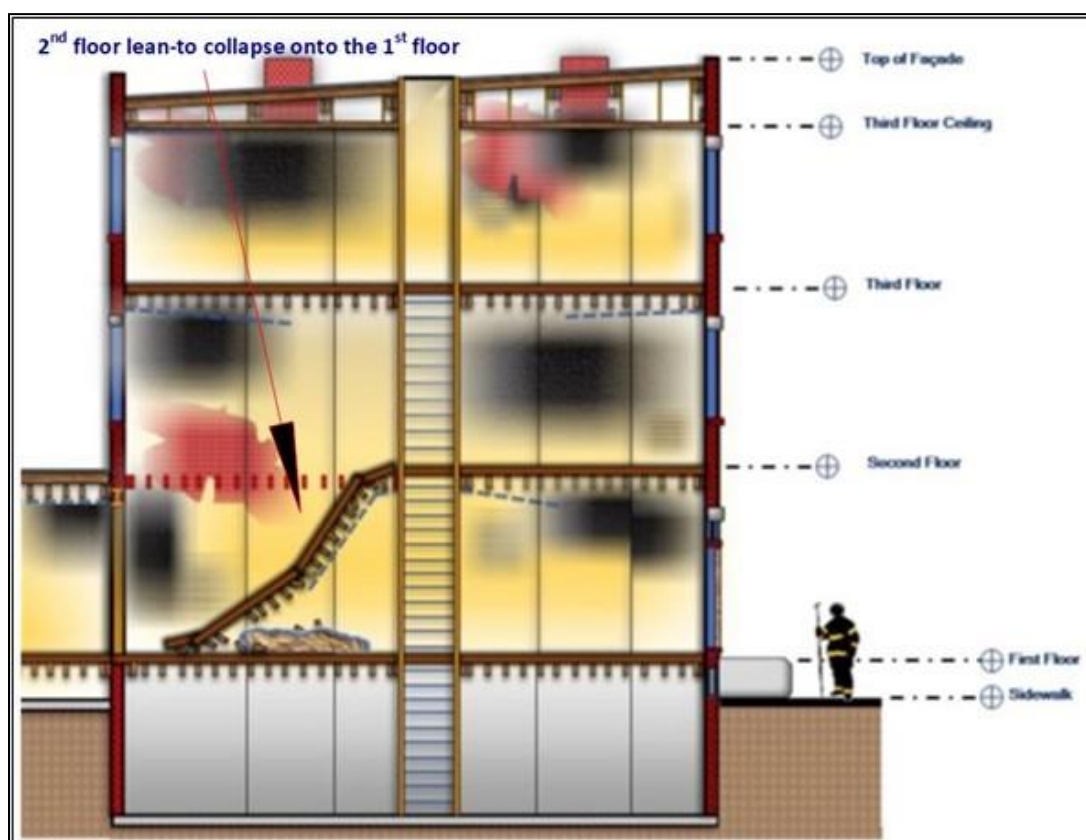
Two major fires previously occurred in the fire building in 2015 and 2016. These fires resulted in significant structural building damage, with major interior compartment compromise and degradation from both the fire and subsequent fire department activities associated with extinguishment, overhaul, and investigation. The 2015 fire caused a collapse of the rear bedroom's second floor onto the first floor in a lean-to collapse configuration. The lean-to collapse configuration of the back of the second-floor assembly was resting on the first floor just beyond the central stairwell core (see **Diagram 1**).

Diagram 1. The cross-section of second floor collapse configuration from previous (2015) fire.
(Courtesy of Buildingsonfire.com - C.J. Naum)

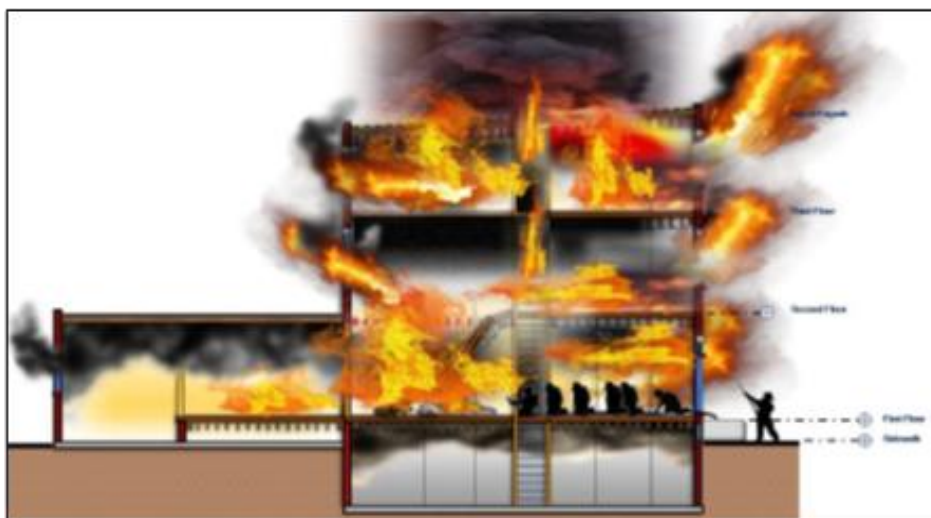
Diagram 2. The cross-section of the initial fire attack by Engine 14.
(Courtesy of Buildingsonfire.com - C.J. Naum)

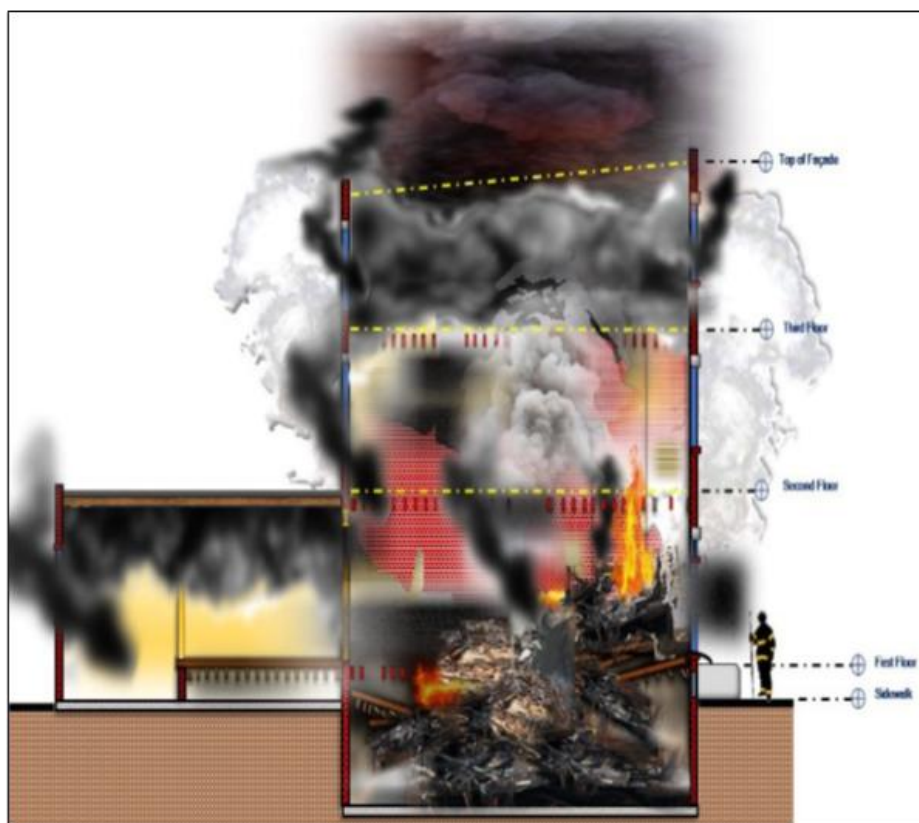
The collapse zone was interior to the fire building's perimeter walls and consisted of the building floor and roof assemblies, systems and components, and building materials. The interior assemblies failed in a pancake-like collapse configuration. The rapid downward momentum and compression of air space between the floors caused a rapid outward release of energy that caused the flames to self-extinguish and diminish in both fire severity and extent. (see **Diagrams 2 and 3**) [Naum 2024].

Diagram 3. The cross-section of the interior collapse of the floors in the fire building.
(Courtesy of *Buildingsonfire.com* - C.J. Naum)

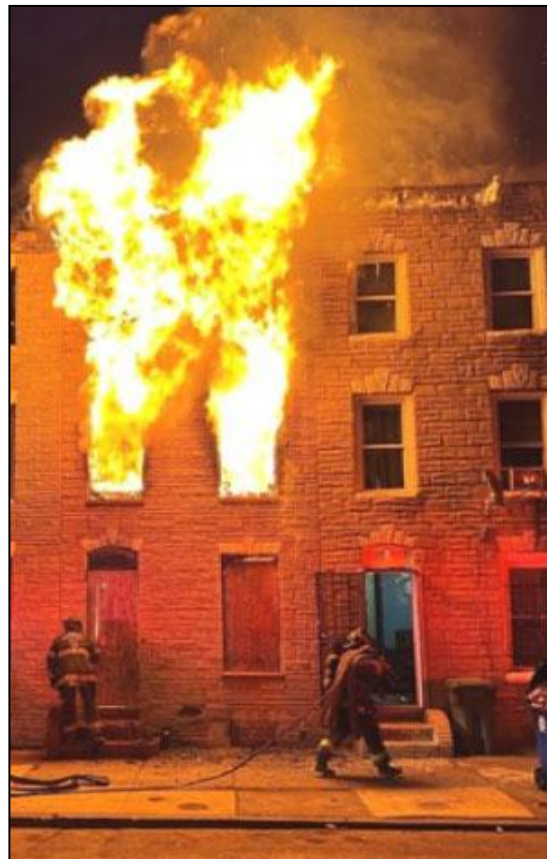
Photo 2. The pipe firefighter from Engine 14 stretching 250-feet of 1¾-inch and off-duty lieutenant cutting plywood off the front door.
(Courtesy of the fire department)

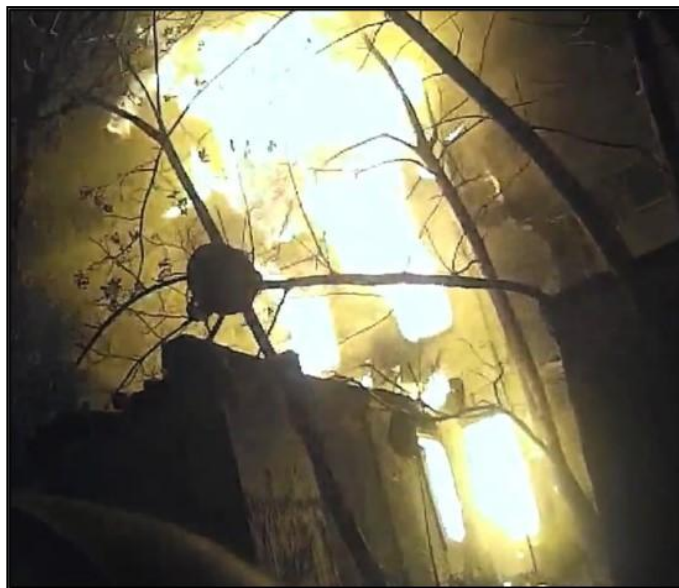
Photo 3. The fire conditions on Side Charlie upon arrival of Truck 10.
(Courtesy of the fire department)

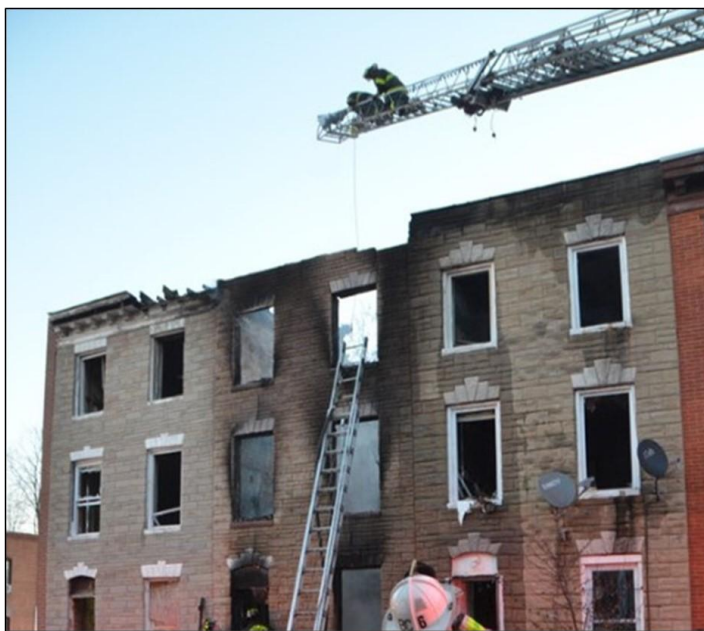
Photo 4. Truck 23 aerial ladder being used for the recovery of Engine 14 pipe firefighter.
(Courtesy of the fire department)

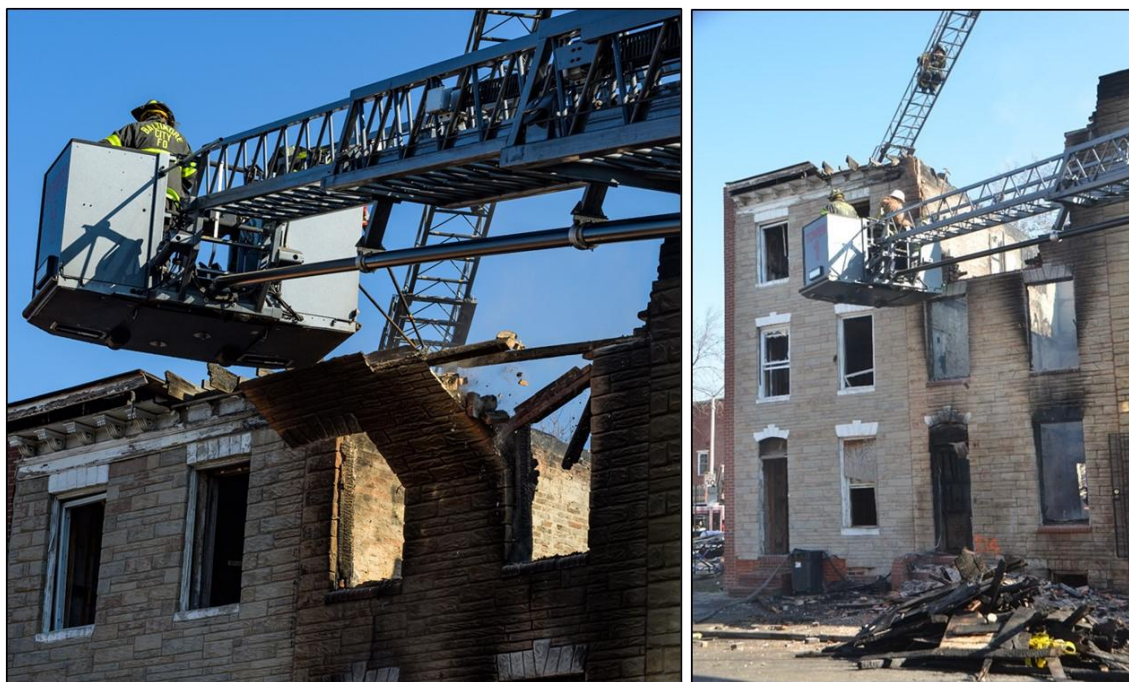
Photo 5 (left) and Photo 6 (right). Tower 1 firefighters were using 8-foot and 10-foot hooks to remove large sections of the Side Alpha wall. Contractors had made cuts in the Side Alpha wall with a circular saw.

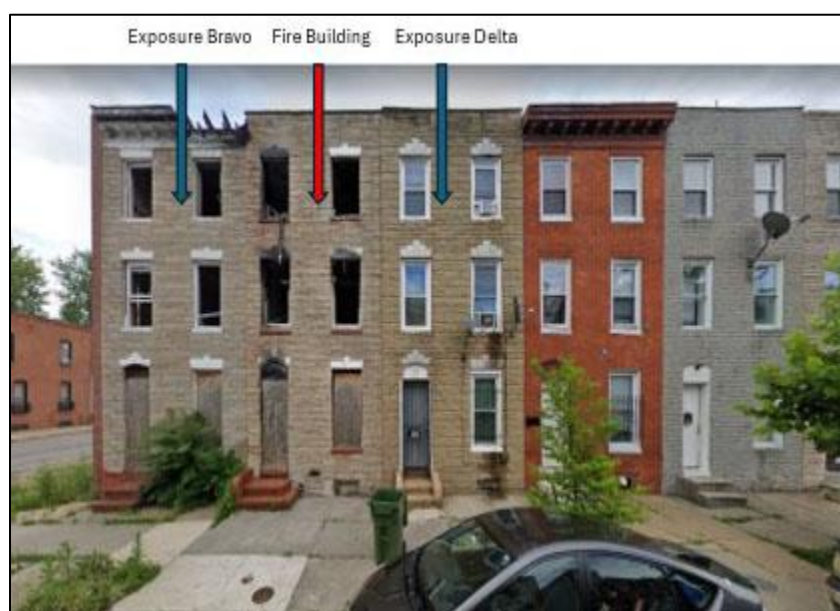
Photo 8. Pre-fire incident photo from 2019 -abandoned, derelict, previously burned structure (red arrow), Bravo exposure (blue arrow). Delta exposure (second blue arrow) was occupied at the time of the photo and during this fire incident.
(Courtesy of Google Earth)

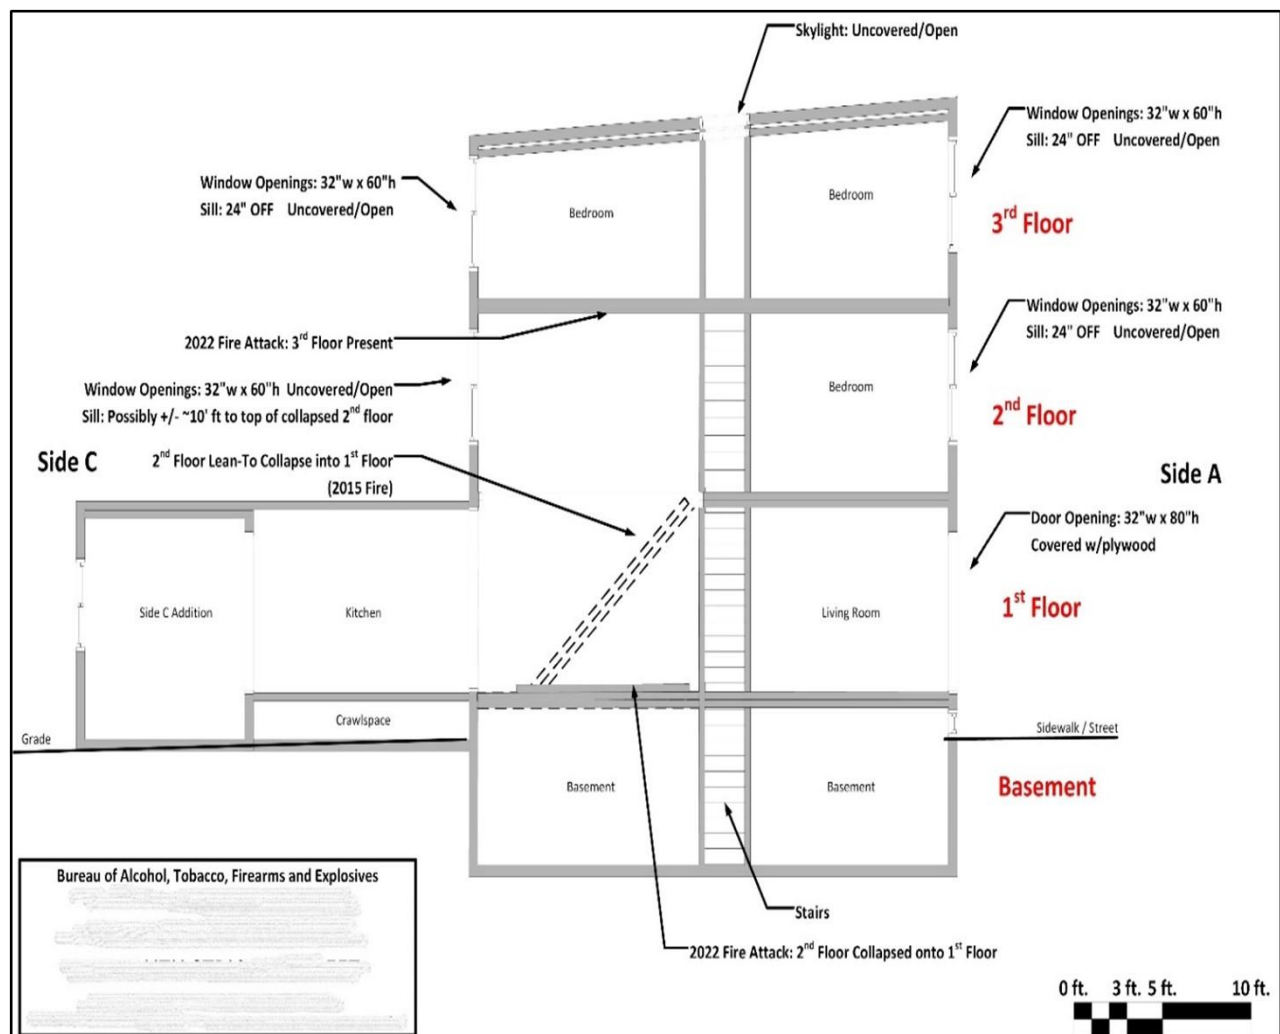
Diagram 5. The elevation of all floors of the row house including the basement and location of previous fires in this building.
(Courtesy of ATF)

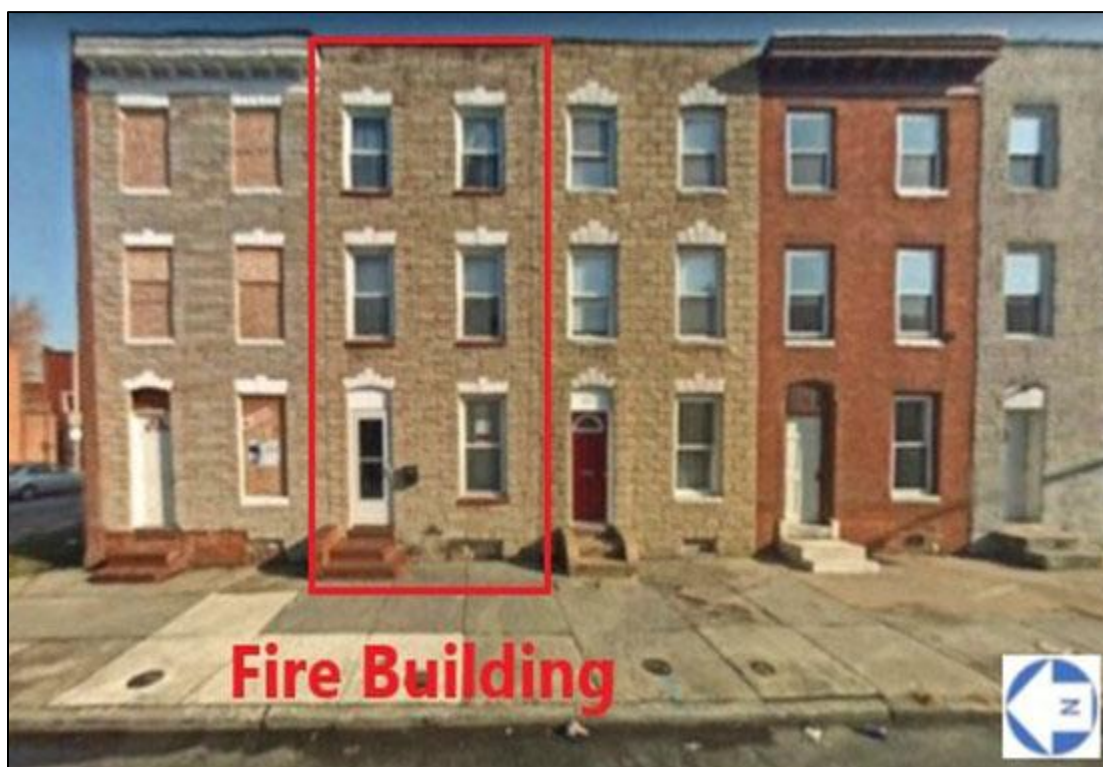
Photo 9. The fire building and exposures (Circa 2007).
(Courtesy of Google Earth)
