**LINE OF DUTY
DEATH REPORT
REPORT SLIDES**

F2022-01

Three Firefighters Die and
another Seriously Injured During
the Collapse of an Abandoned,
Derelict, 3-story Row House Fire –
Maryland

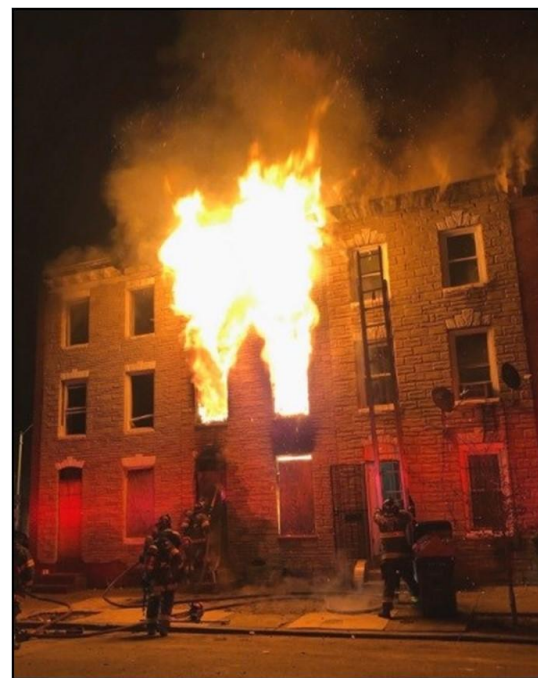
Initial fire conditions on arrival of Engine 14. (Courtesy of the fire department)

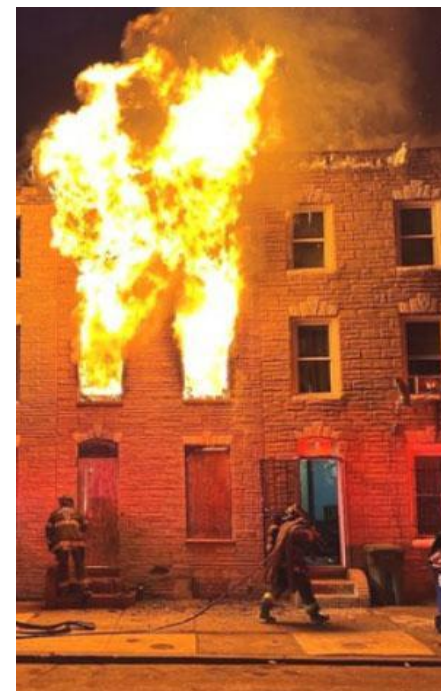
The pipe firefighter from Engine 14 stretching 250-feet of 1¾-inch and off-duty lieutenant cutting plywood off the front door. (Courtesy of the fire department)

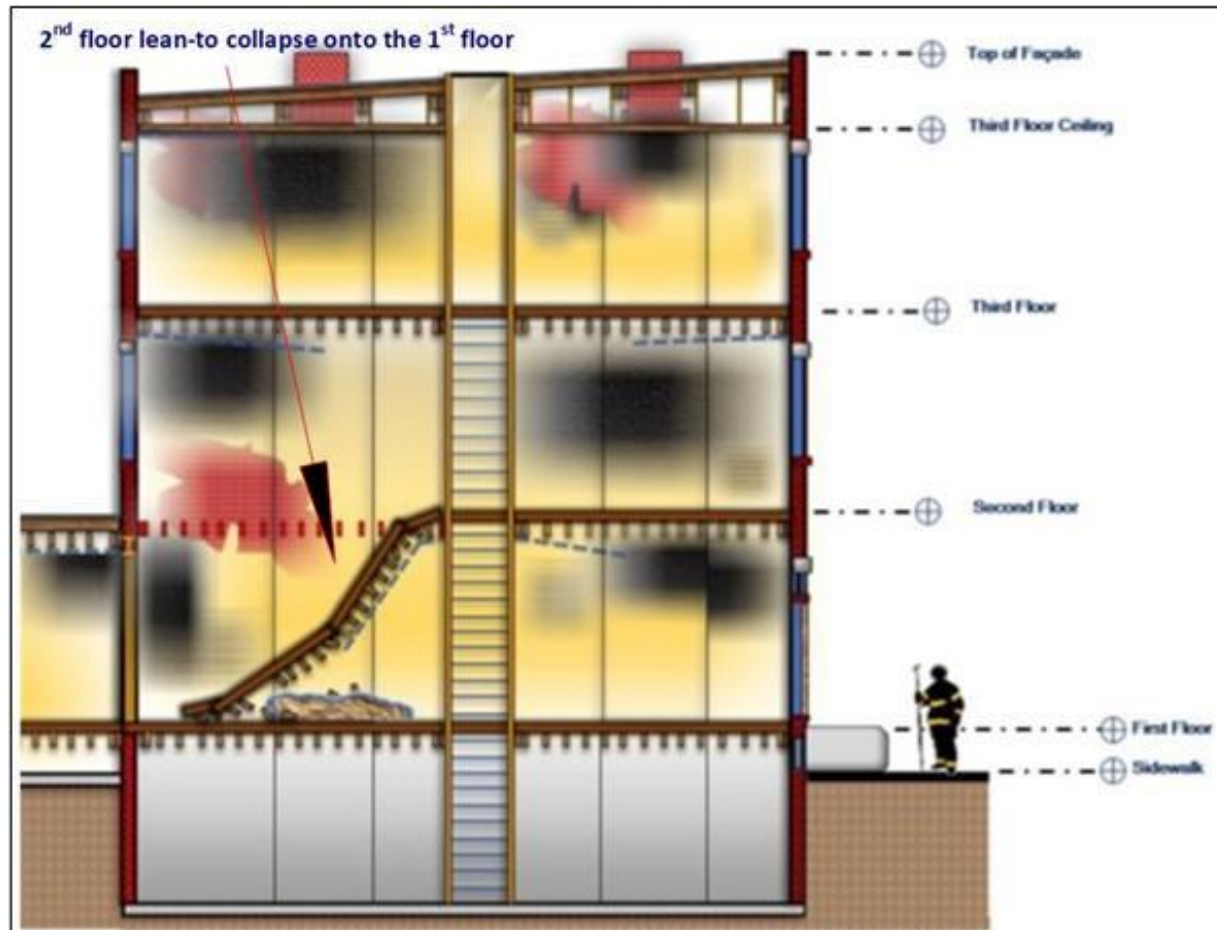
The cross-section of second floor collapse configuration from previous (2015) fire. (Courtesy of Buildingsonfire.com - C.J. Naum)

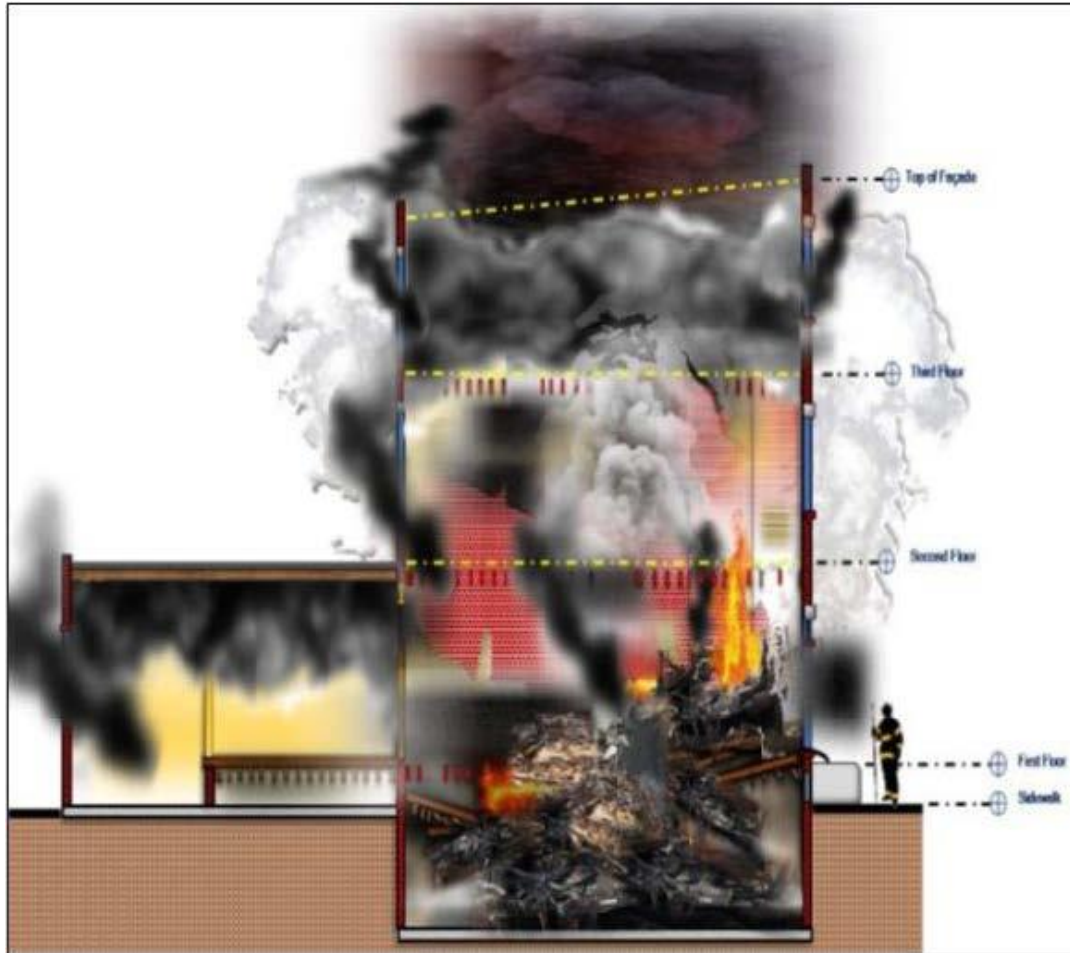
- Engine 55 and Truck 10 were initiating firefighting operations on Side Charlie.
- At 05:57 hours, BC 3 arrived, assumed command, and requested a “working fire” dispatch.
- At approximately 06:00 hours, a total collapse of all interior floors of the fire building occurred.
- Three firefighters from Engine 14, one firefighter from Truck 23, and two firefighters from Engine 36 were inside at the time of the collapse.
- Engine 36 firefighters were initially trapped but were able to self-extricate.

The cross-section of the interior collapse of the floors in the fire building. (Courtesy of Buildingsonfire.com - C.J. Naum)

- Fire departments should consider exterior fire control (defensive strategy) when the initial size-up reveals heavy fire conditions indicating risk of collapse.
- Governing municipalities (federal, state, regional/county, and local) should collaborate with fire departments to develop and implement strategies for the identification and remediation (demolition) of condemned High-Risk buildings.
