**LINE OF DUTY
DEATH REPORT
REPORT SLIDES**

F2022-02

Career Lieutenant Dies and Five Injured in Structural Collapse of Mixed-Use Occupancy during Cause and Origin Investigation - Pennsylvania

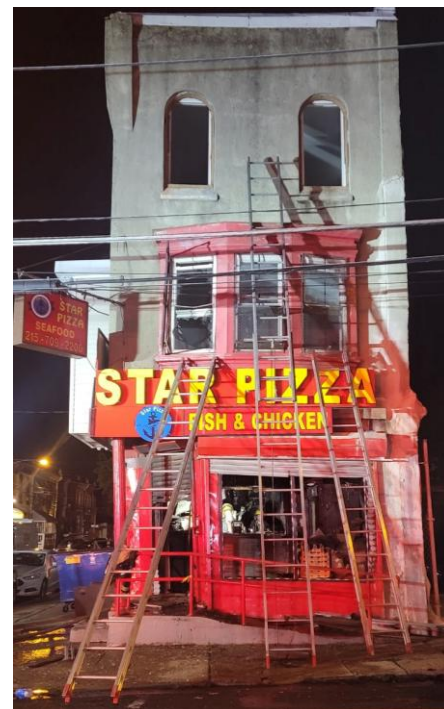
Scene photo of Side Alpha of the structure.
(Courtesy fire department)

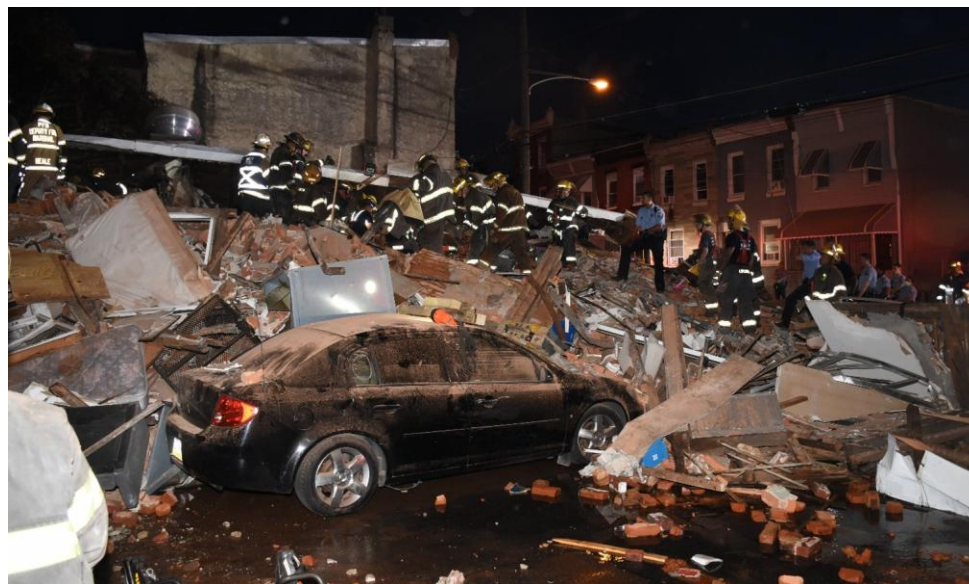
Incident scene of the Bravo side following the collapse.
(Courtesy of fire department)

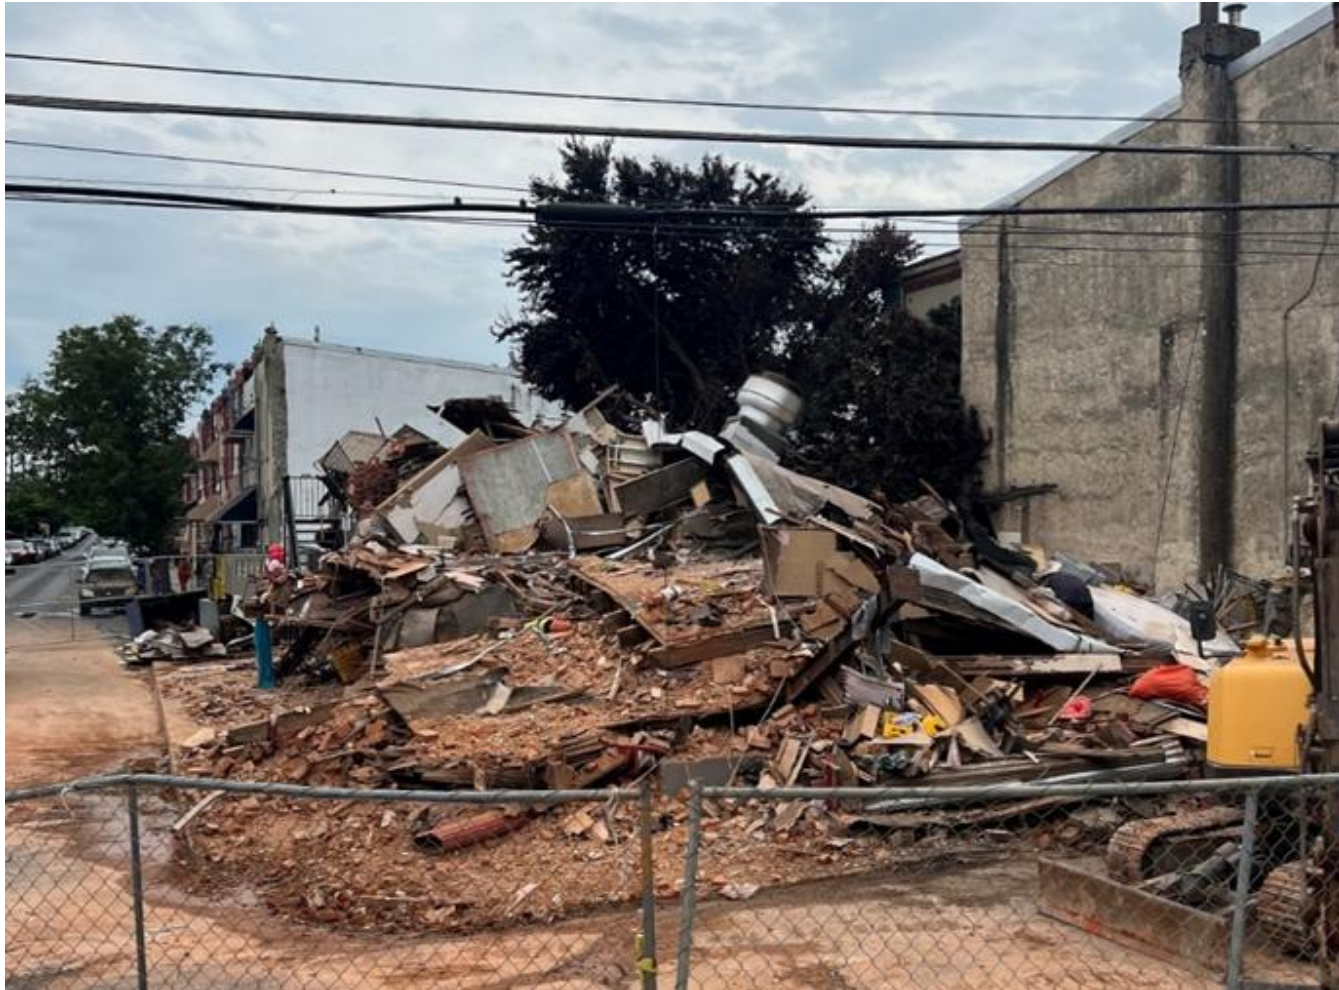
Aftermath of building collapse. *(Courtesy of fire department)*
