### Career Firefighter Dies from Crush Injuries During Sand Trailer Operations – Florida

# Career Firefighter Dies from Crush Injuries During Sand Trailer Operations – Florida

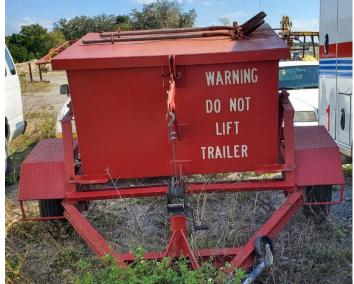
The sand trailer was roughly 117-inches long by 103-inches wide. Sand was contained in an enclosed right-angle trapezoid-shaped metal box (Photos 1 and 2) measuring approximately 59.5-inches wide. The short base (bottom) measured approximately 22.5-inches and the long base (top) approximately 41-inches. The forward-facing leg (right angle, Photo 1) measured approximately 37-inches and affixed with a "warning" message, "WARNING DO NOT LIFT TRAILER", and the rear-facing leg (obtuse angle) measures 42-inches. The box was mounted within a flat-top A-frame and connected on each side with a swivel, which allowed the box to be tipped backwards to release its contents while being towed forward. The box front had a welded post reaching forward to be secured by a winch mounted on the frame for controlled tipping of the box. The front bottom of the box was secured to the A-frame by pins to prevent uncontrolled tipping of the box itself. A removable lid allowed top access for filling. The lid was fitted with metal hangers to store two shovels. The trailer had a six-leaf slipper spring suspension. There were two stabilizing jacks mounted on the frame. One jack was mounted on the towing driver's side of the front trailer framework while the other was located on the rear-most cross member of the trailer framework and positioned within the designed tipping area of the sand box. The mounted tires

Photo 1: Front of sand trailer with front stabilizing jack in retracted position located on the front frame behind the trailer coupler (not visible), while being stored at the city's storage yard. (*Photo by NIOSH*)

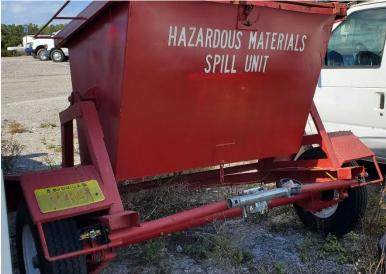
Photo 2: Rear of sand trailer with rear stabilizing jack in retracted position located on the center of the frame. The rear stabilizing jack was reported to be in this position when rescue efforts began. (*Photo by NIOSH*)

The GAWR is also needed for safety modifications. The 2007 tip over incident prompted the installation of a rear utility jack. The NIOSH investigator verified an installed Fulton utility jack located at the center of the rear crossbeam of the sand trailer frame. The stabilizing jack was stamped with a static capacity of 1,000 pounds. Instructions for similar Fulton utility jacks online indicate that a failure to follow the warnings could result in property damage, serious injury, and/or death. The first warning is to never position any part of the body under any portion
