LINE OF DUTY DEATH REPORT

REPORT F2022-09 • May 2025

Lieutenant Dies from a Floor Collapse in Residential Structure Fire with Unpermitted Renovations – Illinois

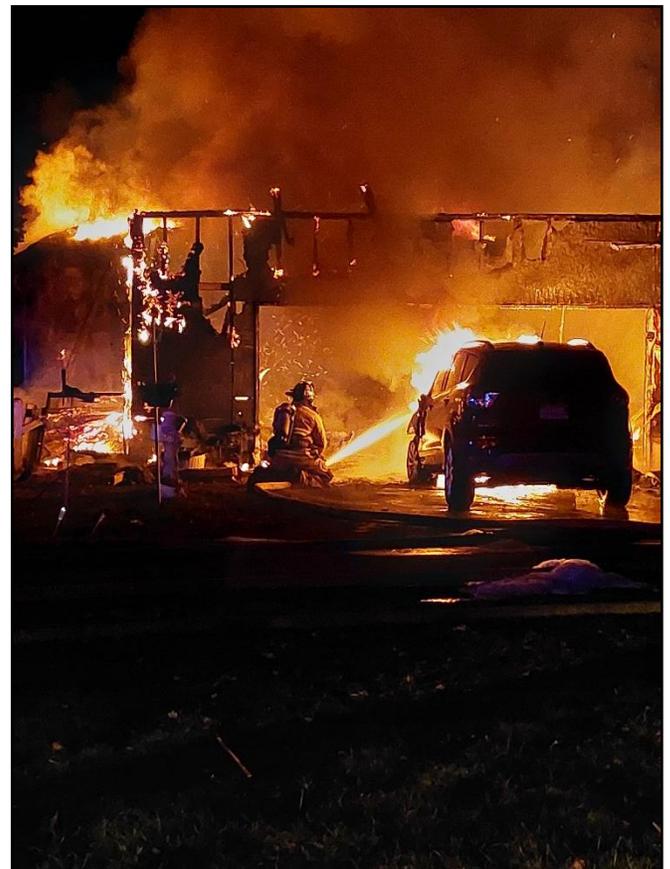
Photo 1: A firefighter from Engine 48 attempting to knock down the fire in the garage.
(Courtesy of Heather Smith - Eye on News)

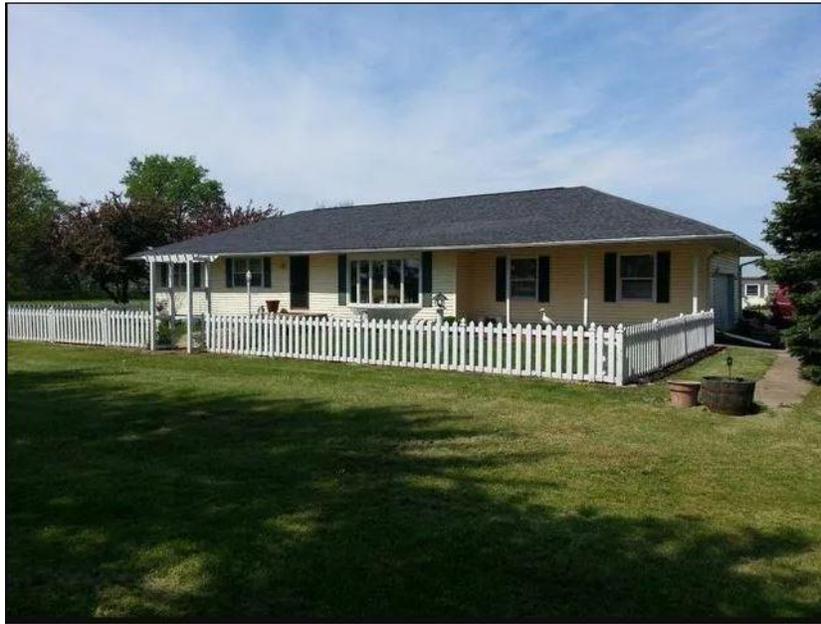
Photo 2. Side Alpha of the house. The garage can be seen on Side Delta.
(Courtesy of Realtor.com)

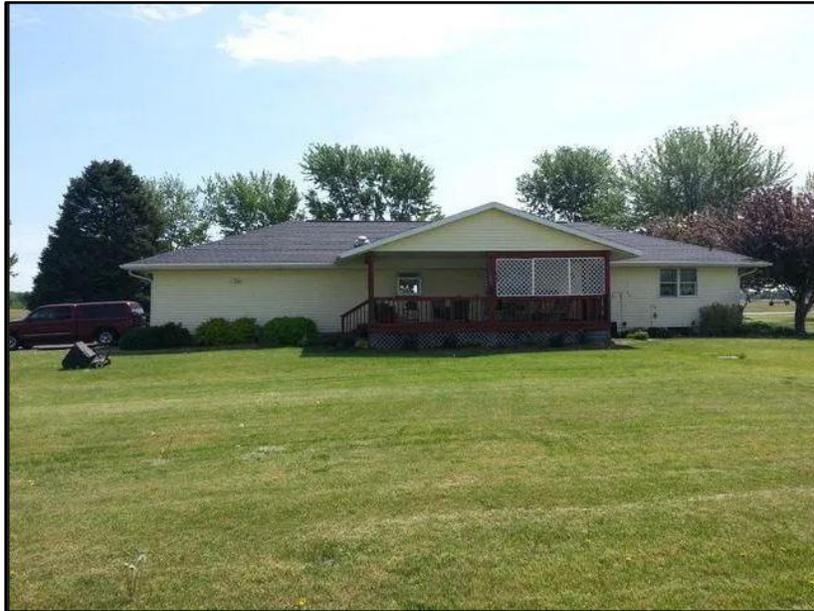
Photo 3. Side Charlie of the house.
(Courtesy of Realtor.com)

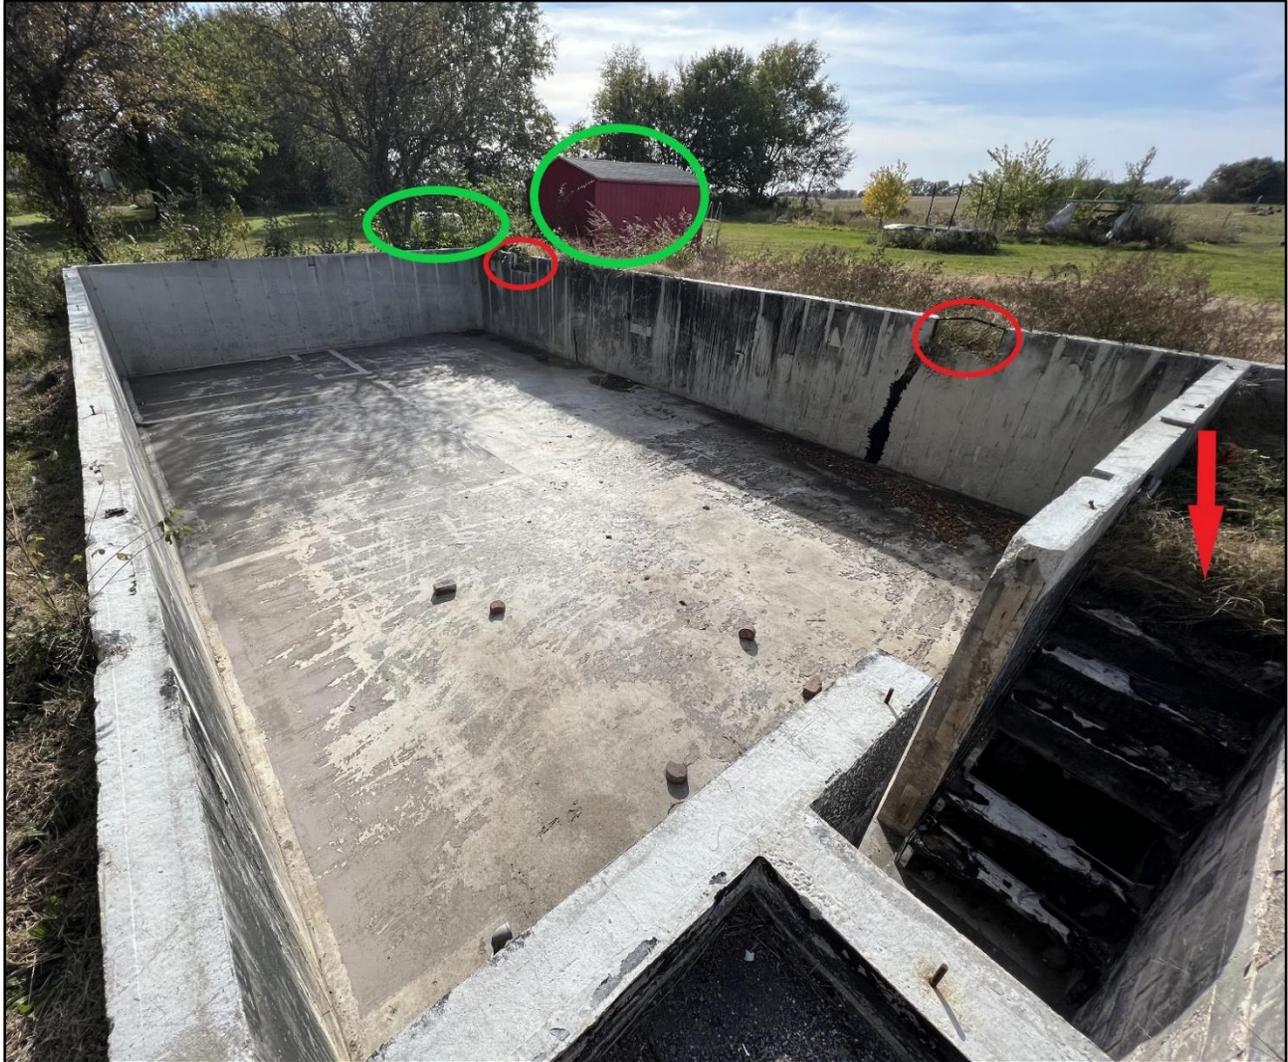
Photo 4. The concrete foundation of the house. The red circles indicate the location of the basement windows. The red arrow indicates the basement steps that were the only access to the basement. The green circles indicate the shed and propane tank.

In this incident, the property owner made several unpermitted renovations that created a life safety hazard for the responding firefighters. Specifically, all basement windows were boarded up and painted over to match the siding of the structure. This disguised that there was a basement upon initial size-up and ways to access the basement after the Mayday. Neither fire department in this incident are responsible for performing residential fire inspections and the designated authority for code enforcement is the local government.

Recommendation #8: Governing municipalities should ensure the applicable fire and life safety codes are enforced for renovations in residential occupancies and relevant information is shared with the fire department.

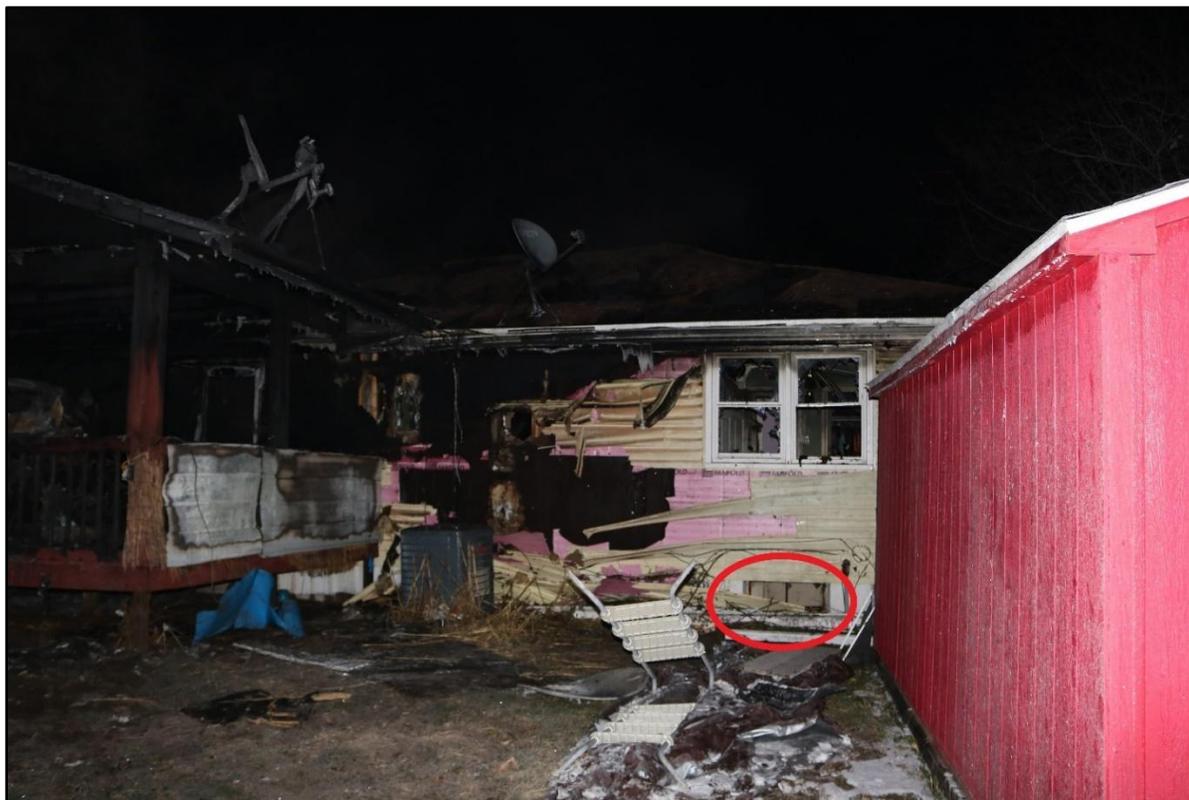
Photo 5. A view of Side Charlie near Side Bravo. The red circle indicates the location of one the basement windows. The storage shed is to the right.
(Courtesy of the Illinois State Fire Marshal's Office)

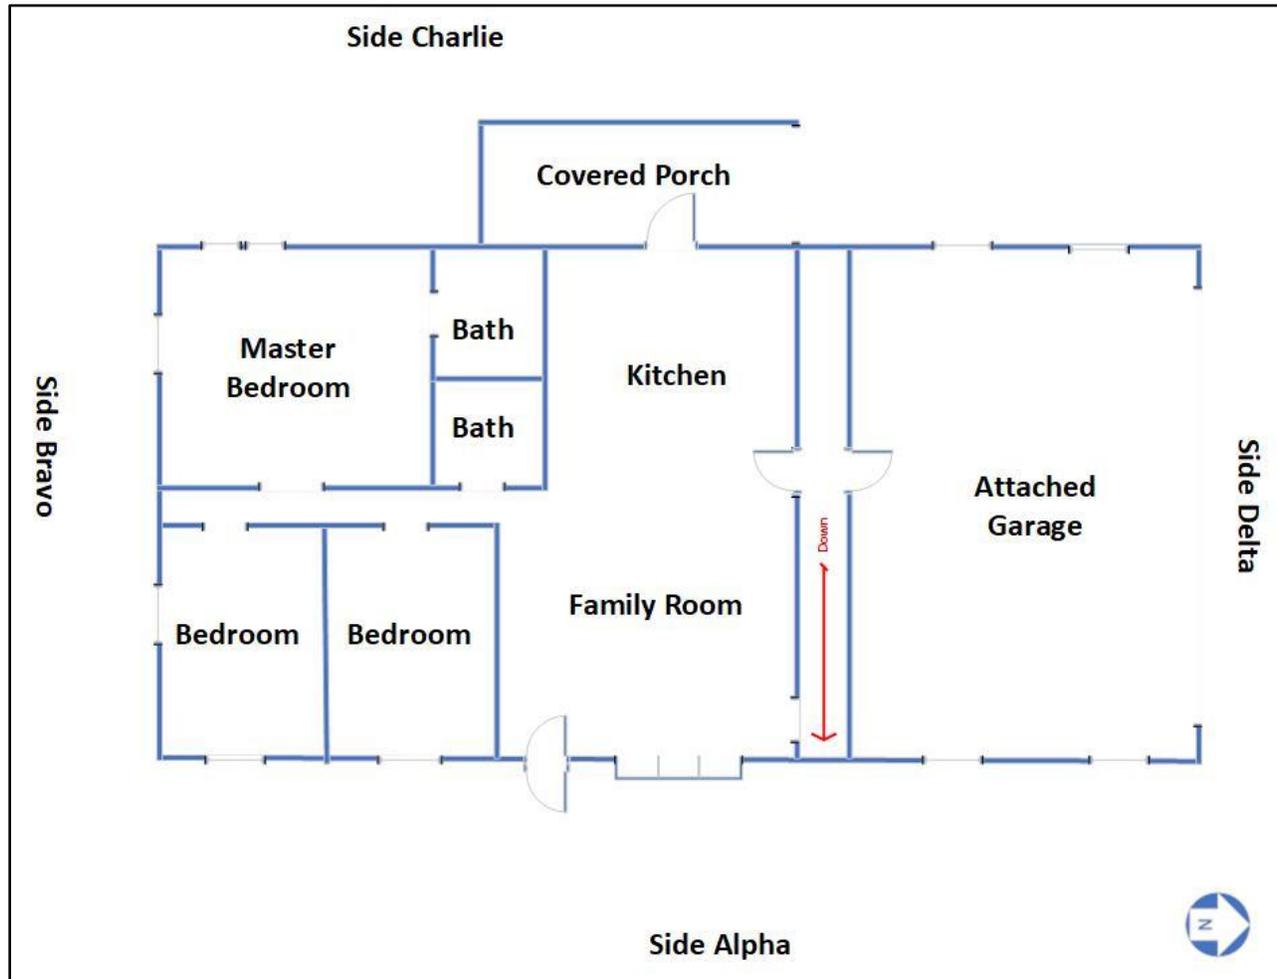
Diagram 1. The floor plan (first floor) (Prepared by NIOSH)

The total living space was 1,548 square feet (see **Diagram 1**). Six residents lived in the house. There was a floor plan of the first floor, but not the basement. The house was built with dimensional lumber, wood frame, and Type V construction. There were two 2-inch x 10-inch main beams that went from Side Bravo to Side Delta. The floor joists were 2-inch x 6-inch and went from Side Alpha to Side Charlie. The flooring was tongue and groove in 3-inch slats. The walls were made of 2-inch x 4-inch and covered with sheetrock.

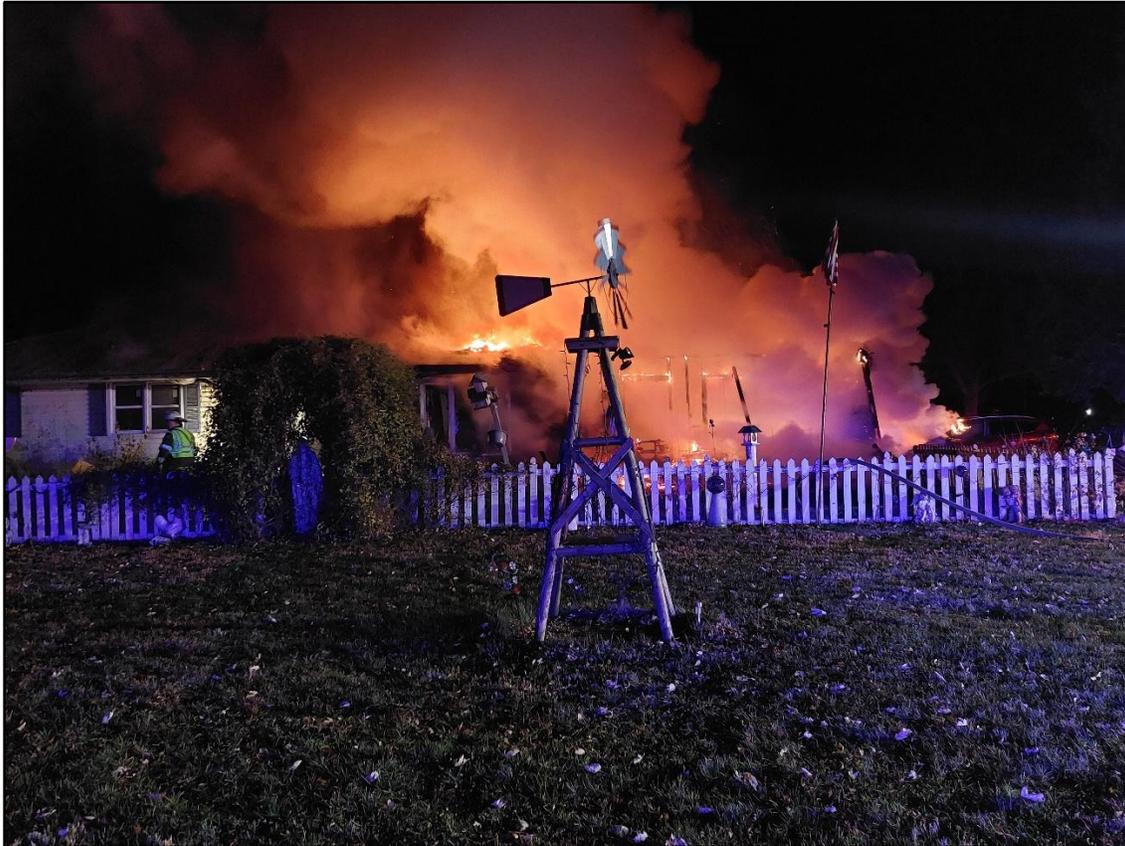
Photo 6. An E48 firefighter deployed a hoseline to knock down the fire in the garage and vehicle.

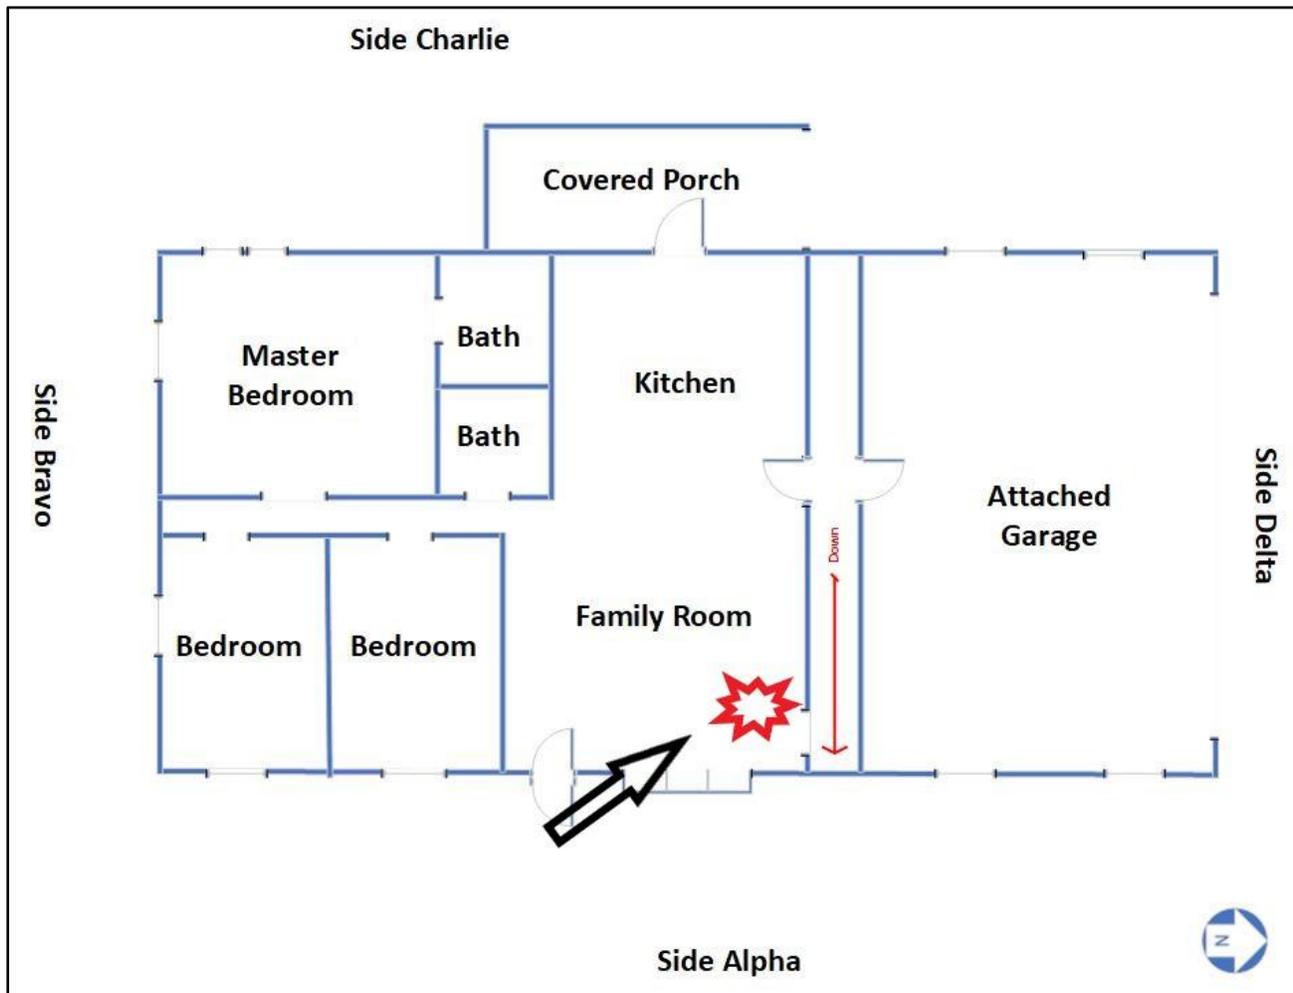
Diagram 2. The arrow shows the location in the family room where the floor collapsed and E6NA fell into the basement. (Prepared by NIOSH)

As he exited the building, E6NA fell through a fire weakened portion of the family room floor into the basement near the Side Alpha/Side Delta corner. E6NA transmitted a Mayday around 00:04 hours on the dispatch channel. Most crews were operating on the MABAS Red and did not hear the Mayday. Car 1 North declared emergency traffic and asked for the member who called the Mayday to repeat the message. There was no response. A photograph taken after the Mayday shows heavy fire in the family room (see **Photo 7**).

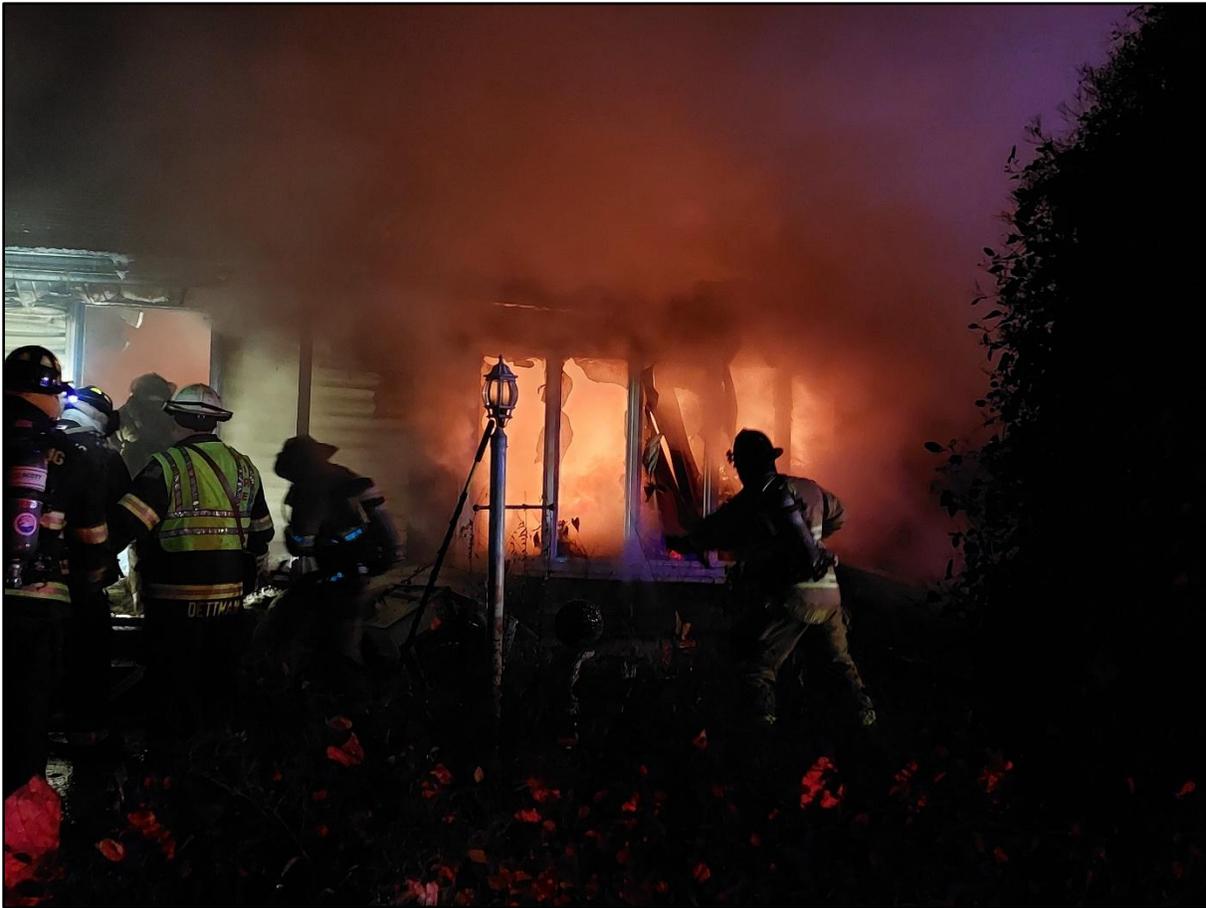
Photo 7: When E6NA fell through the floor, the fire in the family room intensified.
(Courtesy of Heather Smith - Eye on News)

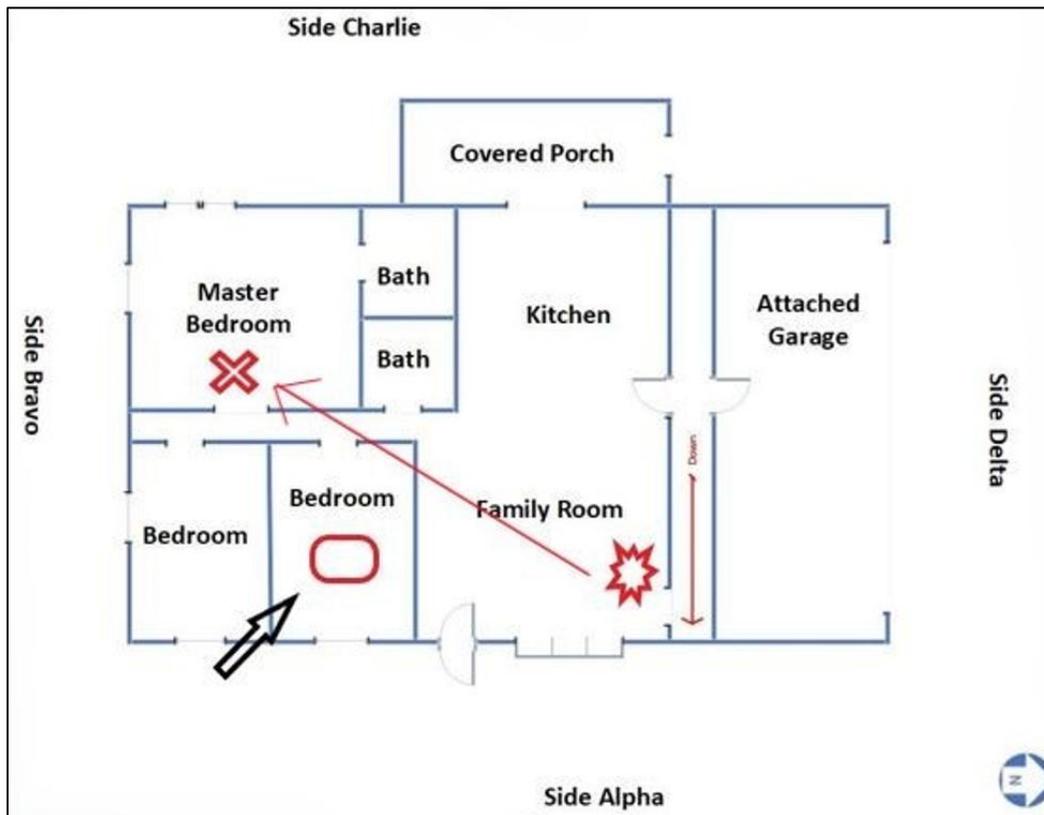
Diagram 3. The approximate path that E6NA took after falling into the basement through a hole in the family room floor and being found in the area under the master bedroom. The arrow points to the hole that a RIC company made in the bedroom to gain access to the basement. (Prepared by NIOSH)

DCE6 reported heavy smoke, no visibility, and no visible fire. Shortly after entering the basement, a member of the crew heard an SCBA PASS alarm sounding. The crew located E6NA with his SCBA facepiece and regulator intact with his helmet on. E6NA was located near the Side Bravo wall of the basement. DCE6 reported to IC that they found E6NA and requested EMS around 00:52 hours. At 00:59 hours, fireground operations were at 120 minutes. DCE6 moved E6NA to a pool table and applied webbing to raise him out of the basement. Two attempts to remove E6NA from the basement were unsuccessful. With additional webbing attached, the third attempt was successful. E6NA was removed and transferred to EMS personnel around 01:02 hours. He was transported by ambulance to a local trauma hospital and pronounced deceased at 01:41 hours. The fire was marked under control at approximately 02:00 hours by IC. The fire was declared out around 06:45 hours and demobilization was started.
