**LINE OF DUTY
DEATH REPORT
REPORT SLIDES**

F2022-09

Lieutenant Dies from a Floor Collapse
in Residential Structure Fire with
Unpermitted Renovations – Illinois

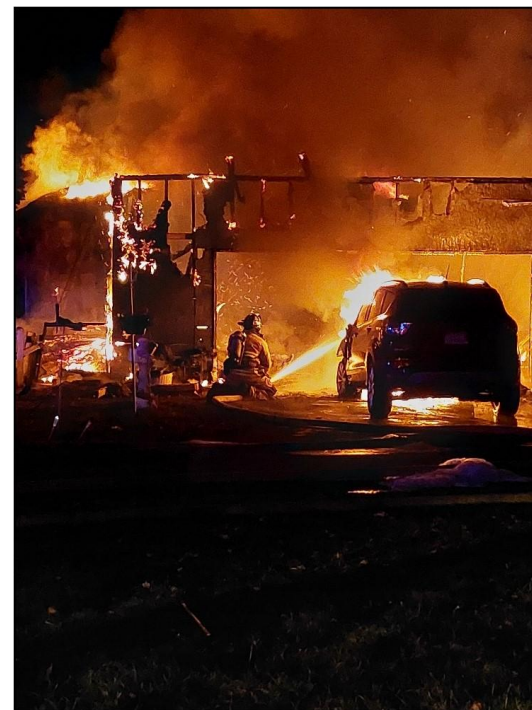
A firefighter from Engine 48 attempting to knock down the fire in the garage.
(Courtesy of Heather Smith - Eye on News)

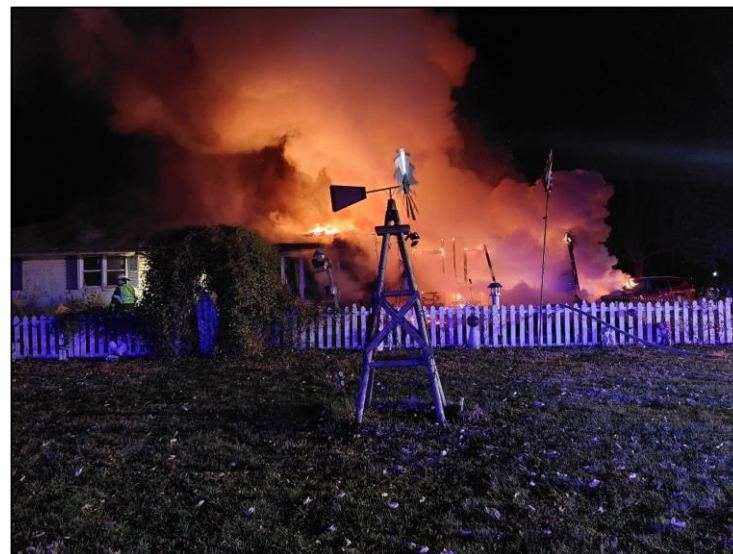
An E48 firefighter deployed a hoseline to knock down the fire in the garage and vehicle.
(Courtesy of Heather Smith - Eye on News)

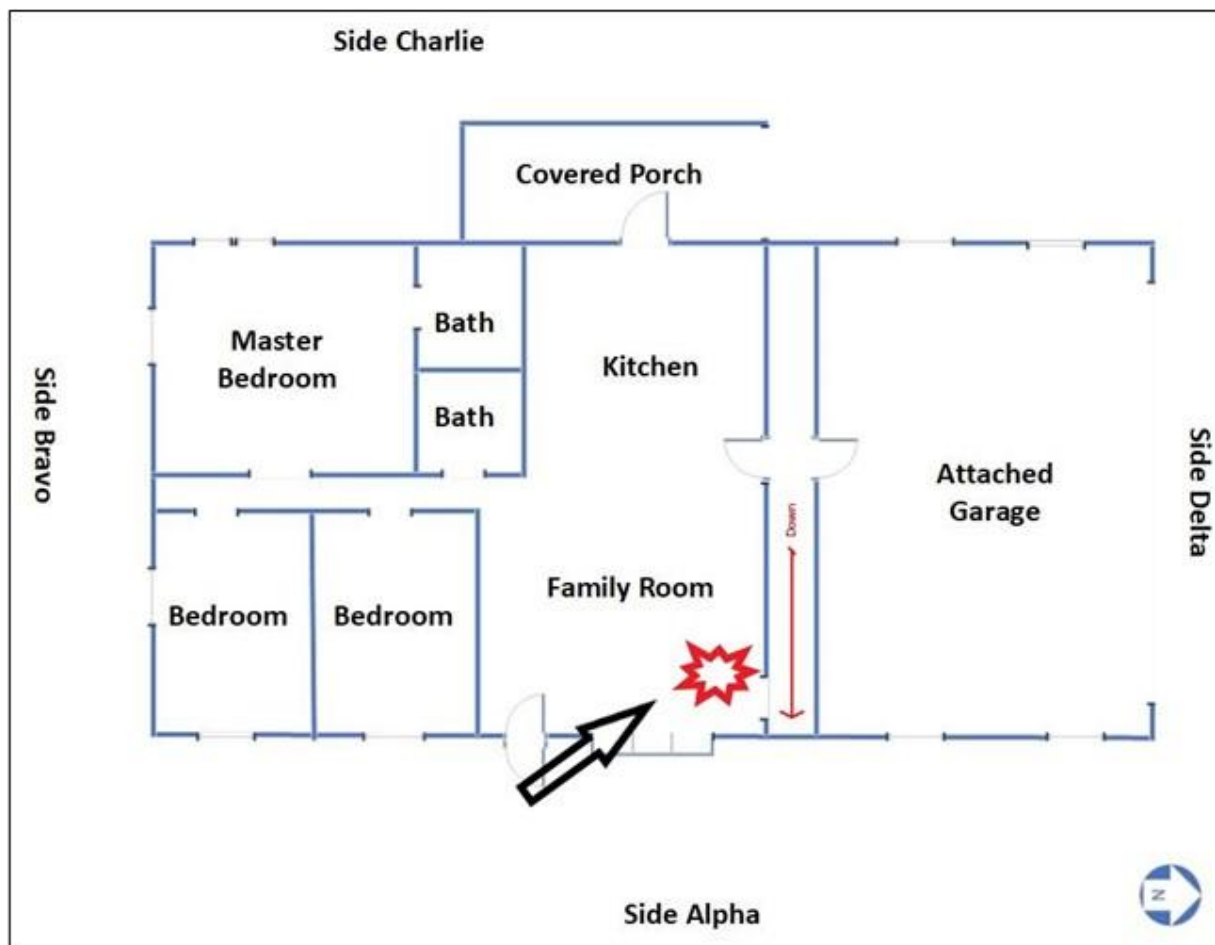
- At approximately 00:01 hours on December 4, a radio report was transmitted on MABAS Red of a partial floor collapse.
- As E6NA exited the building, he fell through a fire weakened portion of the floor into the basement near the Side Alpha/Side Delta corner of the family room floor.
- E6NA transmitted a Mayday at approximately 00:04 hours on the dispatch channel.
- Most crews were operating on the MABAS Red and did not hear the Mayday.
- Car 1 North declared emergency traffic and asked for the member who called the Mayday to repeat the message.
- There was no response.
- A personnel accountability report (PAR) was initiated at approximately 00:06 hours.

The arrow shows the location in the family room where the floor collapsed and E6NA fell into the basement. (Prepared by NIOSH)

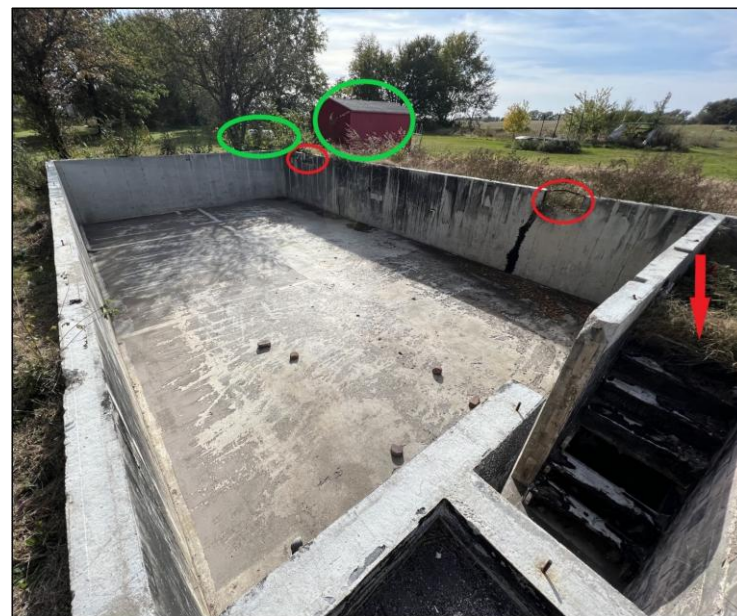
- During the search, IC advised the house had a full basement.
- The presence of a basement was unknown to initial responding units because all the basement windows were boarded up and painted over to match the siding of the structure.
- A crew went to the basement steps but could not enter because of debris from the 1st floor collapse.

The concrete foundation of the house. The red circles indicate the location of the basement windows. The red arrow indicates the basement steps that were the only access to the basement. The green circles indicate the shed and propane tank. (Courtesy of NIOSH)

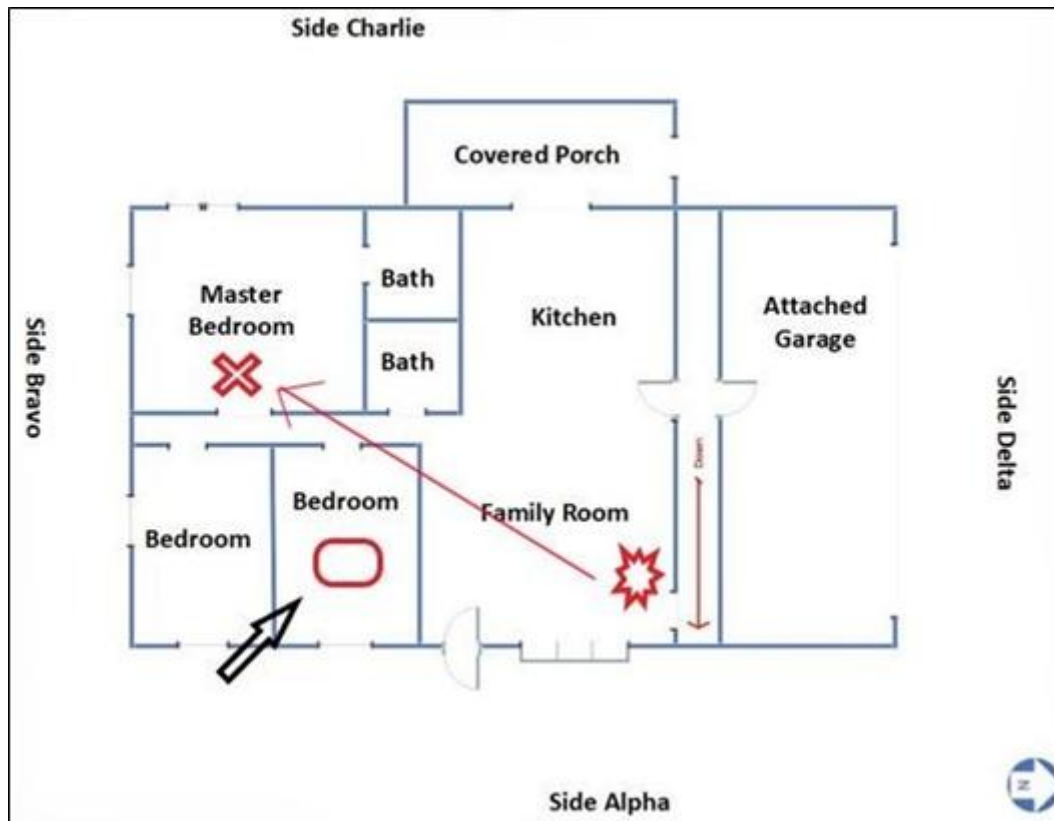
The approximate path that E6NA took after falling into the basement through a hole in the family room floor and being found in the area under the master bedroom. The arrow points to the hole that a RIC company made in the bedroom to gain access to the basement. (Prepared by NIOSH)
