LINE OF DUTY DEATH REPORT

REPORT F2022-10 • April 2025

Two Volunteer Firefighters Die while Conducting Fire Attack at a Single-Family Residence – Pennsylvania

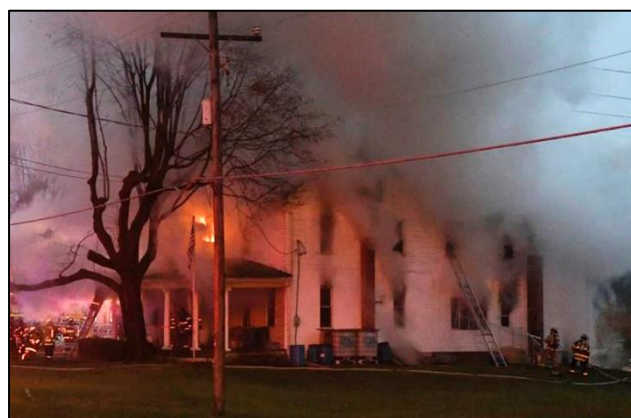
Photo 1. A view of the structure and conditions at the approximate time of the Mayday operation.

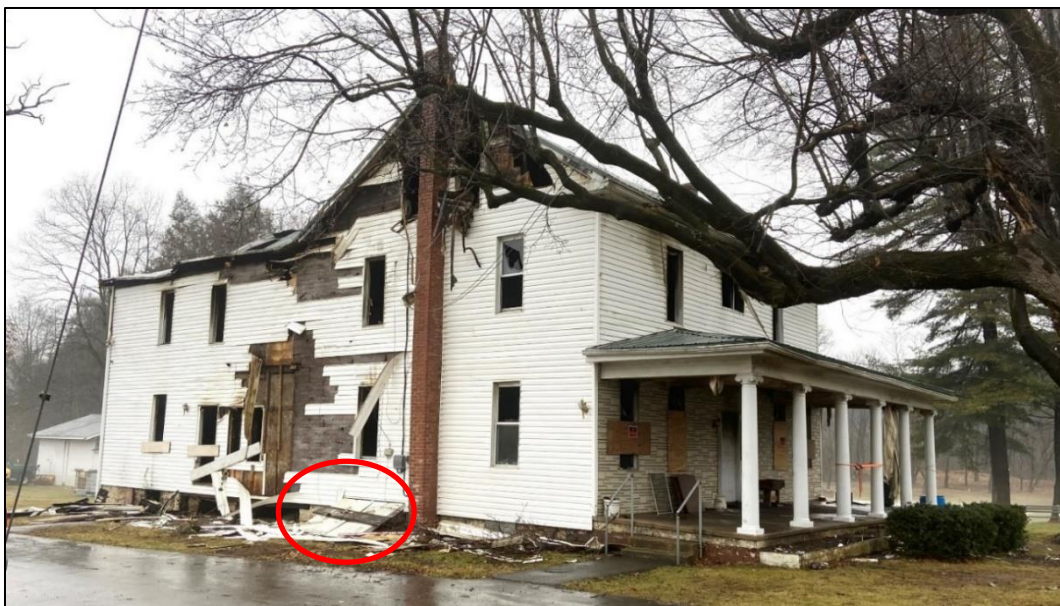
Photo 2. Sides Alpha and Bravo. The Bilco door to the front cellar (circled in red on the photo) was visible on Side Bravo.
(Courtesy of NIOSH)

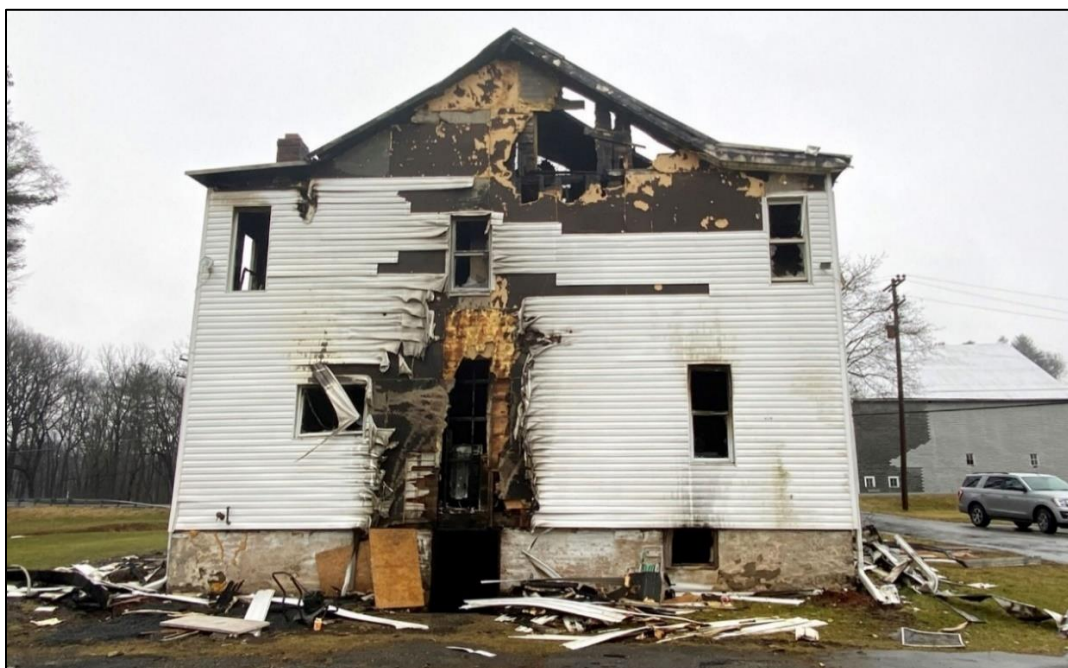
Photo 3. Side Charlie. The exterior door to the rear cellar is visible. The fire extension pathway from the cellar to the top half story is clearly visible.
(Courtesy of NIOSH)

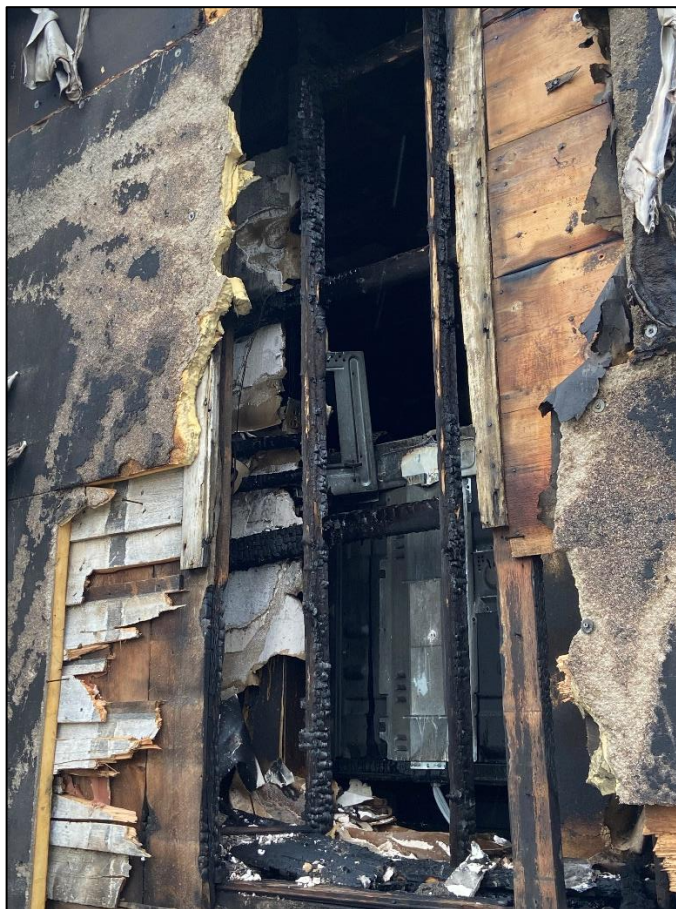
The house was built in 1848 as a residential occupancy. In the 1920s, a fire occurred in the primary kitchen area resulting in damage to the exterior load bearing wall on Side Charlie. Given the unique plank construction used in the house, a new load bearing wall to support Side Charlie was constructed. This construction resulted in a new wood frame wall being built along Side Charlie approximately six inches inside of the existing wall. This created a large vertical and horizontal void space between the original exterior wall and the new interior wall (see **Photo 6**).

Photo 6. First floor Side Charlie wall construction showing original plank wall and new interior wall creating a void space.
(*Courtesy of NIOSH*)

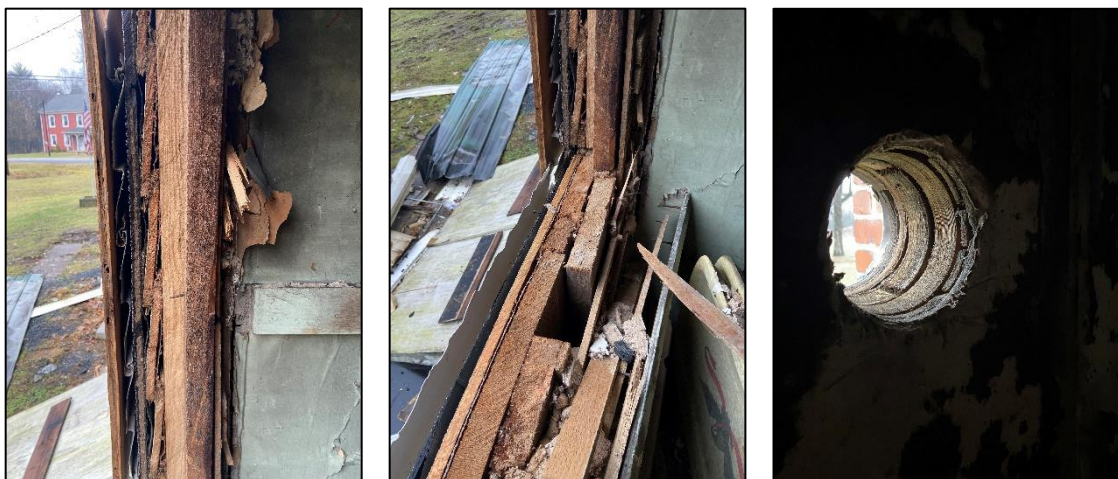
The house was constructed of Type 5 wood frame construction known as “plank construction.” This is unique because the walls were constructed with plank boards placed together in several overlapping layers running vertically (see **Photo 7**).

Photo 7. Plank construction showing various additions to the structure.
(Courtesy of NIOSH)

Unlike typical frame construction, these later additions resulted in a solid wood wall, running both horizontally and vertically, without any voids. The solid wood wall was finished with a protective exterior weather barrier and a finished interior covering. In this construction, the original exterior barrier was wood siding. As **Photo 7** shows, throughout the life of the house, additional exterior layers were added, including asphalt shingles, foam board, and vinyl siding. The interior finish in this construction was wood lath and plaster.

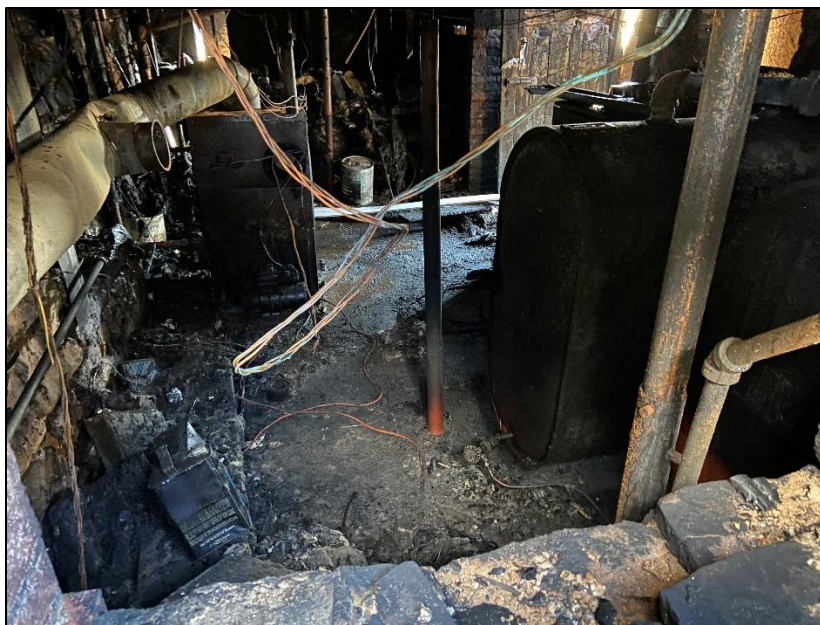
The origin of the fire was determined to be in the rear cellar, along Side Charlie of the structure. The valve of a fuel oil storage tank in the Charlie/Delta corner of the rear cellar (**see Diagram 1**) was intentionally damaged which allowed the fuel oil to flow out and onto the cellar floor where it was intentionally ignited (**see Photo 8**).

Photo 8. Rear cellar with fire origin from the side Delta window view.
(Courtesy of NIOSH)

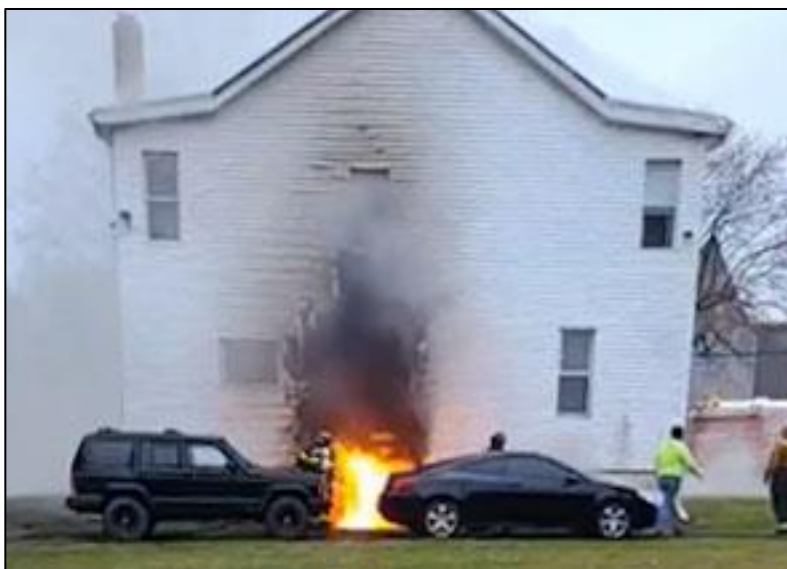
fire attack continued for the next 4-5 minutes but proved to be ineffective due to the fire involving an ignitable liquid (fuel oil). The firefighters initiating the attack recognized the smell of an ignitable liquid, combined with the ineffective fire attack, and determined that they would need to switch to a foam-based fire attack. An additional 1¾ inch hoseline from E-6512 which was setup to flow foam, and the fire attack was reinitiated at the rear cellar (see **Photo 9**).

Photo 9. Initial main body of fire located in the rear cellar.
(Courtesy of the fire department)

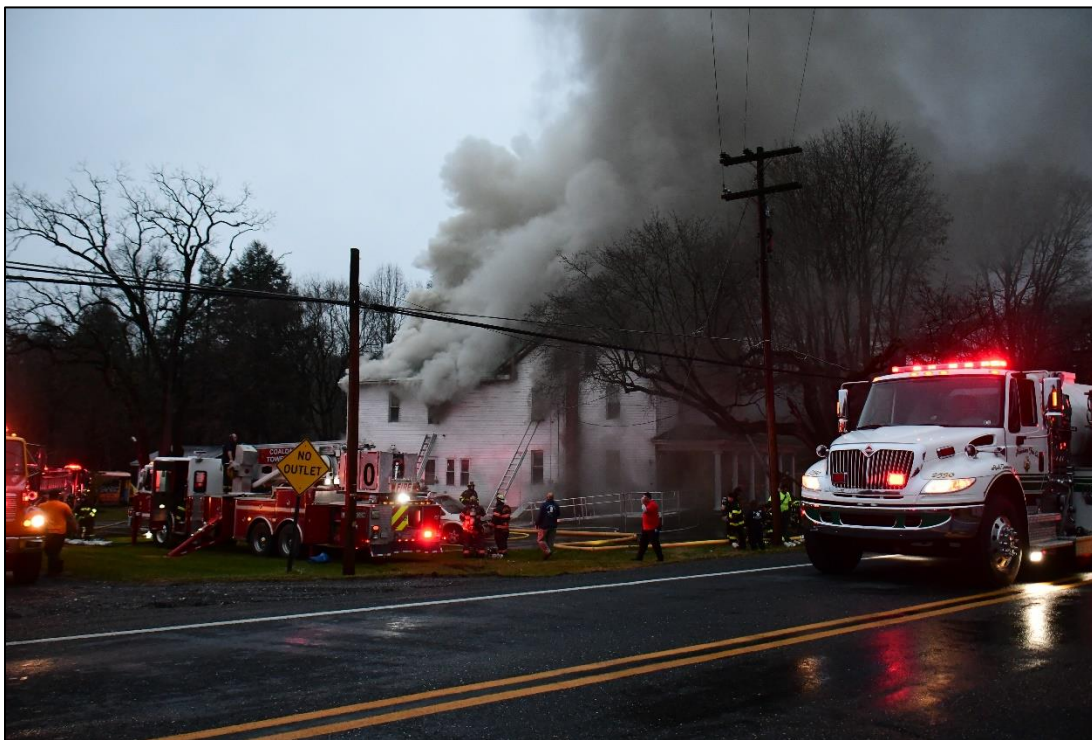
At 16:11 hours, the interior crew from fire department 65 reported that there was fire in multiple locations on the second floor towards the rear and requested additional hoselines to the second floor (see Photo 10).

Photo 10. Conditions at approximately 16:11 when the second hoseline was deployed.
(Courtesy of the fire department)

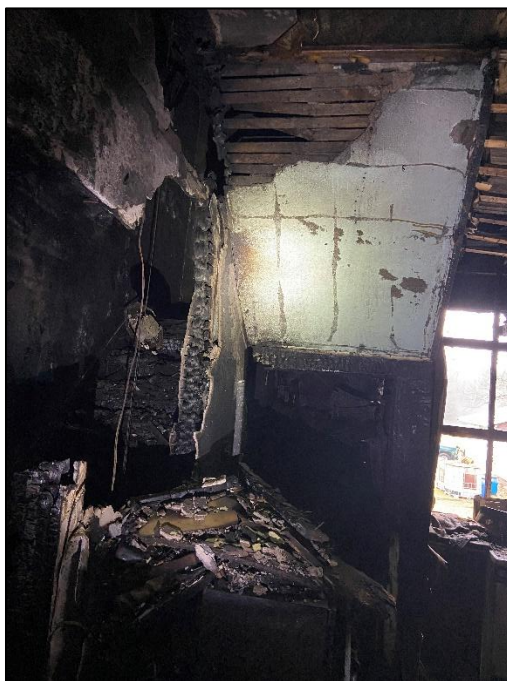
At 16:17 hours, the interior crew from fire department 65 who were operating on the second floor encountered fire extending up the rear stairs (see **Photo 11**). They advised C-3701 that the conditions were deteriorating rapidly, they had heavy fire on the first floor, and they were leaving their position on the second floor. Upon exiting at 16:19 hours, the interior crew from fire department 65 reported that the secondary searches were all clear.

Photo 11. Rear stairs, showing the flow path from the rear cellar, to the first floor, to the second floor (Side Charlie).

- The rear staircase ran from the rear cellar to the second floor. This vertical pathway allowed the rapid spread of smoke and fire throughout the interior of the structure. The rear stairway, combined with the center hallway running unobstructed from the rear to front of the second floor, created a flow path when the window at the end of that hallway failed. Also, having both a rear and front set of stairs allowed for the rapid spread of smoke, heat, and fire up to the second floor.

Recommendation #2 - Recognize and react to the impacts of building construction on fire behavior.

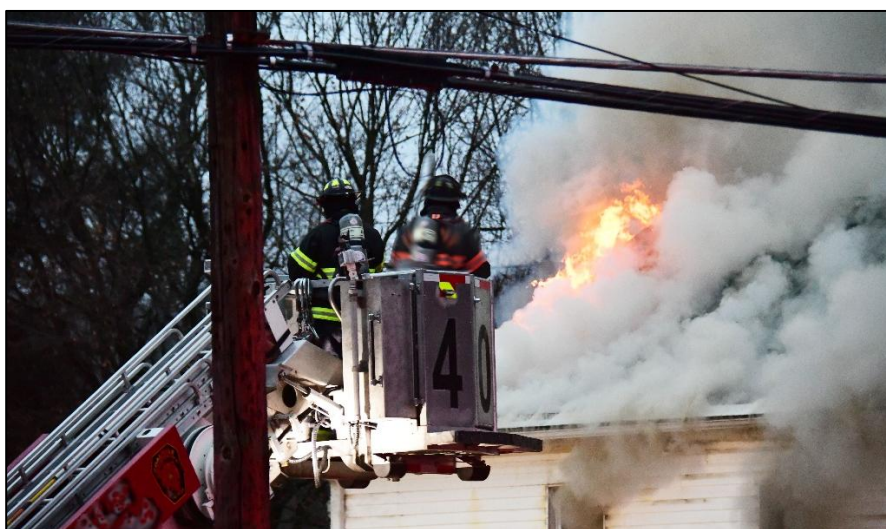
At approximately 16:24 hours, T-4024 placed the aerial ladder to the roof to conduct vertical ventilation. However, the deteriorating fire and smoke conditions forced them to abandon the operation (see Photo 12).

Photo 12. Conditions at the time that T-4024 attempted to ventilate the roof.
(Courtesy of the fire department)
