**LINE OF DUTY
DEATH REPORT
REPORT SLIDES**

F2022-10

Two Volunteer Firefighters Die
while Conducting Fire Attack at a
Single-Family Residence –
Pennsylvania

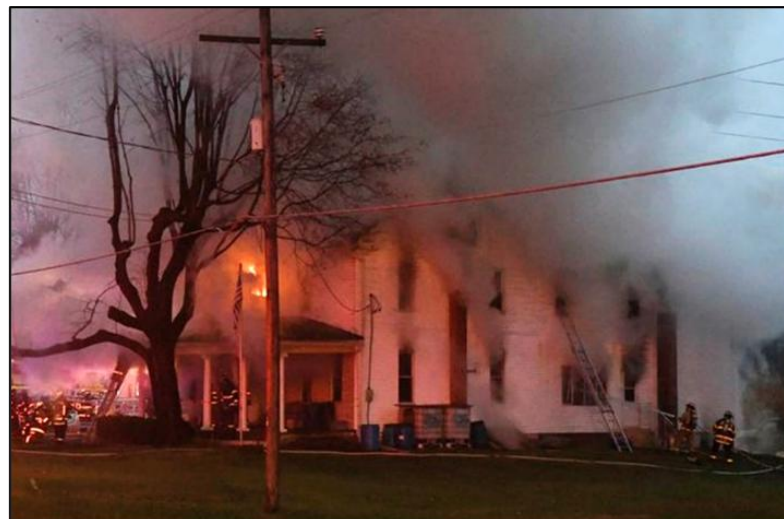
A view of the structure and conditions at the approximate time of the Mayday operation.
(Courtesy of the fire department)

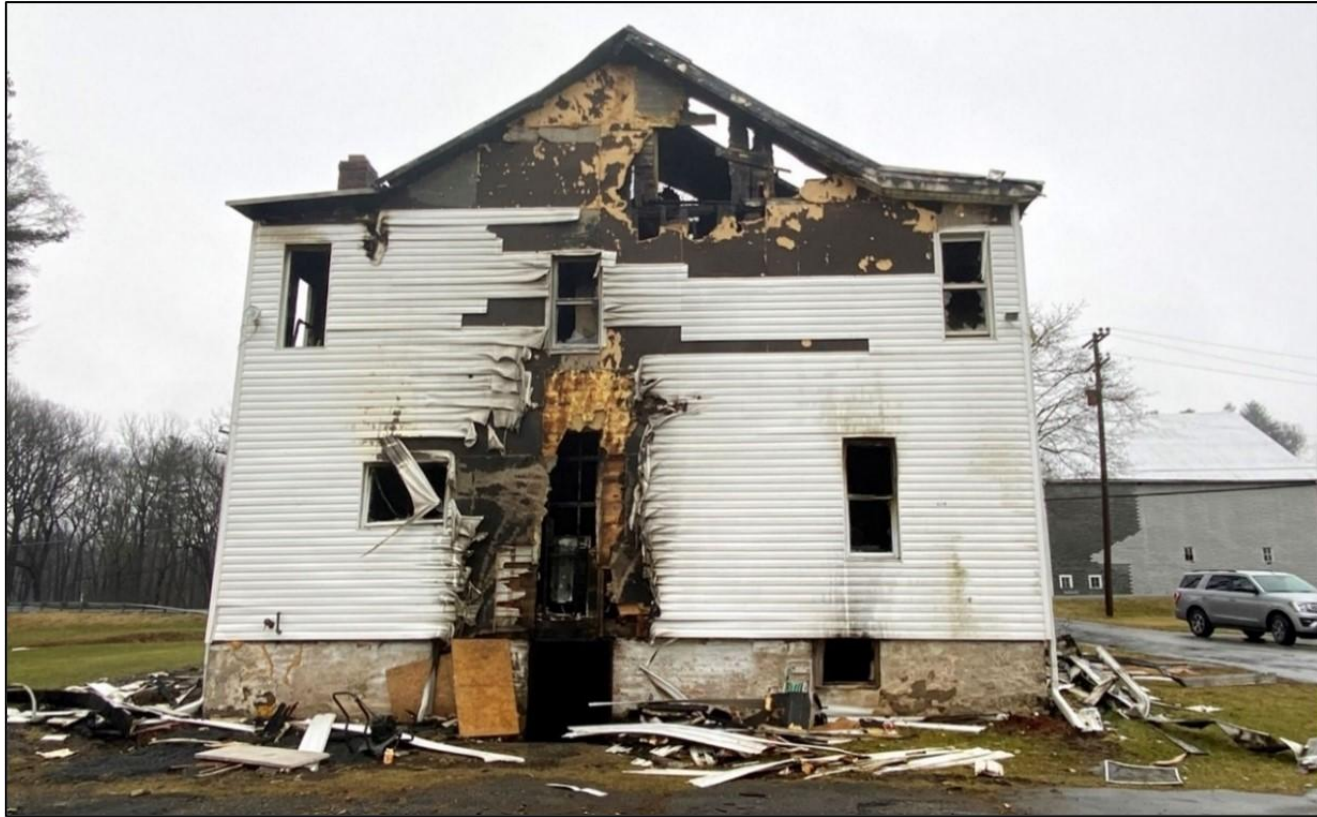
Side Charlie. The exterior door to the rear cellar is visible. The fire extension pathway from the cellar to the top half story is clearly visible. *(Courtesy of NIOSH)*

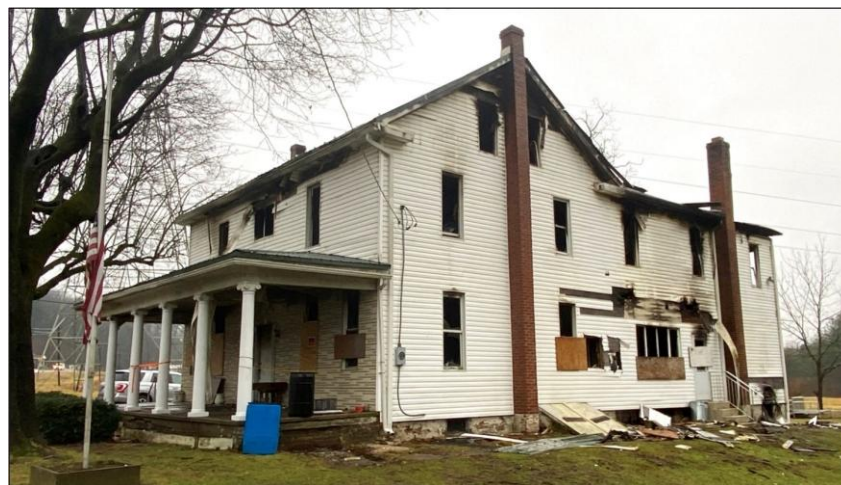
Sides Alpha and Delta.
(Courtesy of NIOSH)

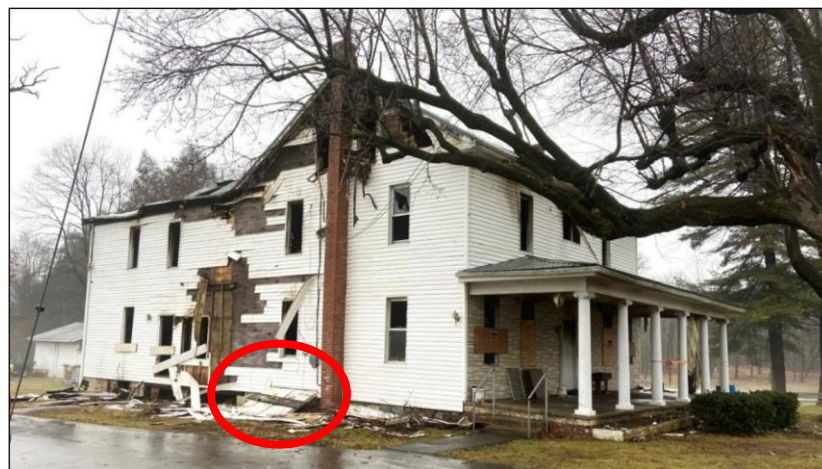
Sides Alpha and Bravo. The Bilco door to the front cellar (circled in red on the photo) was visible on Side Bravo.
(Courtesy of NIOSH)
