# LINE OF DUTY DEATH REPORT

REPORT F2023-07 • April 2025

## ***Career Firefighter Dies in Collapse involving Lightweight Construction with Two separate Maydays – South Carolina***

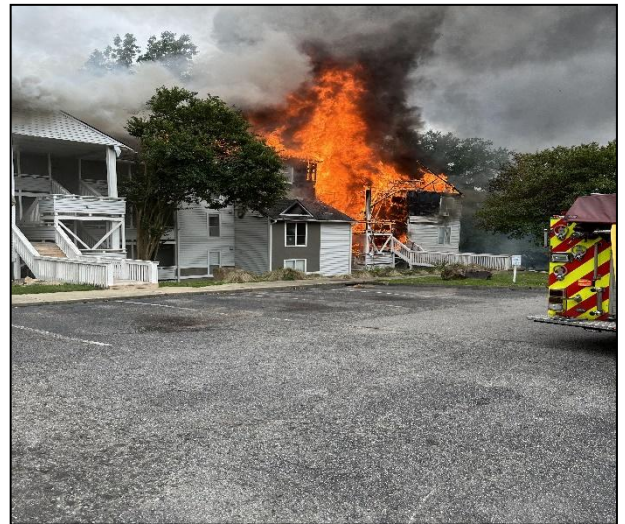
**Photo 1: Side Alpha arrival conditions.**  
(Courtesy of the ATF)

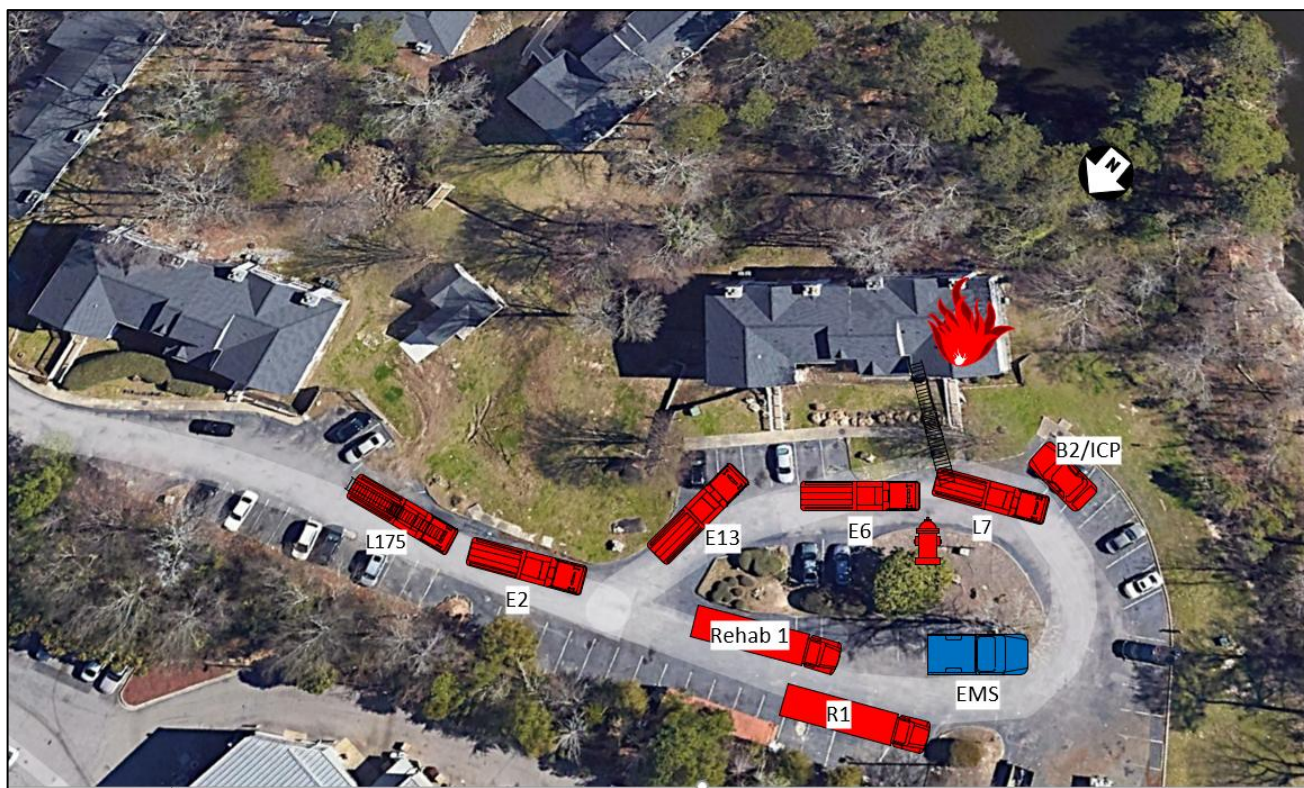
**Photo 2: First alarm apparatus positioning showing seat of the fire.**  
(Prepared by NIOSH)

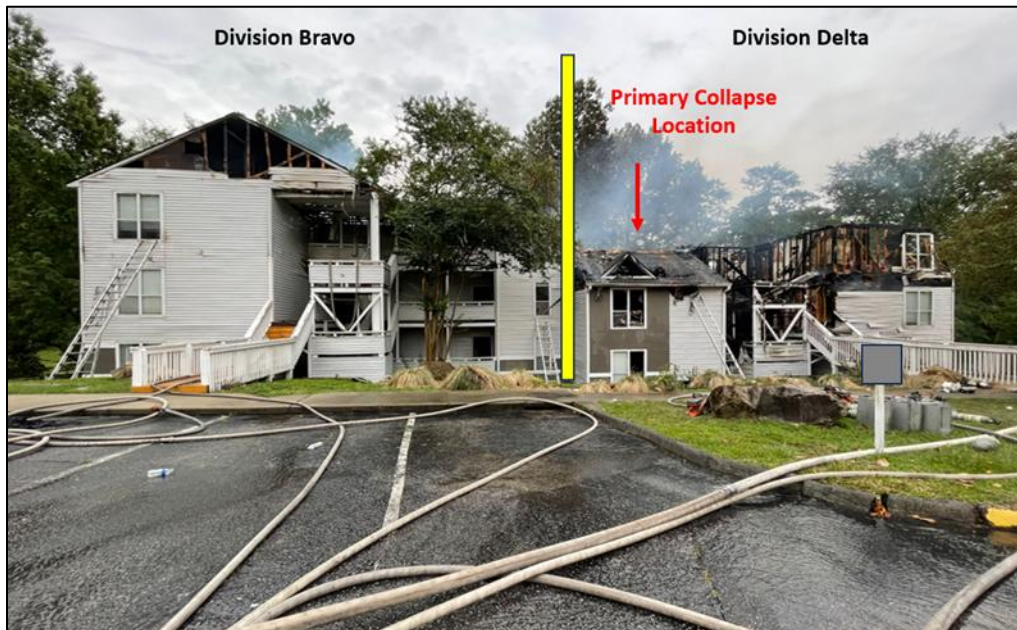
**Photo 3: Division Bravo (left) and division Delta (right) separation. (Prepared by NIOSH)**

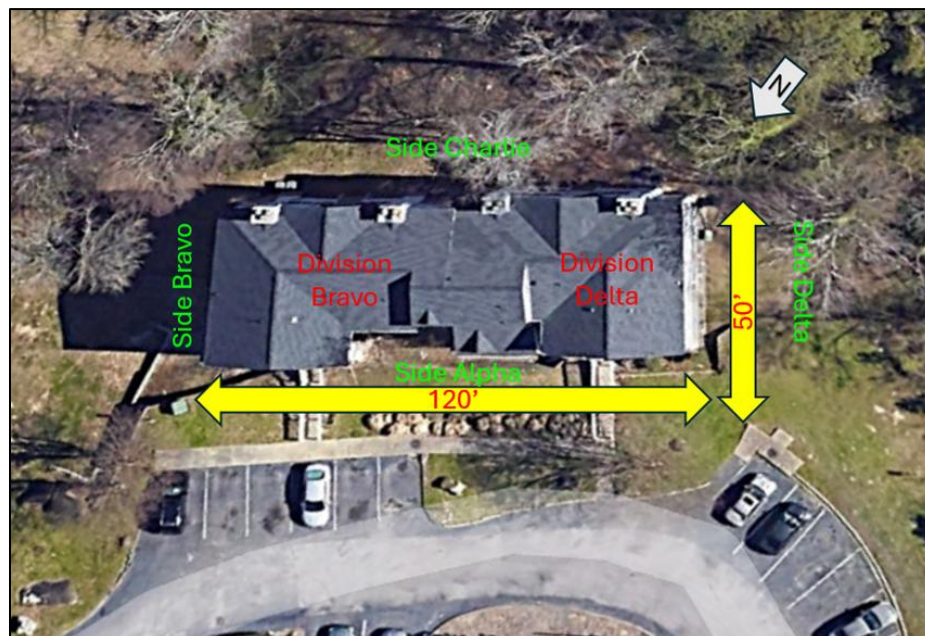
**Photo 4: Aerial view of apartment building. (Prepared by NIOSH)**

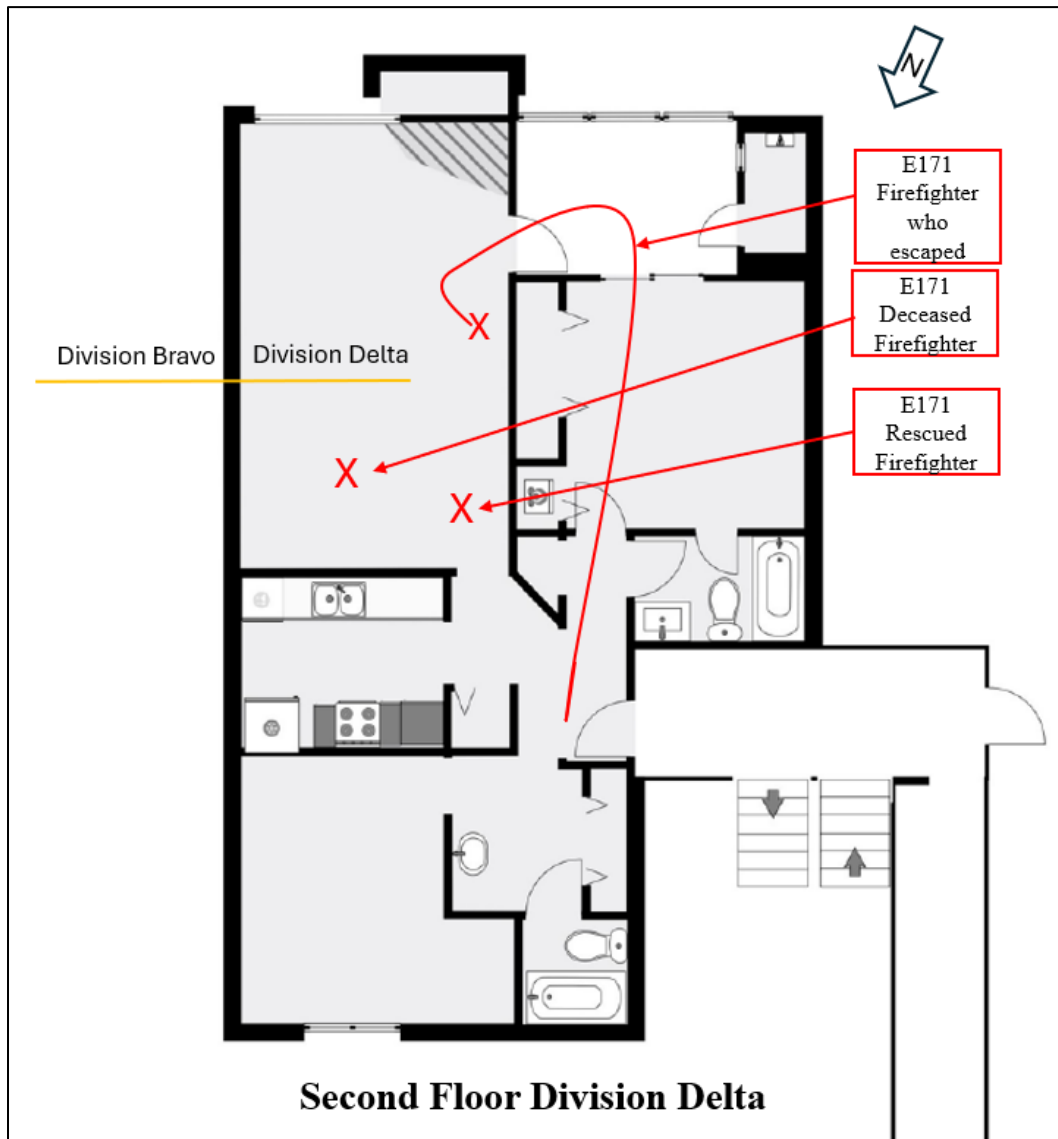
**Figure 1: Original fire apartment layout.**  
(Prepared by NIOSH)

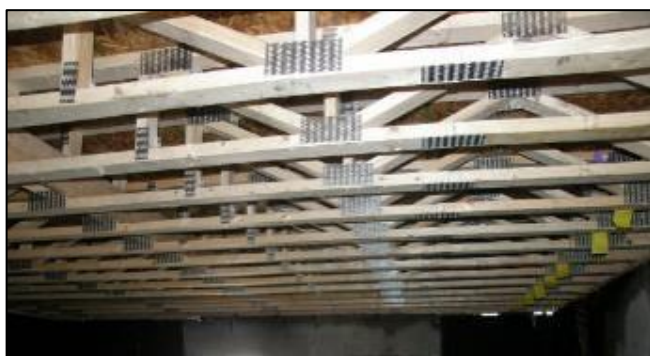
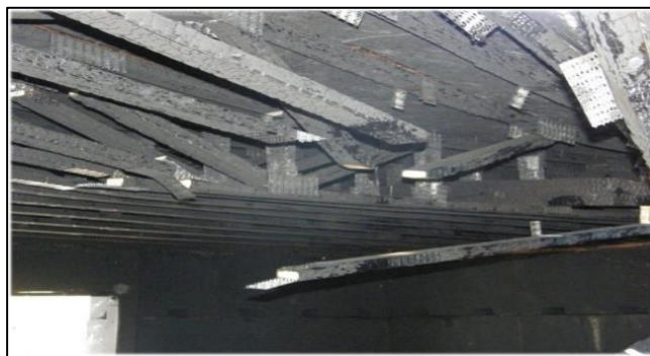
Research has shown that lightweight engineered lumber trusses and joists can lose their structural integrity and be prone to collapse within five minutes of being exposed to open flame (see **Photo 5 and 6**). These experiments included metal-plate-connected wood parallel chord trusses [Kerber et al. 2012].

**Photo 5 and 6: Lightweight parallel chord trusses. Left shows the truss as new and the other shows how the truss loses structural integrity after less than 5 minutes of fire exposure.**  
(Courtesy of FRSI)
