**LINE OF DUTY
DEATH REPORT
REPORT SLIDES**

F2023-07

Career Firefighter Dies in
Collapse involving Lightweight
Construction with Two separate
Maydays – South Carolina

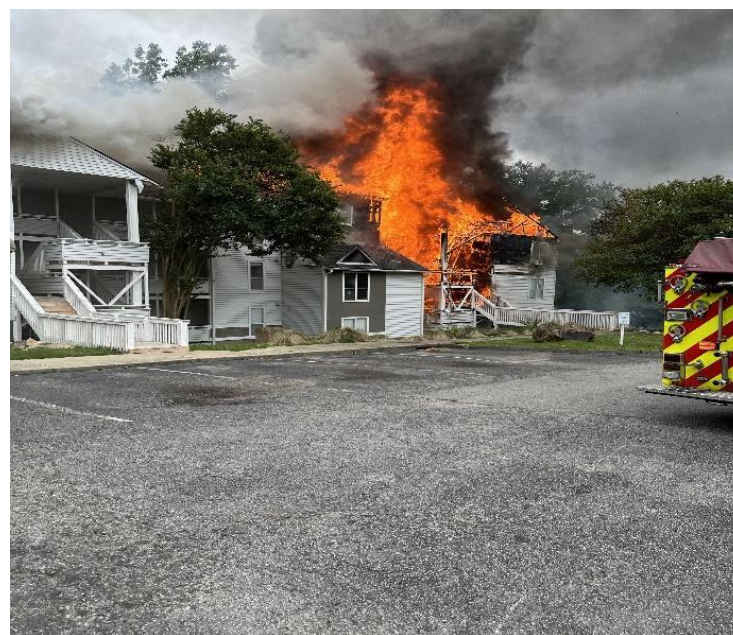
Side Alpha arrival conditions.
(Courtesy of the ATF)

- Ladder 9 (L9) added themselves to the incident after hearing L7's size up report.
- Fire was showing in the attic on Side Bravo with the Side Delta structure fully involved (see Photo 1).
- E6 arrived on-scene and began an offensive fire attack utilizing a 1¾ - inch attack line, attempted to establish a positive water supply, and prepared to supply the aerial ladder pipe to L7.
- B1 arrived on-scene and assigned himself as the division Alpha supervisor, passing command to B2 when they arrived on-scene at 16:20 hours.
- B2 served as the incident commander (IC) at the Side Alpha/Delta corner.

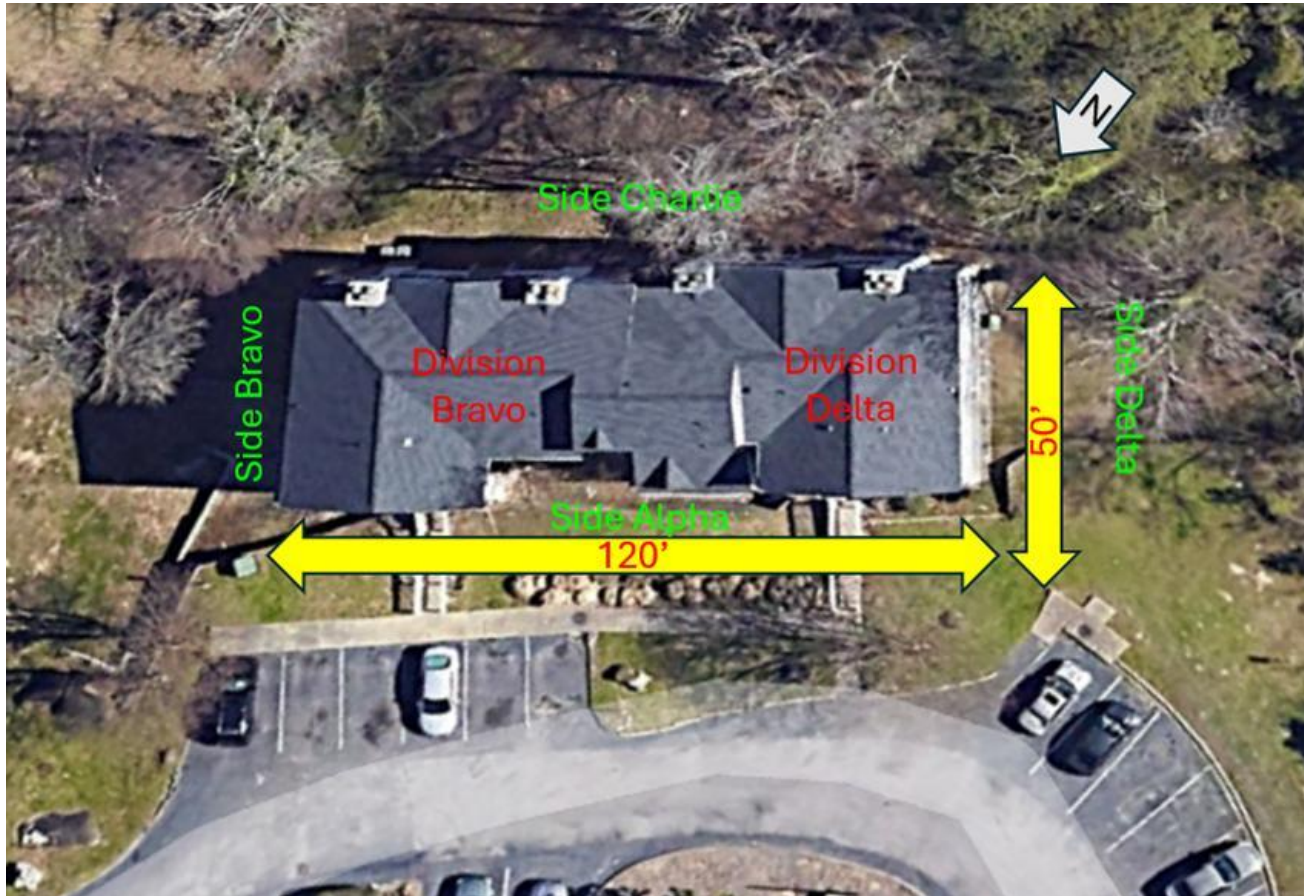
Aerial view of apartment building.
(Prepared by NIOSH)

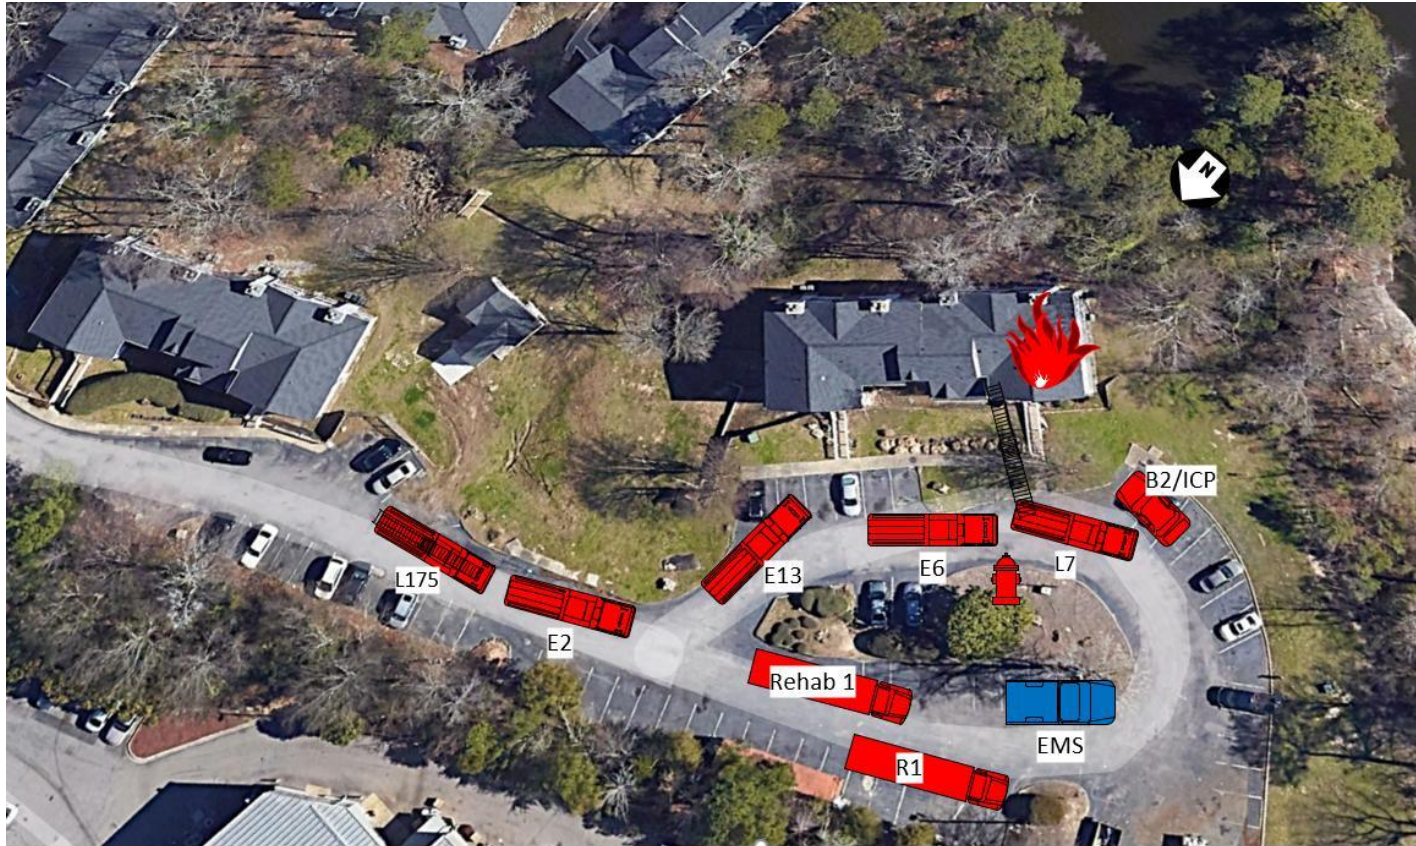
First alarm apparatus positioning showing seat of the fire.
(Prepared by NIOSH)

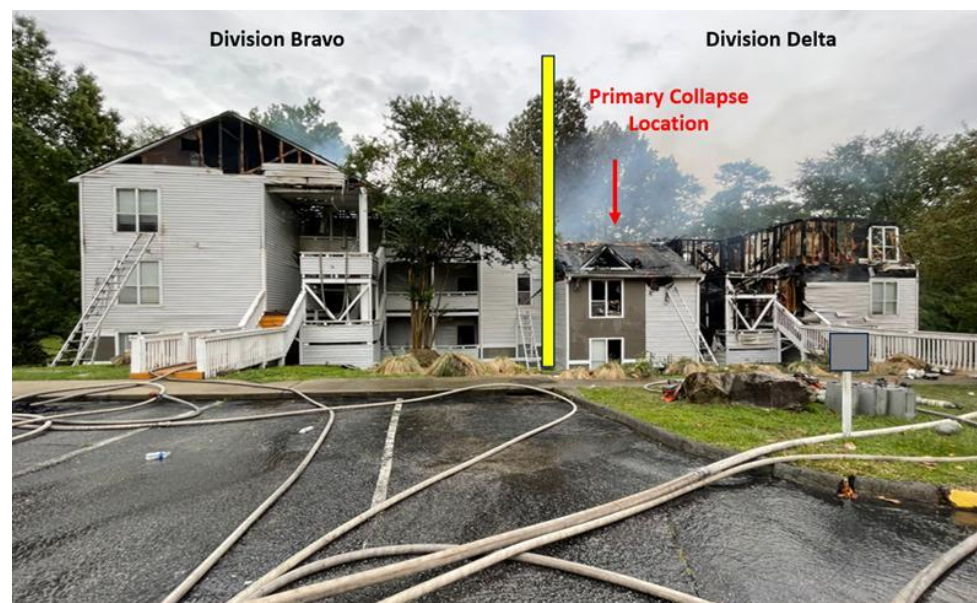
- E171 was assigned to stretch a 1¾-inch attack line to the second floor of division Delta, but E6 was unable to provide adequate pressure on the attack line.
- E171 assumed the original attack line from E6 as they exited the original fire apartment.
- At 16:44 hours, a Mayday was transmitted reporting the collapse of the third floor with firefighters from E1 and R1 trapped.
- Less than a minute later the fourth-floor loft bedroom fell through the third floor and into the second floor, trapping the E171 crew.

Division Bravo (left) and division Delta (right) separation. (Prepared by NIOSH)
