# LINE OF DUTY DEATH REPORT

REPORT 2023-10 • April 2025

## ***Two Career Land-Based Firefighters Die After Becoming Lost and Running Out of Air During a Marine Vessel Fire in Port – New Jersey***

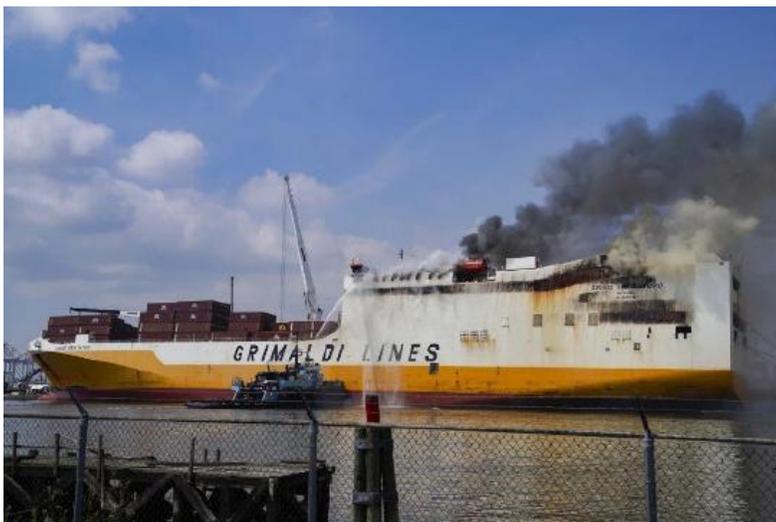
**Photo 1: A view of the marine vessel fire in port.**  
*(Courtesy of U.S. Coast Guard)*

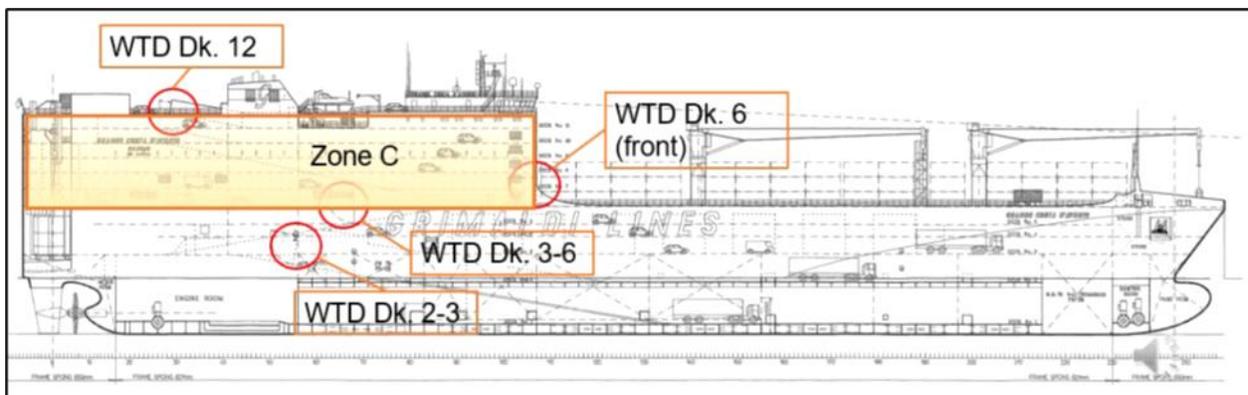
**Diagram 3. Vessel fire protection zones and weather tight doors (WTDs).**

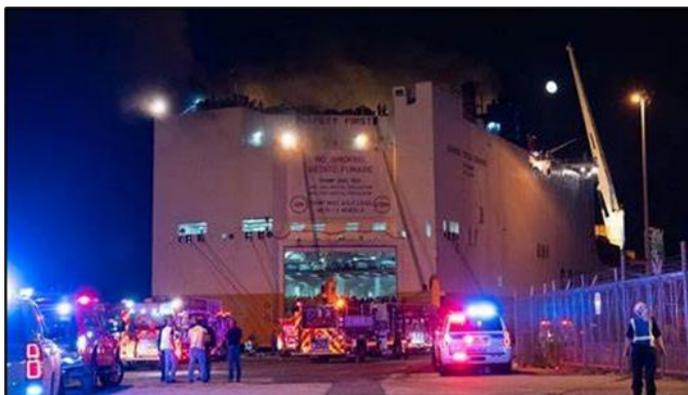
**Photo 4: A view of the vessel and the conditions at the time of the fire department arrival.**  
*(Courtesy of U.S. Coast Guard)*

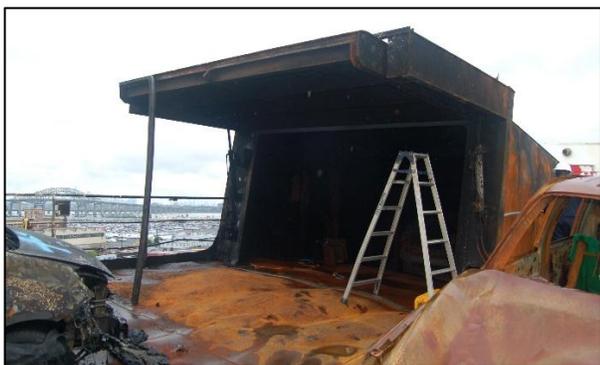
At approximately 22:00 hours, the vessel's Chief Mate and Bosun reported to the WTD on deck 12. They determined that given the improvement in conditions and reports of no fire on deck 11, they could attempt to close the WTD (see **Photos 5 and 6**). An attempt was made to close the door, but a fault/malfunction light appeared on the control panel indicating that the door would not operate. They decided to cease and consider other options.

**Photo 5. WTD on deck 12 that failed to close.**

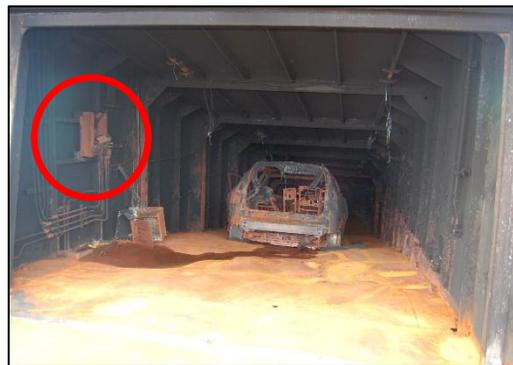
**Photo 6. Inside the WTD, showing the door controls on the left.**

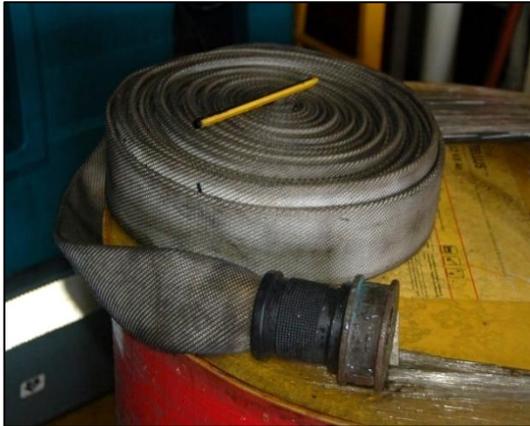
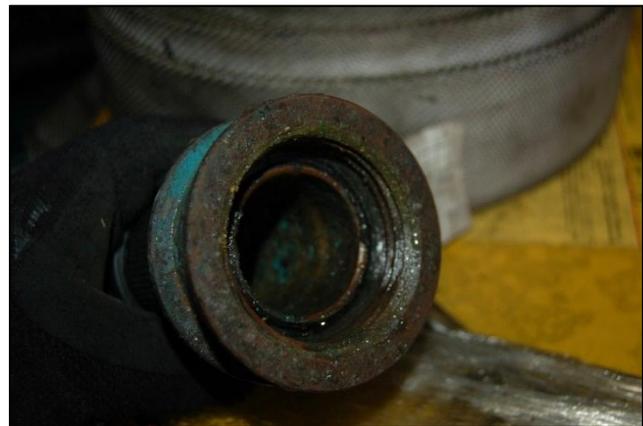
Between 22:06 and 22:12 hours, there were requests for firefighters to bring additional lengths of hoseline to deck 12. The original plan was to connect the fire department hose to the vessel's hose station so that a hoseline could be extended from deck 12 to deck 10 for fire attack. Once the firefighters attempted to connect the fire department hose to the vessel's hose station, they realized that the hose fittings were not compatible. The vessel's hose was a 1½ metric diameter with an international coupling (see **Photos 7 and 8**).

**Photos 7 and 8. Vessel's 1½ inch fire hose and coupling.**

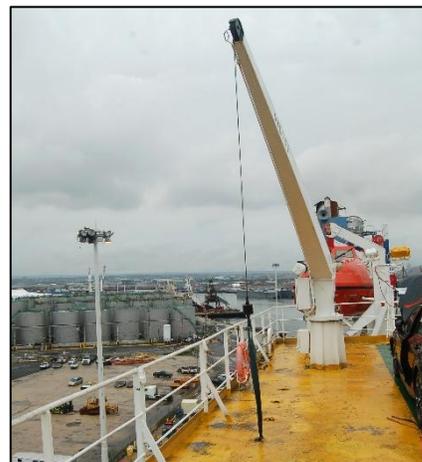
**Photo 9. The vessel's crane used to lower the missing firefighters.**

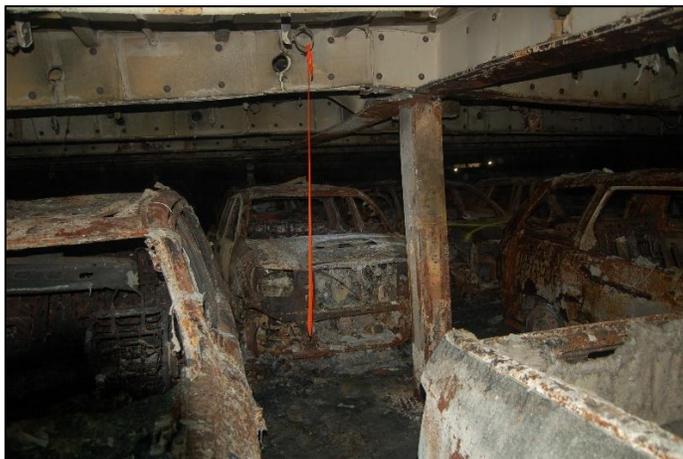
From approximately 02:00 to 02:09 hours, the third UASI search operation took place. They searched deck 10. UASI Rescue 5 (R5) split into two teams following the two search lines previously deployed. The team operating on the rope closest to the starboard side found a discarded firefighter flashlight. They took this as a possible sign that the missing firefighter could be in the area. When that team reached the end of the original search rope, they heard a PASS device sounding. They deployed an additional rope search line approximately 75 feet in the direction of where the PASS was sounding. At 02:08 hours, R5 located the missing Ladder 4 firefighter (**see Photo 10**). He had his SCBA on, but his facepiece was not in place.

**Photo 10. Location (deck 10) where Ladder 4 firefighter was found.**

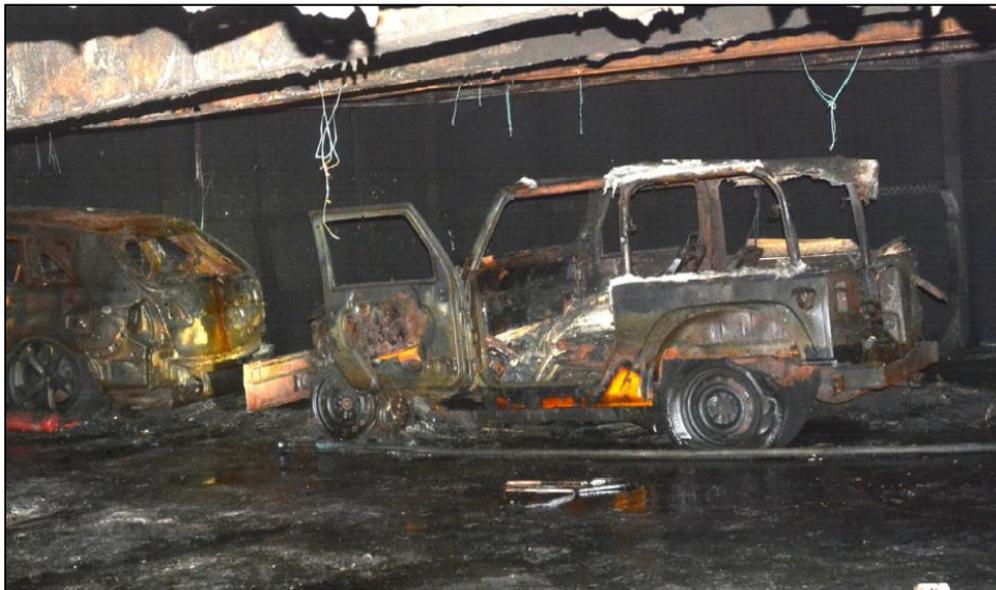
The origin of the fire was determined by the ATF National Response Team to have been from the deck 10 pusher vehicle (see **Photo 11**). The vehicle had been used throughout the day to push disabled vehicles onto the vessel. The ATF investigation determined that the transmission in the vehicle overheated, which resulted in the release of flammable transmission fluid. Several witnesses described fire “dripping down from under the vehicle” consistent with this finding. The fire was ruled as accidental.

**Photo 11. The pusher vehicle experienced a transmission failure, serving as the origin and cause of the fire on deck 10.**
