LINE OF DUTY DEATH REPORT

REPORT F2023-11 • March 2025

Lieutenant and Probationary Firefighter Die after experiencing Thermal Degradation of Self-Contained Breathing Apparatus Facepiece Lenses – Maryland

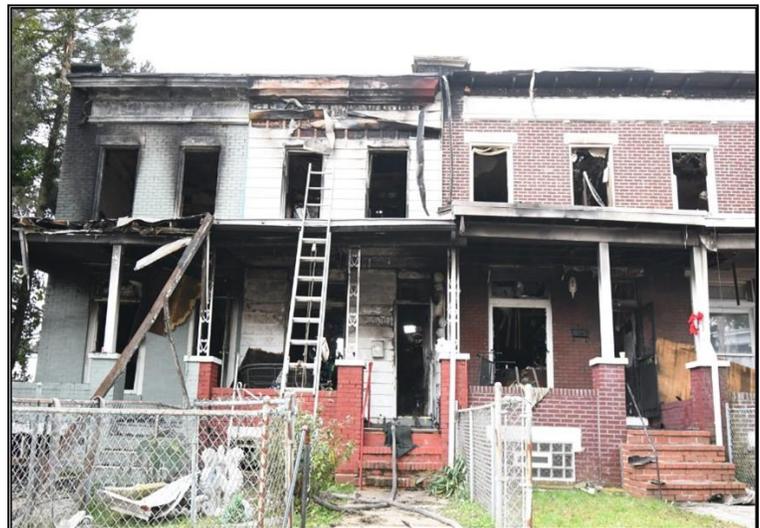
Side Alpha post fire event.
(Courtesy of Fire Marshal Office.)

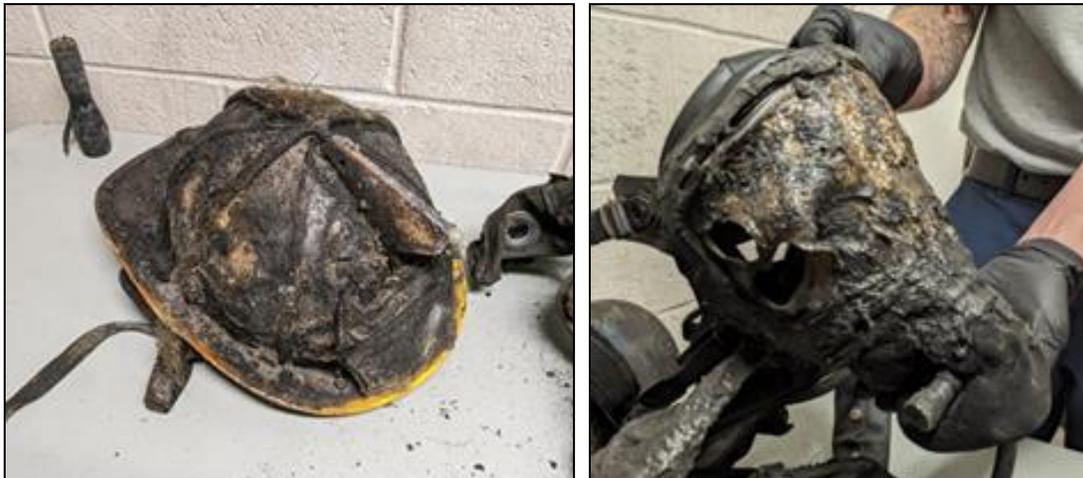
Upon visual inspection of E29 probationary's PPE, extensive thermal degradation was noted to the outer shell of the turnout coat. This was noted more specifically to the left where the horizontal retroreflective trim was burned away from the PPE garment. Burn holes were observed near the left shoulder/arm/back areas with visible exposure to the inside moisture and thermal layers. The helmet suffered thermal degradation both on the outside and inside of the helmet shell. E29 probationary's protective hood was noted as having significant charring near the neck and ear areas. The pants were noted as being dirty from debris with very little to no thermal degradation.

E29 probationary's SCBA was found to be damaged with thermal degradation noted to the SCBA frame, air supply hoses and facepiece. During inspection, the SCBA facepiece lens was found to be severely melted, deformed, with holes completely burned through on both the right and left sides and melted to the second stage regulator. Figures 1 and 2 represent the recorded SCBA cylinder data at the time of incident with the blue line representing the cylinder pressure while the red line indicates breathing/flow rate.

**Photo 2 and Photo 3. E29 Probationary firefighter's Helmet (left photo) and SCBA Facepiece Lens (right photo).
(Courtesy of NIOSH.)**

Recommendation #2: Consider upgrading or replacing current SCBAs to meet the 2013 or more recent edition of the NFPA 1981 or NFPA 1970 (1981) standard.

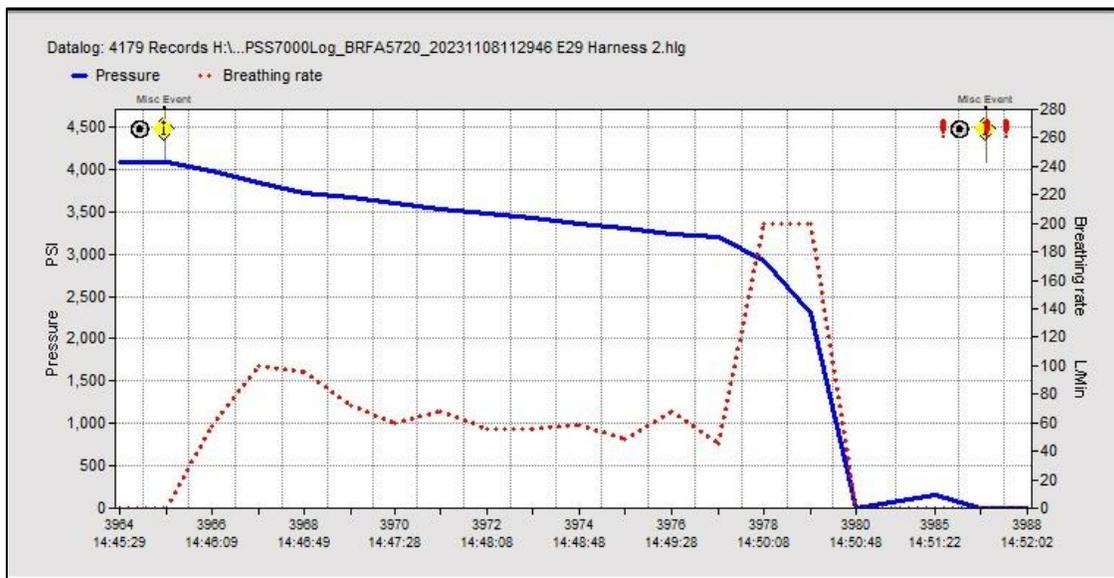
Figure 1. E29 Probationary Firefighter SCBA air loss rate during event.
Note: Due to time drift of the internal SCBA clock the times represented are roughly sixty minutes behind.
(Courtesy of the fire department.)

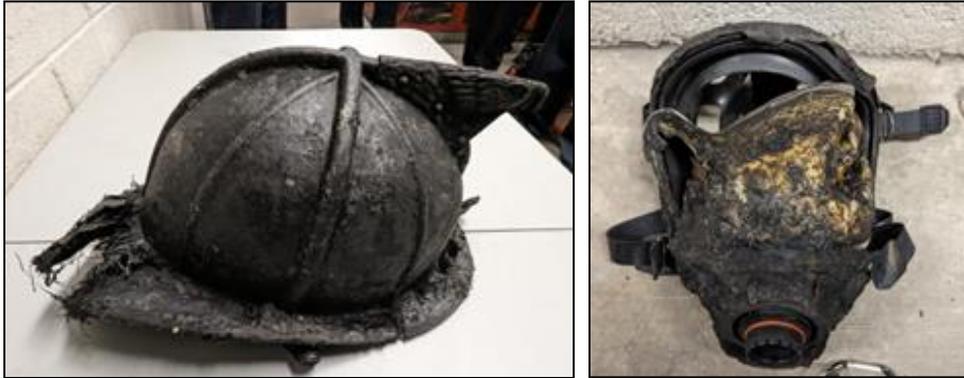
Upon visual inspection of E29 lieutenant's PPE, extensive thermal degradation was noted to the outer shell of the lieutenant's coat more specifically to the right where the horizontal retroreflective trim was burned away from the PPE garment. Burn holes were observed on the back of the coat with damage to the retroreflective trim and visible exposure to the inside moisture and thermal layers. The helmet suffered thermal degradation both on the outside and inside of the helmet shell with damage to the helmet chin strap. E29 lieutenant's protective hood was noted as having charring near the neck and ear areas with holes in the hood. The bunker pants were noted as being dirty from debris with very little to no thermal degradation.

E29 lieutenant's SCBA was found to be damaged with thermal degradation noted to the SCBA frame, air supply hoses and facepiece. The SCBA cylinder had a green padding/foam material melted to the cylinder, which is assumed to be from nearby furniture during the event. During inspection, the SCBA facepiece lens was found to be severely melted, deformed, with a hole completely burned through on the right side.

**Photo 4 and Photo 5. E29 Lieutenant's Helmet (left photo) and SCBA Facepiece Lens (right photo).
(Courtesy of NIOSH.)**

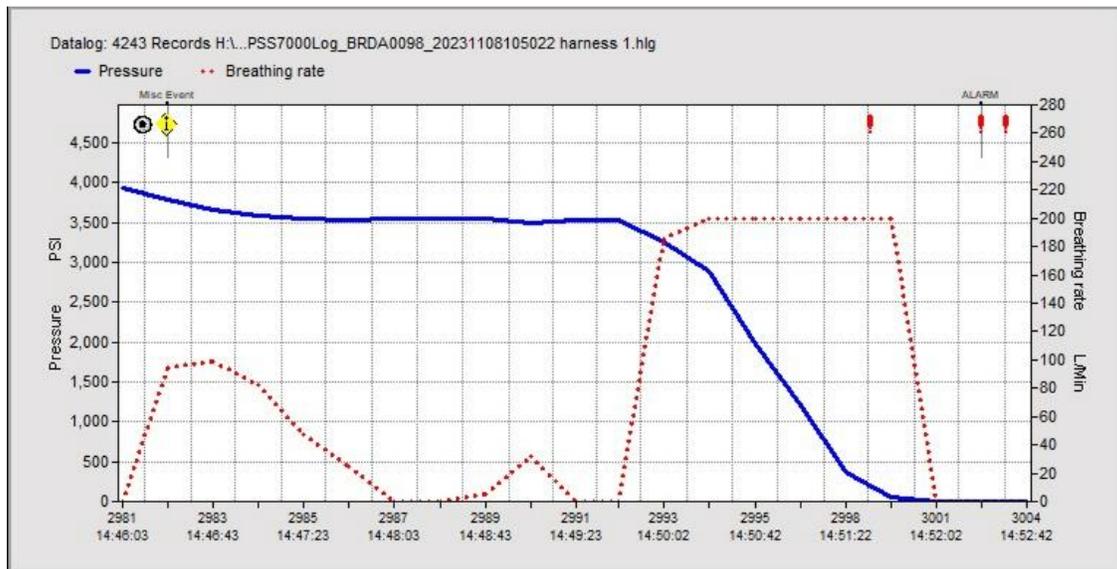
**Figure 2. E29 Lieutenant SCBA air loss rate during event.
Note: Due to time drift of the internal SCBA clock the times represented are roughly sixty minutes behind.
(Courtesy of the fire department.)**

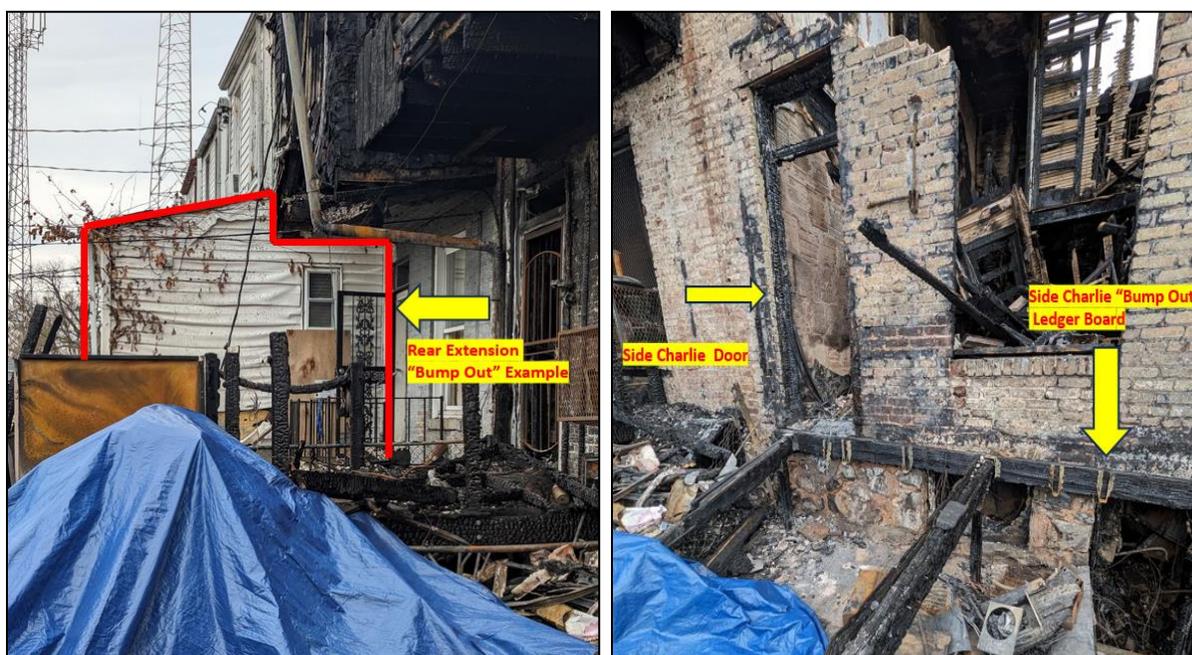
Exterior fires with both vertical and horizontal progression can present a hazard to arriving personnel. It is common that the additions of exterior porches and rooms to a preexisting structure are constructed with typical building materials that have known combustible characteristics like wood framing, vinyl siding, sheathing, and insulating materials. In this incident, the main structure consisted of a non-combustible exterior finishing but, the wood frame exterior porch was connected to the exterior of the structure. Upon arrival of E29, the fire was well developed beyond the initial stage on side Charlie.

Photo 8 and Photo 9. Side Charlie exterior porch (left photo) and Side Charlie exterior porch frame (right photo).

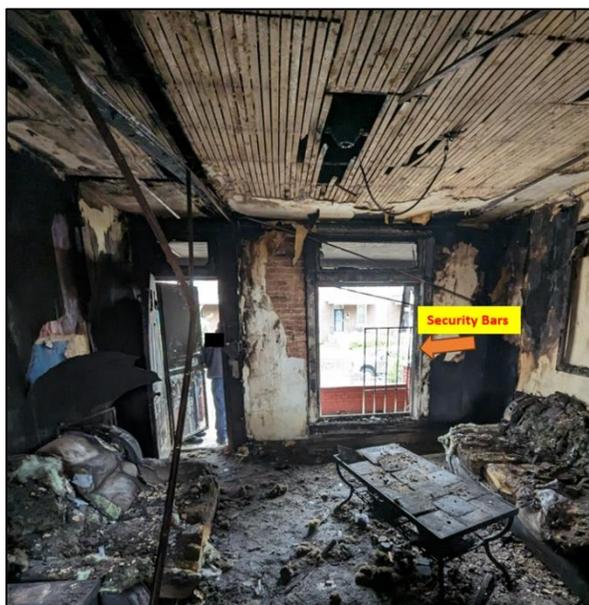
During the interior fire attack, the front door on side Alpha was unlocked and was opened as the point of entry for the lieutenant and probationary firefighter from E29. The front door remained open during the incident. The living room window on side Alpha was intact upon the arrival of E29 and during the initial interior fire attack. It is unknown how the window on side Alpha was broken, although it was already broken during the Mayday operations when the captain from T12 was removing the security bars to gain access.

Photo 10. Living room facing side Alpha.
(Courtesy of NIOSH.)

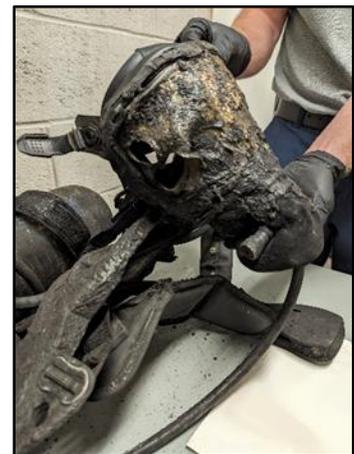
An SCBA facepiece with severe deformation and failure.
Photo by NIOSH.

- ❑ Recognize that that SCBA facepiece lenses meeting the 2007 or earlier edition of NFPA 1981 will undergo thermal degradation when exposed to intense heat faster than lenses meeting the 2013 or later editions
- ❑ Understand that the tests added to the 2013 edition of NFPA 1981 increase SCBA facepiece lens integrity
- ❑ Upgrade or replace current SCBAs to meet the 2013 or more recent edition of the NFPA 1981 standard
- ❑ Report any conditions involving an SCBA or SCBA components that lead to failure, near-failure, or a significant degradation of performance according to the relevant edition of NFPA 1852
