LINE OF DUTY DEATH REPORT

REPORT 2024-01 • April 2025

Volunteer Firefighter Dies when Propane from an Underground Tank Leaked into a Residential Home causing a Catastrophic Explosion – Virginia

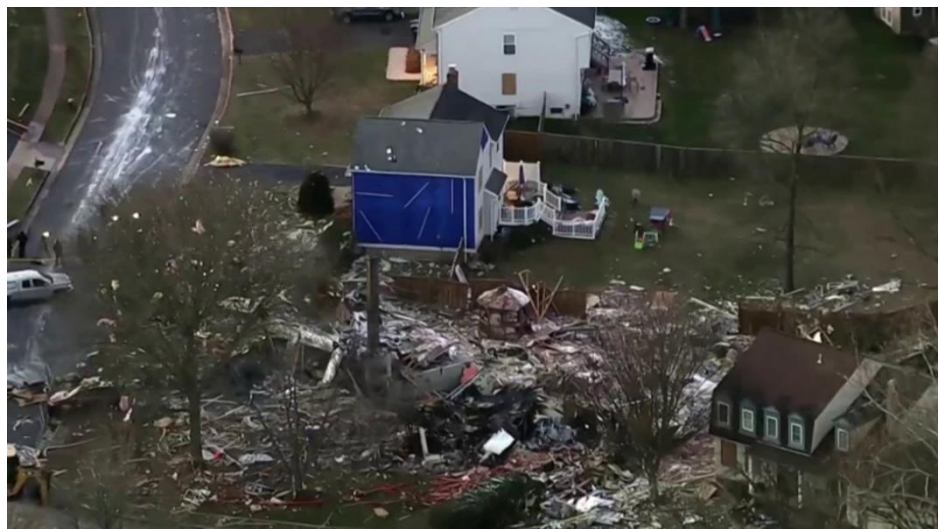
Photo 1: Aerial view of structure and surrounding area post explosion. (Courtesy of fire department)

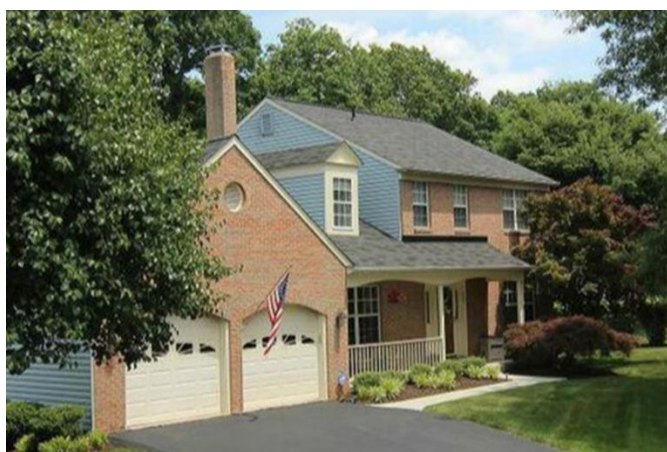
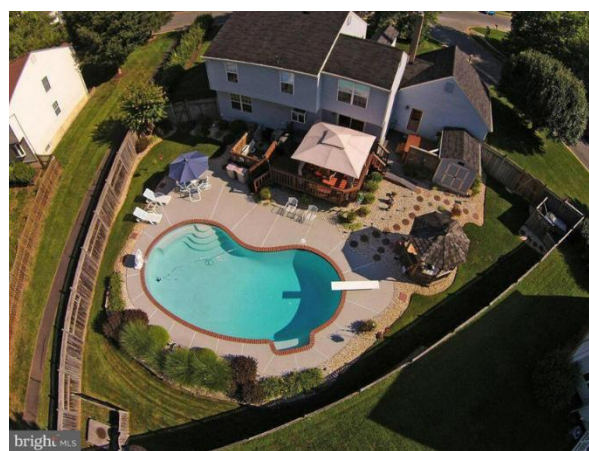
The single-family two-story residential structure was a colonial style type V construction, built in 1985 (see **Photo 2**). It had 2,078 square feet of above ground living space with 1,068 square feet of below grade, fully furnished living space. The below grade portion of the structure was constructed into living space in 2019 (see **Diagram 1**). The home had a lightweight truss gable roof covered with plywood and asphalt/fiberglass shingles, a brick veneer front, a two car 440 square foot attached garage, and a center positioned front porch. The rear of the structure contained an attached wood deck, solid wood fence with a lattice top lining the property, a storage shed, and a concrete swimming pool (see **Photo 3**).

Photo 2 and 3: View of structure pre-incident.
(Courtesy of Fire Marshal's Office)

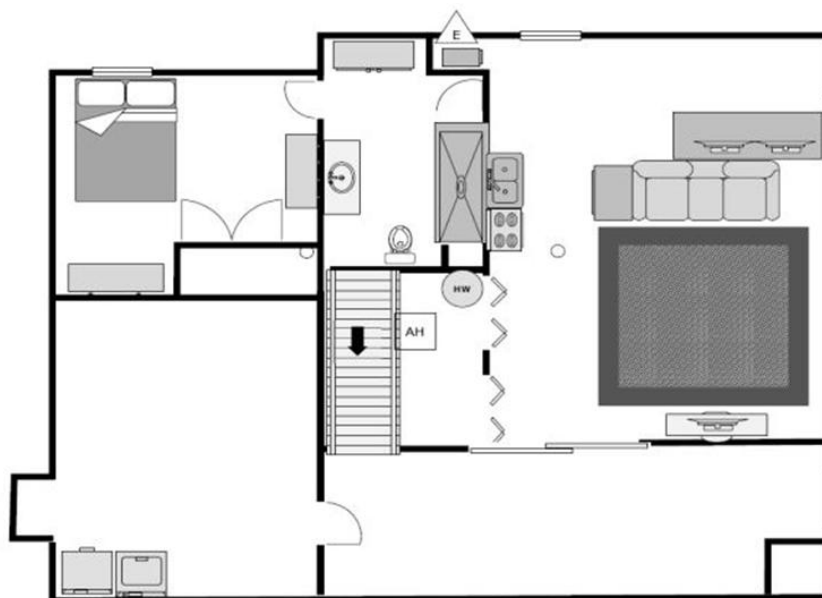
Diagram 1: Basement of the structure.
(Courtesy of Fire Marshal's Office)

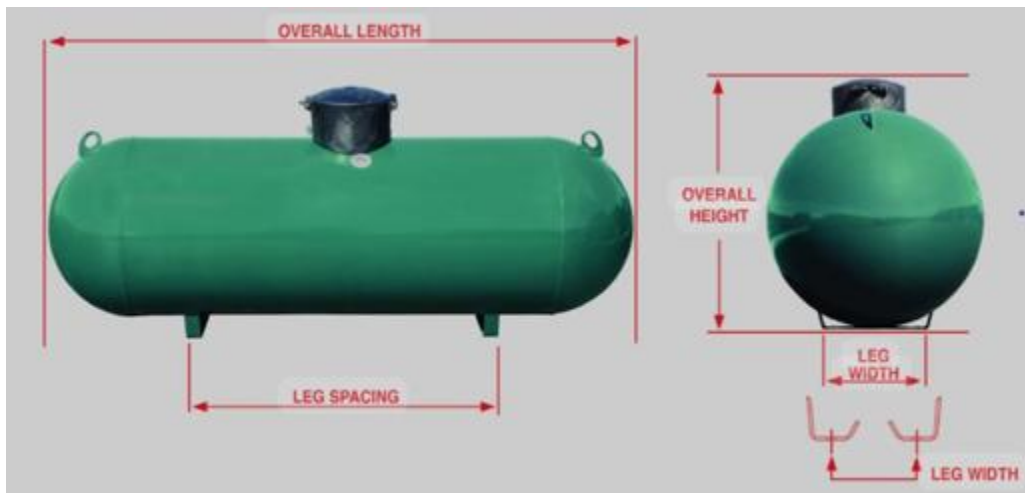
The propane tank was located on Side Delta of the structure approximately 20 feet from the structure's exterior wall. The tank supplied the swimming pool heater located near the Side Bravo/Charlie corner of the house. Underground propane tanks are available in an assortment of sizes (see **Photo 4**). Tanks are typically coated with either a powder phenolic finish or liquid applied epoxy primer coat followed by a urethane topcoat. There is a dome above the ground. A grounding process, which involves attaching a sacrificial anode (similar to a magnesium rod) to the tank, allows it to attract stray electric currents in the soil to prevent corrosion. Details regarding the propane tank involved in the incident were not available to the NIOSH investigators.

Photo 4: Example of a similar type 500-gal underground propane tank.
(Courtesy of NIOSH)

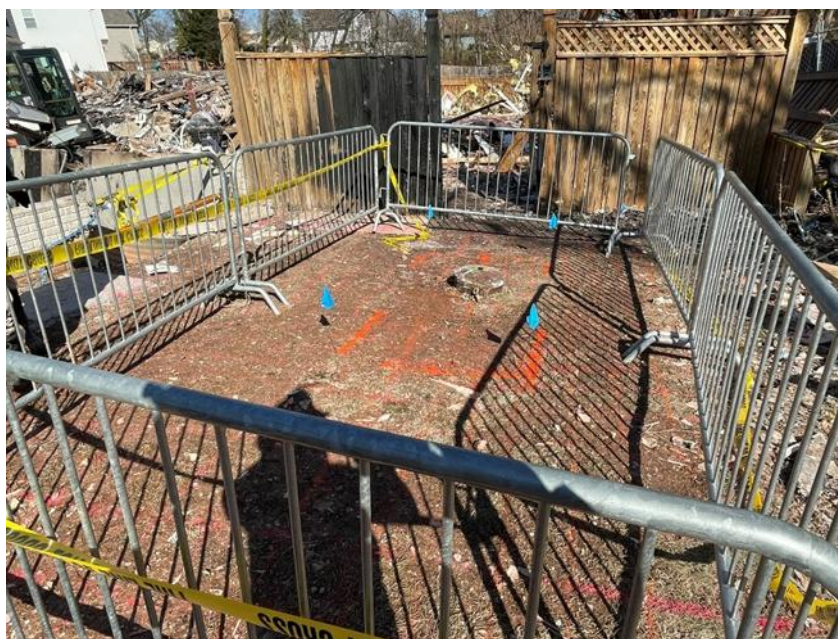
Photo 5: View of the area the propane tank was located.
(Courtesy of Fire Marshal's Office)

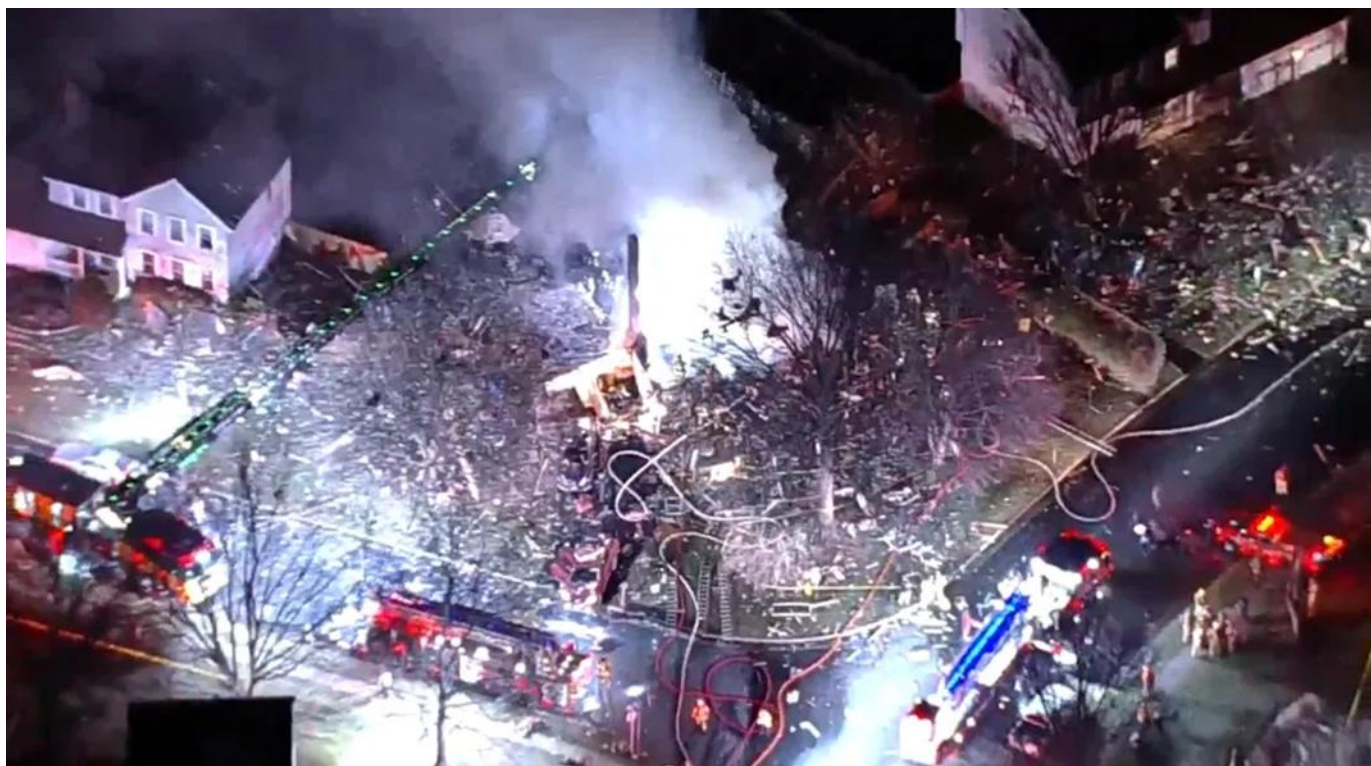
Photo 6: Aerial view of area effected by explosion.
(Courtesy of NBC News)

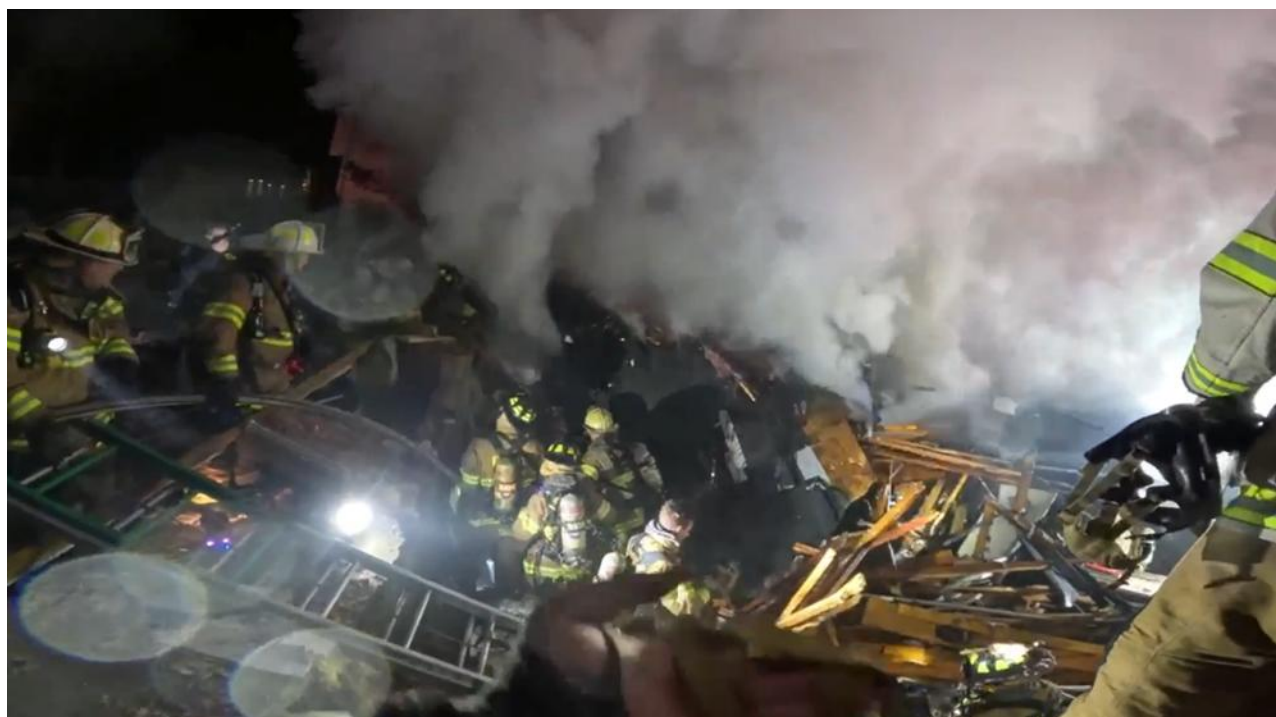
were out of water. Units on-scene identified that the deceased firefighter was a volunteer assigned to T611. At 20:31 hours, Lieutenant T611 declared a second Mayday. He reported being in the basement in a void space, under heavy debris, with fire advancing towards him, and unable to get out. Both trapped firefighters managed to secure their SCBA facepieces to their face, preventing exposure to the heat and smoke. At 20:32 hours, BC601 contacted Lieutenant T611 requesting information regarding his location. He thought he was on the Side Alpha, left of the basement steps, positioned in the Side Alpha/Delta quadrant. BC601 acknowledged the message and were getting water on the fire. Approximately a minute later, E611 confirmed they were getting a water supply. At 20:35 hours, E618FF1 announced a fifth Mayday stating, “please come and help.” During this fifth Mayday, E404 arrived on-scene. The rescue efforts for the trapped firefighters were hampered by the heavy fire conditions, large amount of debris, and heavy structural components blocking access. Units were extinguishing the fire, along with digging through the mound of debris searching for the two trapped members (see **Photo 7**).

Photo 7: View of rescue operations.
(Courtesy of Fire Marshal's Office)
