LINE OF DUTY DEATH REPORT

REPORT F2024-05 • March 2025

Career Battalion Chief Dies from Explosion while Fighting Tractor Trailer Fire – Georgia

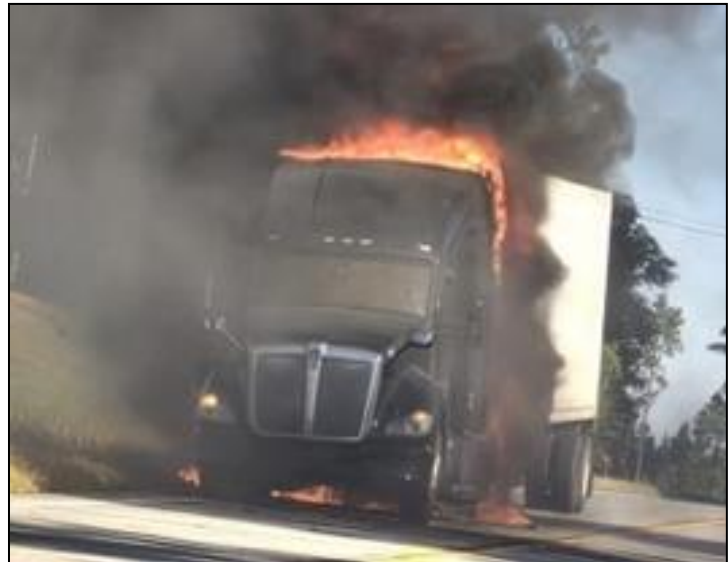
Photo 1: Fire conditions on arrival of Battalion 1.
(Photo courtesy of the fire department)

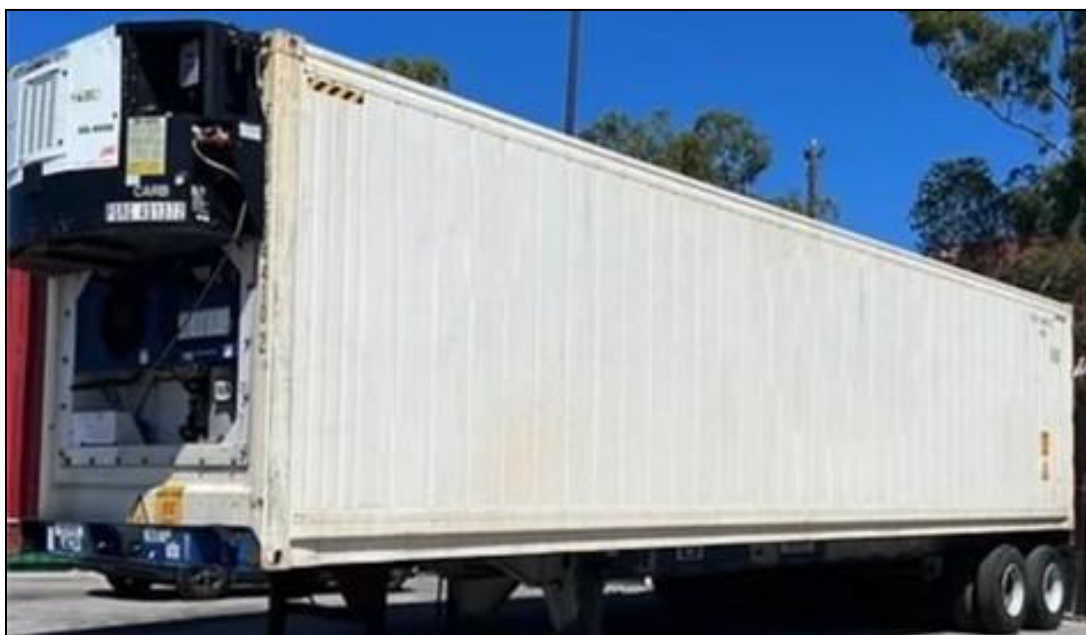
The vehicle involved in this incident was a tractor trailer style commercial vehicle (see **Diagram 1** and **Photo 2**). The trailer portion of the vehicle consisted of a container chassis with a refrigerated intermodal container secured to the chassis with twistlocks on all four corners of the container. The refrigerated intermodal container had a portable generator, or genset, affixed to the bulkhead of the container. The genset in this incident ran on diesel fuel and included a self-contained diesel fuel tank on the lower portion of the genset device. Based on the information provided by the UL Research Institutes team, a visual inspection of the diesel tank did not present any evidence of bulging or rupture. The container was loaded with frozen chicken.

Photo 2. Type 111 Intermodal Freight Container secured to trailer chassis with genset.
(Photo courtesy of UL FSRI)

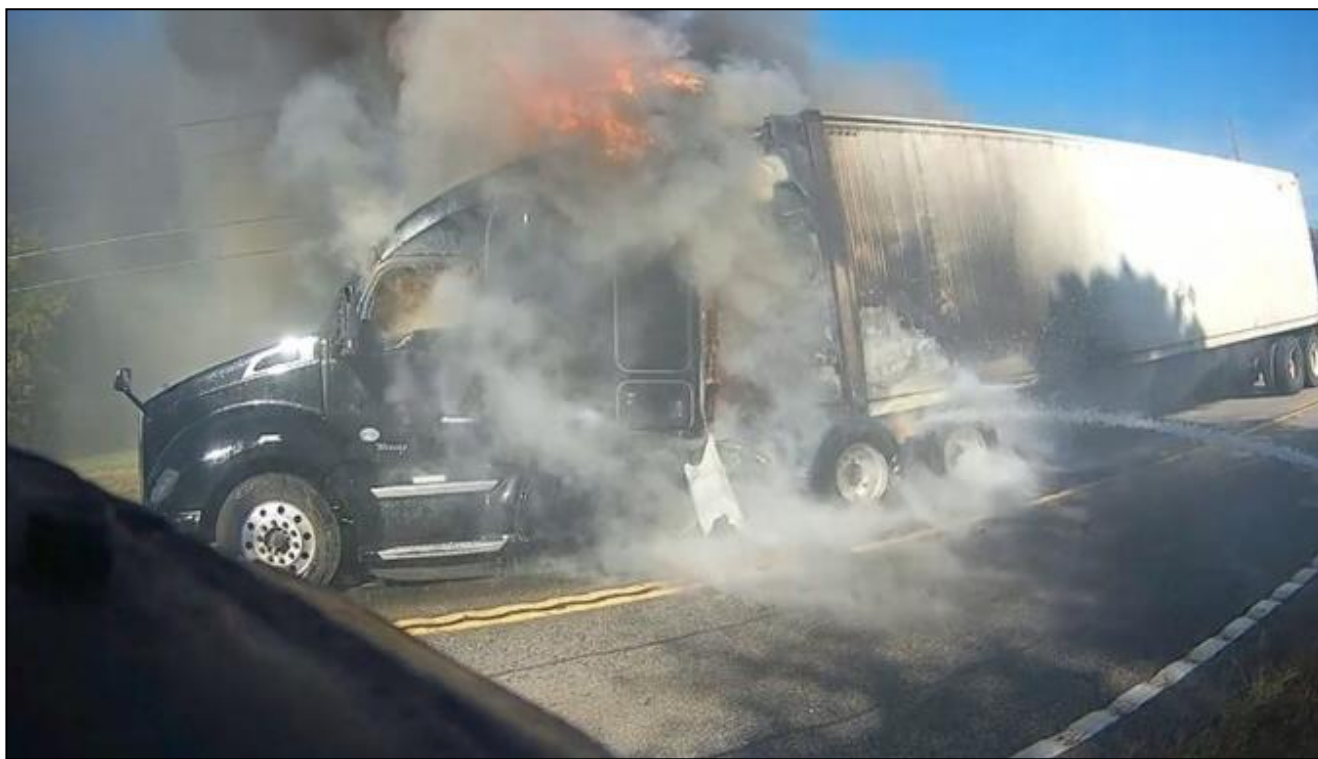
Photo 3 and Photo 4. View of fire behavior on passenger side of vehicle (top photo) and view from the fire attack team as Battalion 1 declared water on the fire (bottom photo).

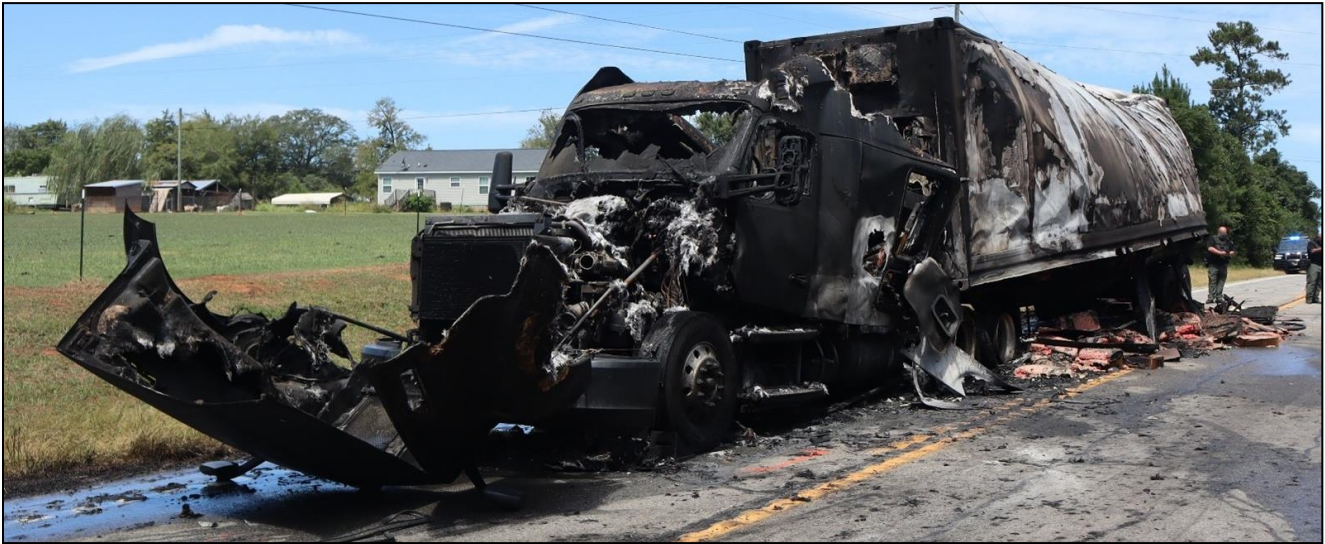
Photo 5. View of driver side of involved vehicle following extinguishment.
(Photo courtesy of fire department)

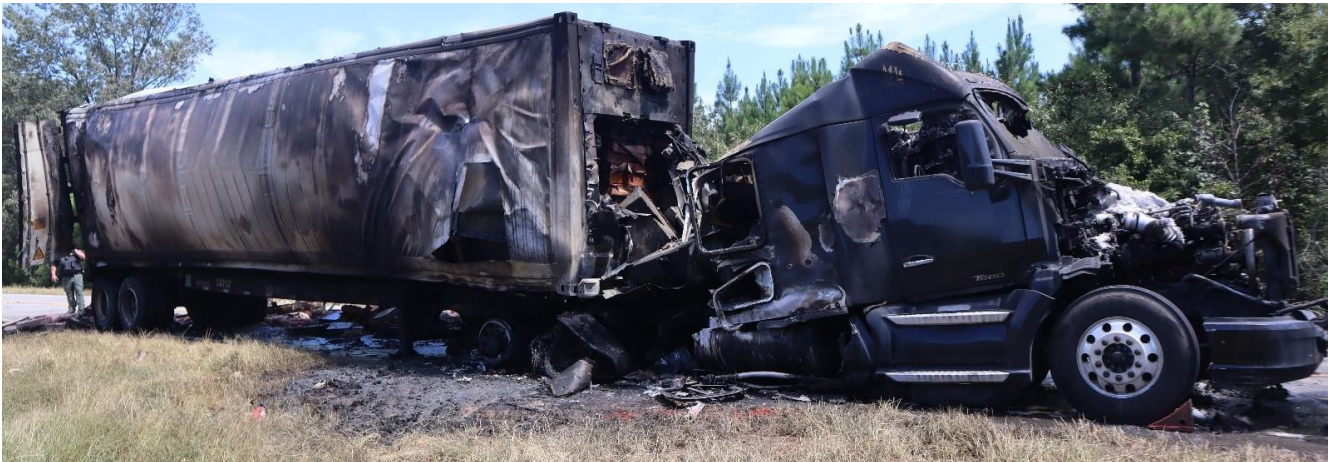
Photo 6. View of passenger side of involved vehicle following extinguishment. *(Photo courtesy of fire department)*

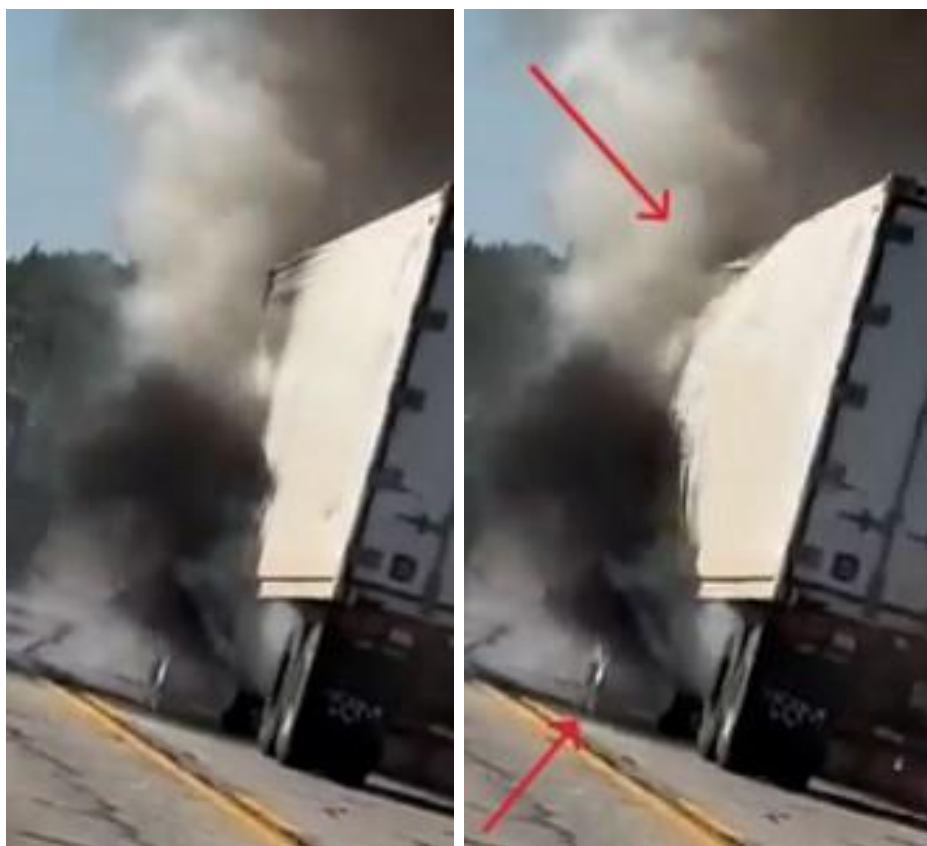
Photo 7 and Photo 8. Driver side of trailer just prior to explosion (left photo) and change of smoke behavior and expansion of container as explosion is occurring (right photo).
(Photos courtesy of fire department)

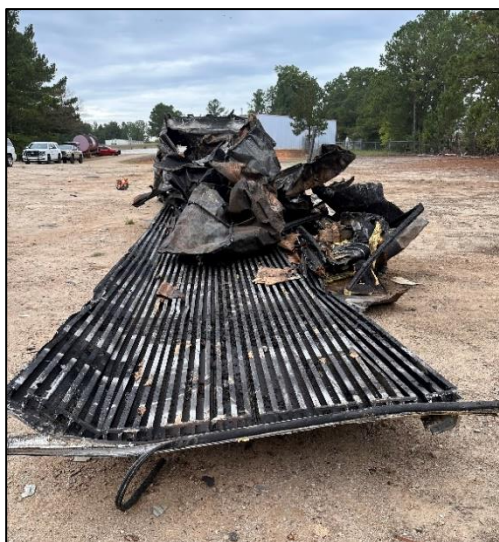
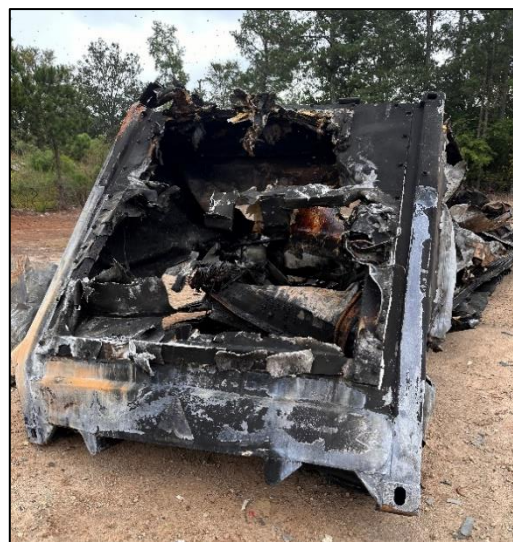
The intermodal portion of the refrigerated trailer had been reduced to the floor, front wall, and some sections of the sides, Figure 1. The floor, walls and roof of the refrigerated trailer had void spaces between the exterior metal of the trailer and the interior metal lining of the trailer. By design, the void spaces were filled with a blown in foam that sets up as a rigid foam plastic. This provides the insulation for the refrigerated trailer. This foam could be a significant source of fuel. It was noted that foam insulation had been consumed completely or showed significant mass loss in areas of the trailer that had been exposed to the exterior fire sources.

Photo 9 and Photo 10. Photographs of the remains of the refrigerated trailer. Rear view on the left and front view on the right. Most of the foam insulation had been burned out of the front portion of the trailer.
(Photos courtesy of UL FSRI)

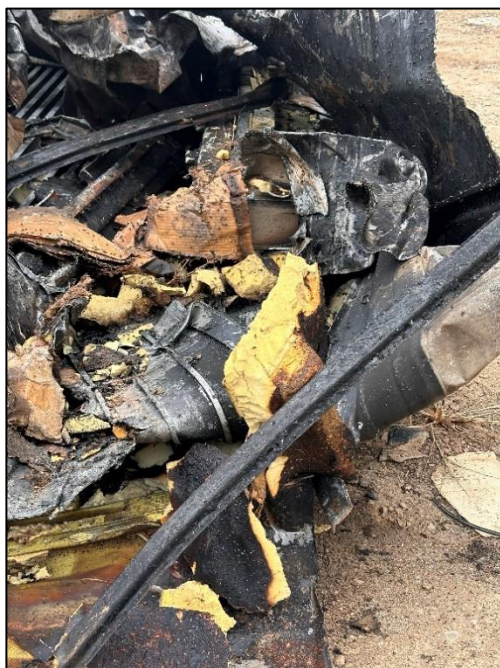
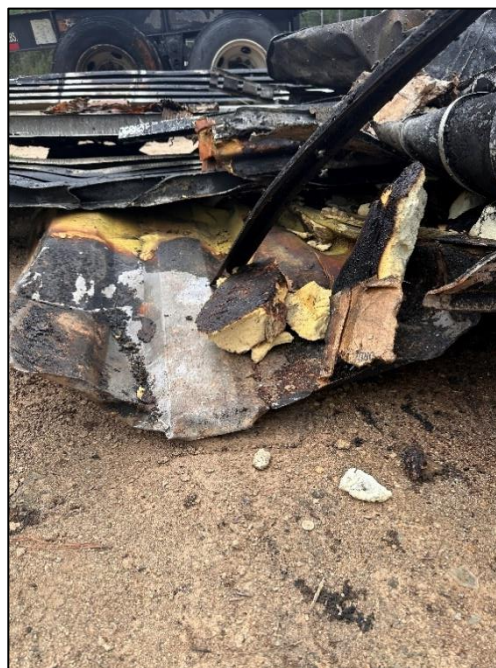
Photo 11 and Photo 12. Some of the remaining foam insulation. Partially charred foam from a wall panel (left photo) and partially charred foam in the floor section of the trailer (right photo).

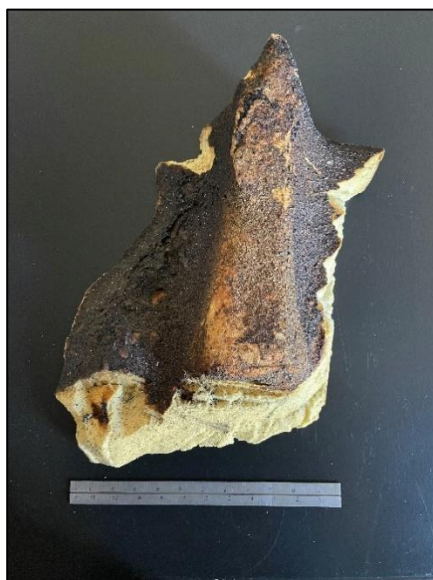
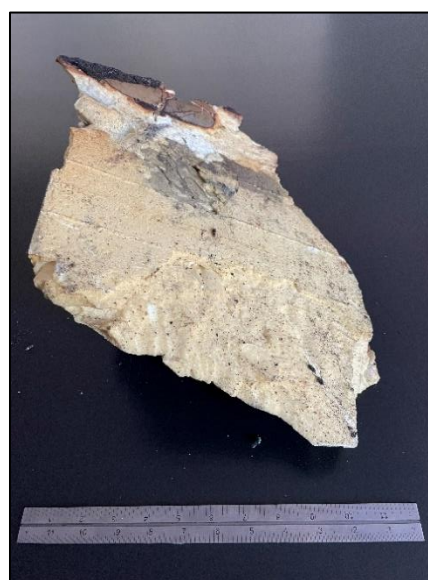
Photo 13 and Photo 14. The foam sample from the trailer flooring section that was provided for testing. Bottom of the sample (left photo) and top of the sample (right photo).

Samples of the foam were prepared as a powder to ensure the sample was homogeneous for Py/GC-MS and microscale combustion calorimetry experiments. The temperature range for the pyrolysis of the sample was 300-900 °C with a temperature ramp of 5 °C/s. Pyrolyzates were directed into the GC-MS column and identified by the MS. Peaks consistent with polyisocyanurate foam were observed in the chromatogram.

The polyisocyanurate foam was also subjected to a series of tests to determine its potential heat release rate capability. Powdered foam samples were tested with the microscale combustion calorimeter (MCC) in general accordance with ASTM D 7309-21. The samples were heated from room temperature to 700°C at a heating rate of 1°C/s. The peak specific heat release rate in the MCC was observed at 371 °C and was measured as 293 W/g and the specific heat of combustion was 25.4 MJ/kg.

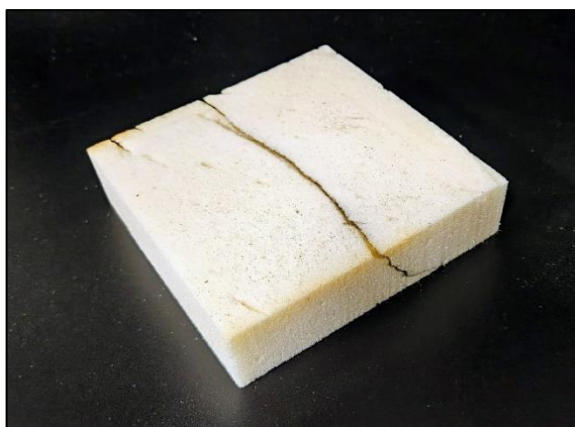
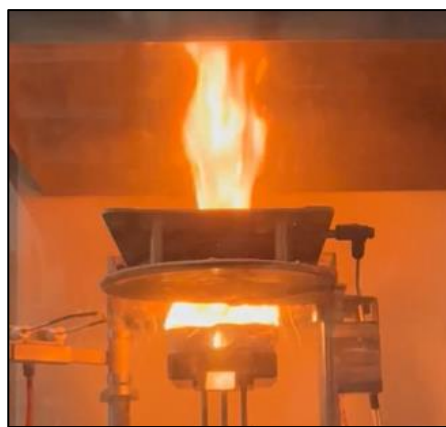
Compared to materials like wood, <https://materials.fsri.org/materialdetail/wood-stud>, under similar test conditions, the foam insulation has an average peak heat release rate twice as high as wood, and an average heat of combustion, 30% higher than wood.

The fire service take away, even if the refrigerated trailer were empty, it still has a large fuel load, with the potential for significant fire or explosion hazard.

Photo 15 and Photo 16. One of the foam samples prepared for testing in the cone calorimeter (left photo) and amount of flame generated by the foam sample during a cone calorimeter test (right photo).

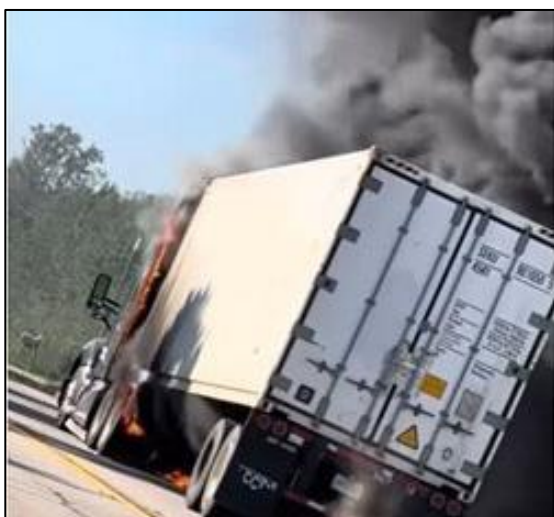
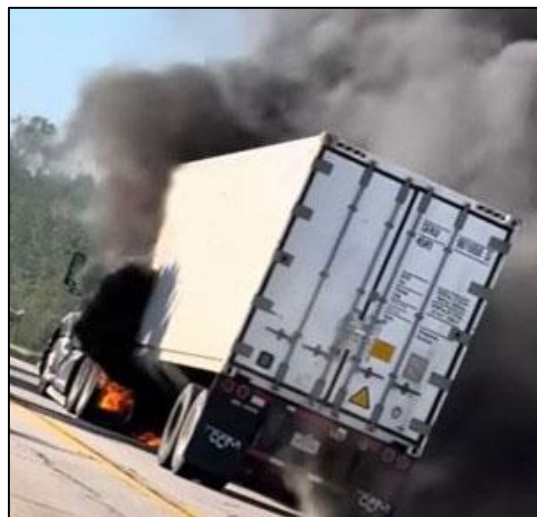
Still images taken from a video of the incident show notable changes to smoke and fire coming from the trailer. The smoke and flames prior to suppression seem to cycle, build, stop, and start again, see Photos 17 through 19. After initial knockdown, the smoke from the trailer again seems to cycle or pulse until the explosion, Figure 8. After the explosion the ventilation limited/fuel rich environment in the truck resulted in a vent point ignition, followed by an increased amount of fire, Figures 9 and 10. The images captured throughout the incident captured pulsating fire behavior indicative of the onset of a smoke explosion.

Photo 17 and Photo 18. The photograph on the left shows the fire at approximately 0928, the fire has been burning for almost eight minutes. The images are approximately two seconds apart. The photograph on the right shows a noticeable amount of dense black smoke from the underside of the trailer. It seems to have enough pressure to flow against the direction of the wind, then it stops.

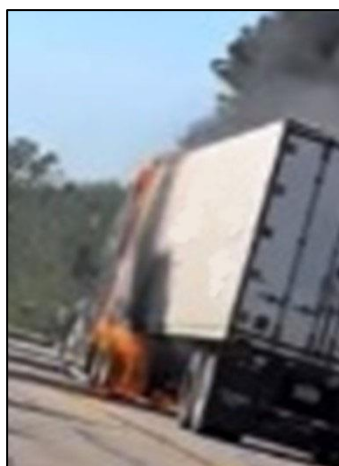
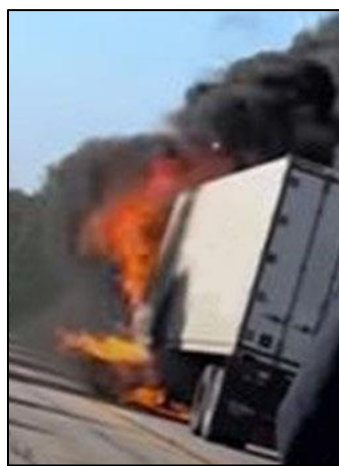
Photo 19 and Photo 20. This set of images was recorded between 0929 and 0930. The interval between the image on the left and the image on the right is about five seconds. These images show flames jetting upwind from a localized point under the trailer. This may be an indication of pressurized fire gases exiting an opening in the trailer.

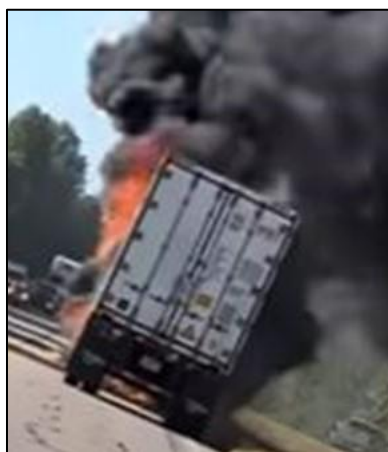
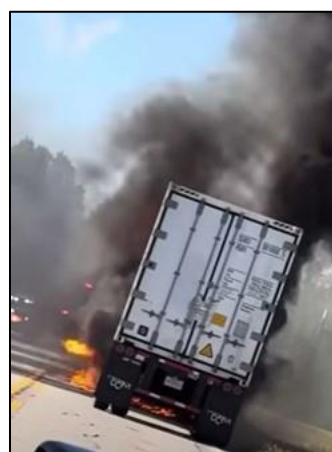
Photo 21 and Photo 22. Between 0930 and 0931, just prior to water on the fire, the image on the left shows that the flame jetting had stopped and then started again 35 seconds later. Seven seconds later the flame jet stopped again.

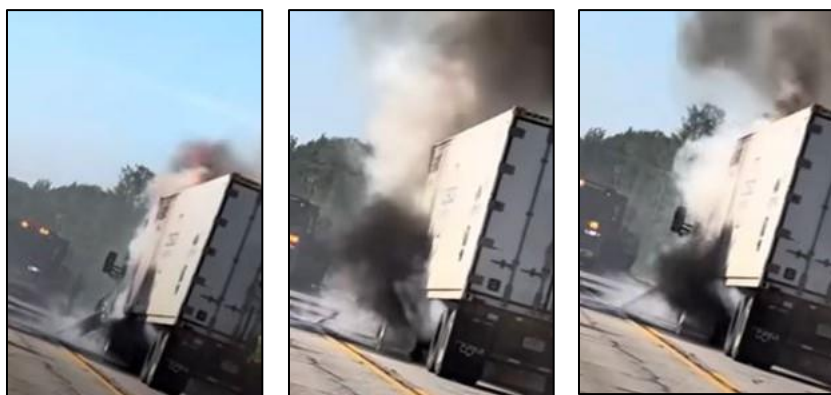
Photo 23, Photo 24, and Photo 25. These images are one second apart between 0932 and 0933. Dense black smoke flow from under the trailer once again is pushing out. This was seconds before the explosion.

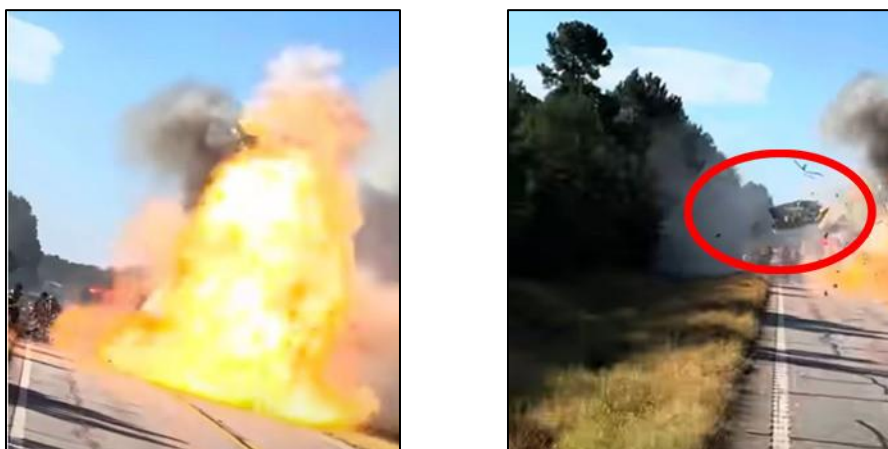
Photo 26 and Photo 27. These images provide a sense of the amount of energy released by the explosion in terms of a blast, projectiles, and thermal radiation. The image on the right shows the latched door that was blown off the trailer.

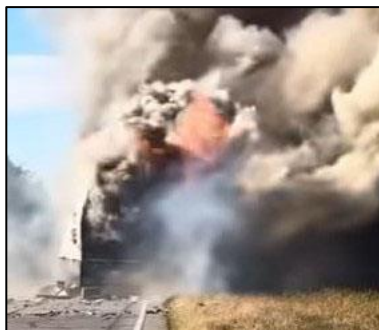
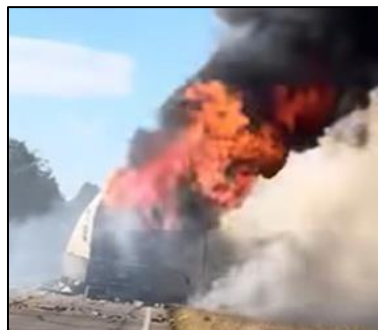
Photo 28 and Photo 29. After the explosion, the inside of the trailer was still a fuel rich environment providing the conditions for a “vent point” ignition, as shown on the left. As additional air was entrained into the smoke the area of flaming combustion increased. The source of the fuel for the fire is mainly the trailer and not the cargo.

The fire analysis showed it is important to recognize that ventilation limited fire conditions can occur in compartments on wheels, such as this refrigerated trailer, just as they occur in compartments in fixed structures. Fires burning inefficiently in a ventilation limited compartment can generate significant amounts of gaseous fuel. When a portion of the compartment contains an explosive mixture of oxygen and gaseous fuel, all that is needed to generate a smoke explosion is a source of heat.
