LINE OF DUTY DEATH REPORT

REPORT 2025-02 • April 2025

One Firefighter Dies During Unprotected Search in Nine-Apartment Building that was Originally Constructed to be a Single-Family House – Hawaii

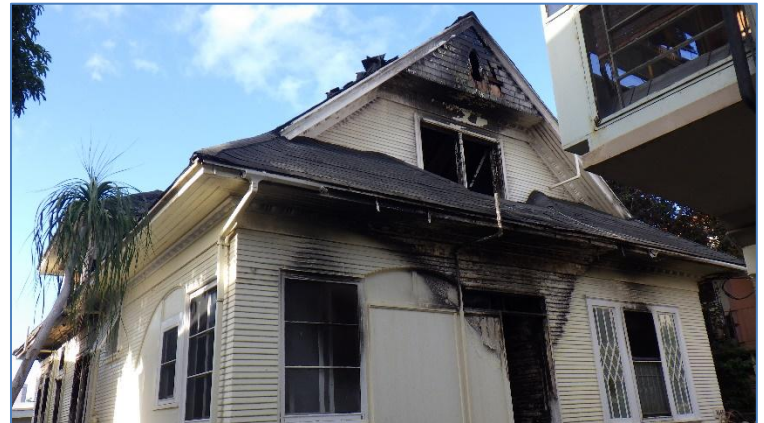
Photo 1: The apartment building, post-fire, Side Alpha
(Courtesy of NIOSH)

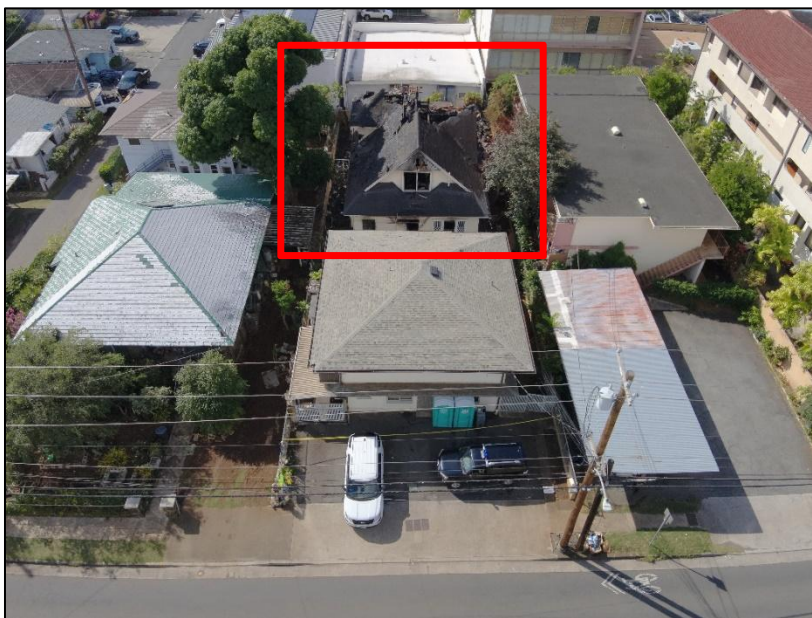
Photo 2: The apartment building (red square), post-fire, view from above on Side Alpha.
(Courtesy of the fire department)

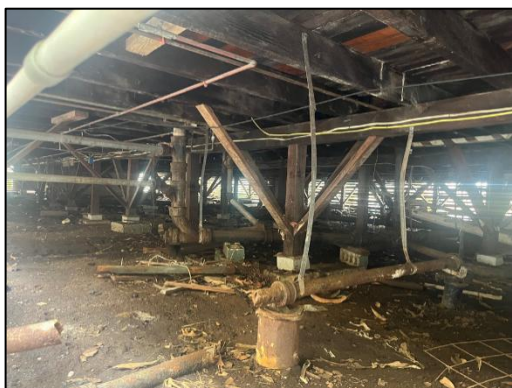
Photo 3: Post and pier foundation.
(Courtesy of NIOSH)

The building had a post and pier foundation, 2" x 6" floor joists, and 1" x 12" floor sheathing (see **Photo 3**). The walls were a combination of 2" x 4" studs with 1" x 12" interior sheathing and 1" exterior shiplap siding, and single wall construction. Single wall construction is unique to Hawaii and utilizes 1" x 12" boards oriented horizontally on one side, and 1" x 12" boards oriented vertically on the opposite side to create walls without any vertical structural members or studs (see **Photo 4**). The roof consisted of conventionally framed 2" x 4" rafters with 1" x 4" skip sheathing, which had been covered over by plywood at some point. The building had been

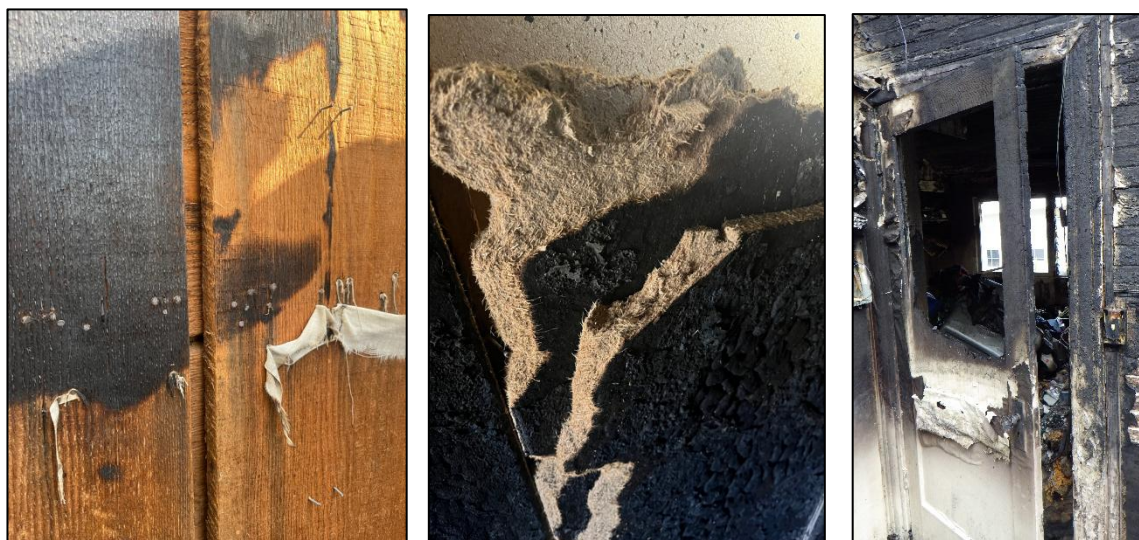
remodelled during its life cycle, and as a result, there was a combination of 1” shiplap and Canec fiberboard interior wall finishes. Canec is a fiberboard building material made from sugar cane bagasse, which is the residual fiber that remains after juice has been extracted from the sugar cane. Canec fiberboard was used extensively as an interior wall finish until 1964. In this incident, the Canec interior wall coverings were heavily charred and likely contributed to flame spread within the structure (see **Photo 5**).

Photo 4, 5, and 6: Single wall construction (left) Canec fiberboard interior wall finishes (middle), and door (right). (Courtesy of NIOSH)

Throughout the building, there were several doors that were permanently shut to separate the individual dwelling spaces. These doors did not provide sufficient fire separation and even contributed to fire spread between units (see **Photo 6**).

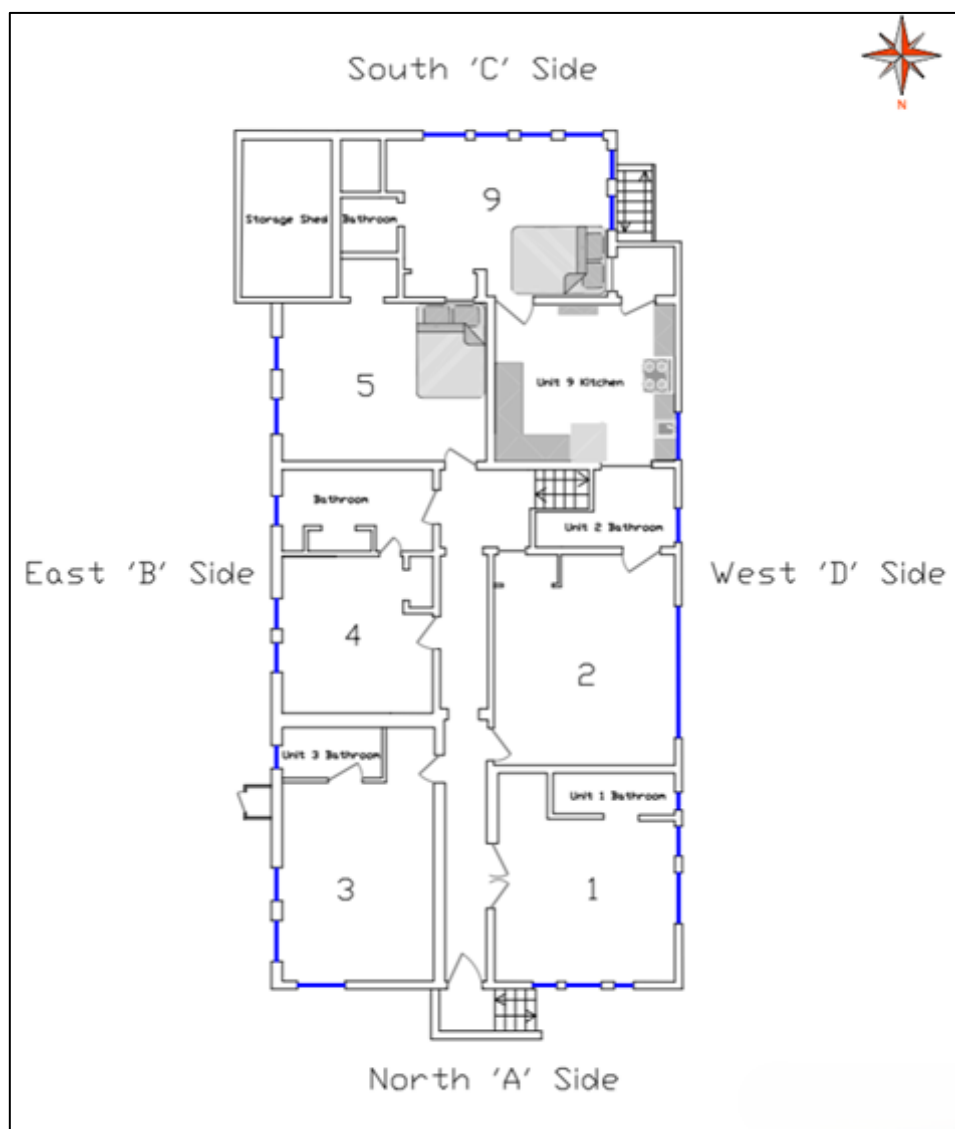
Diagram 1: First division of the apartment building with windows shown in blue.
(Courtesy of the Bureau of Alcohol, Tobacco, Firearms and Explosives)

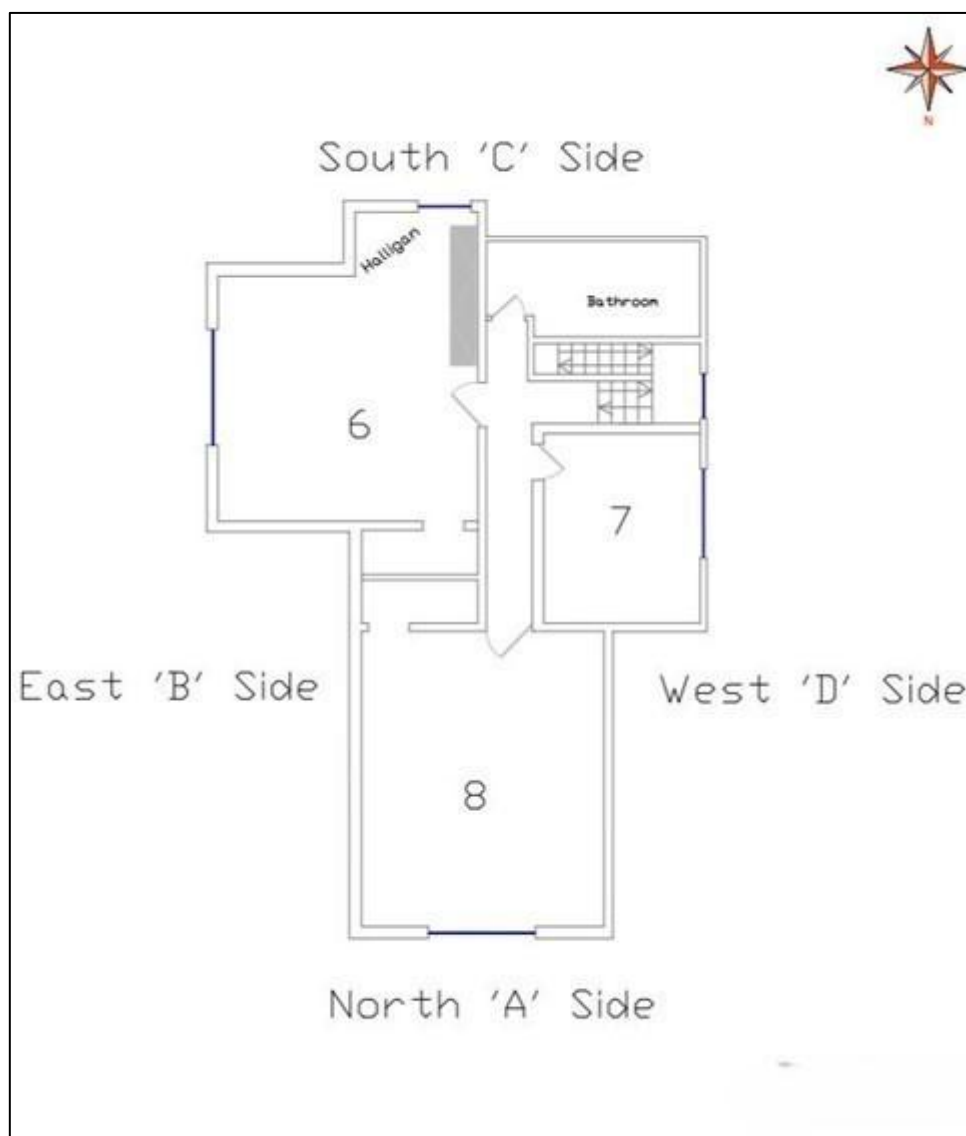
Diagram 2: Second division of the apartment building with windows shown in blue.
