LINE OF DUTY DEATH REPORT

REPORT F2025-03 • July 2025

Career Firefighter Dies after being Trapped by Collapse of Two Vacant Commercial Buildings – New York

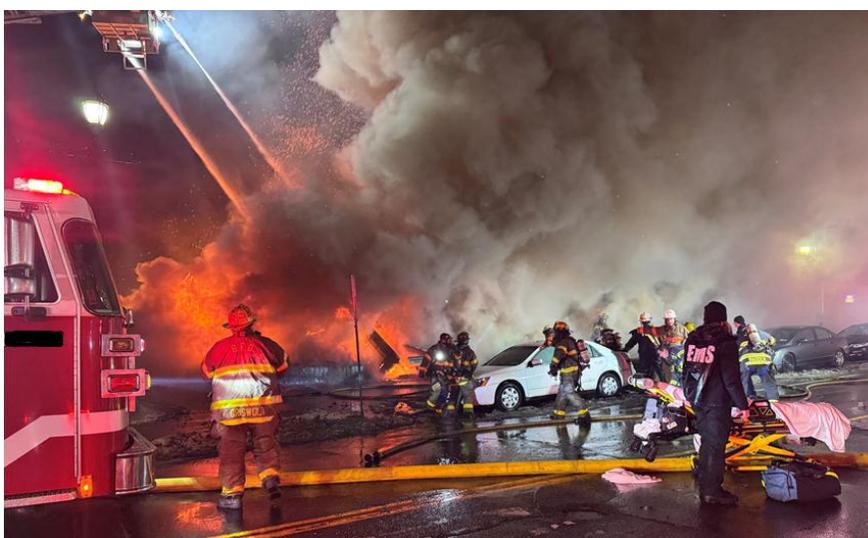
Photo 1: Side Alpha showing extrication operation, post collapse.

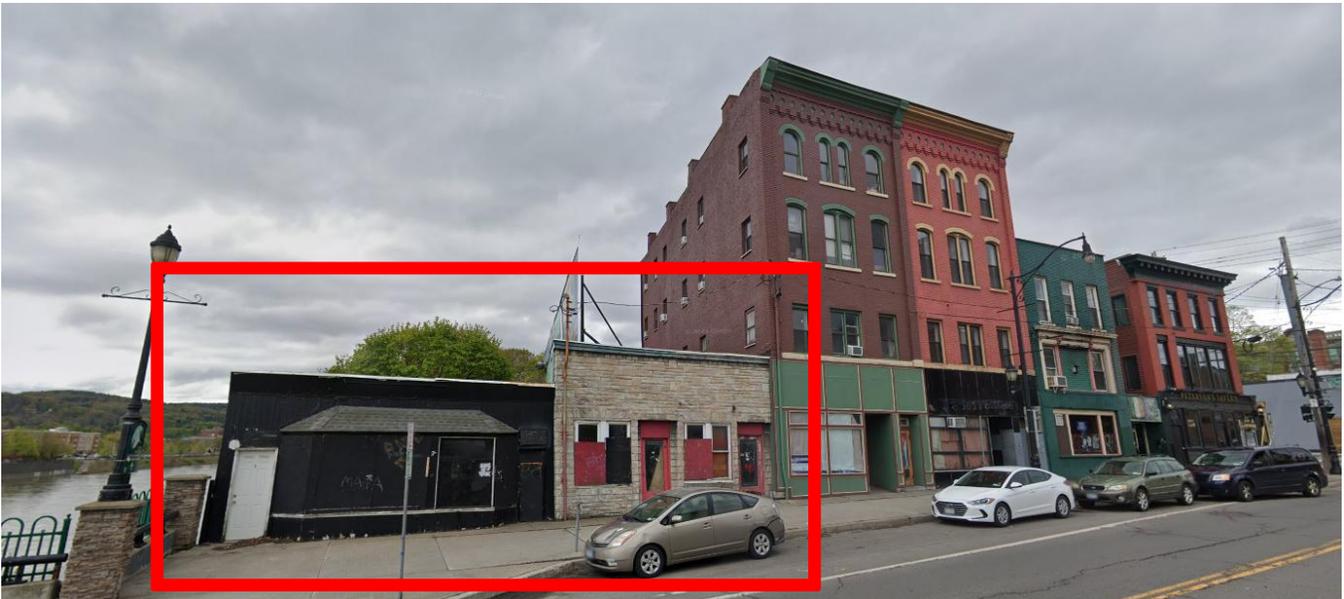
This incident involved two commercial buildings that were the end of a row next to a river, 1 and 3 Main (see **Photo 2**). Official zoning department records indicated that 3 Main was built around 1885 and was about 25 ft x 75 ft, with 1,875 square feet on the first floor, and another 1,875 square feet in the basement. It was wood frame construction with clapboard siding on Side Bravo and Side Charlie. It had a flat roof and a small parapet wall. The roof and floor joists were pocketed into the adjacent brick building, 5 Main (see **Photo 3**). The original post-in-ground foundation was replaced in 1949 with steel beams and concrete piers. The building originally was used for the commercial manufacturing of carriages. Over the years, it was remodeled and the storefront had two entrances on Side Alpha. There was also a stone facade, supported by a wood frame, that was added before 1992. In the 1940's, three billboards were installed on the roof which spanned the length of the building. The billboards were present at the time of the incident.

Photo 2. The row of buildings in the incident in order from left to right: 1, 3, 5, 7, 9, and 11 Main. Red box shows 1 and 3 Main. (Courtesy of the fire department)

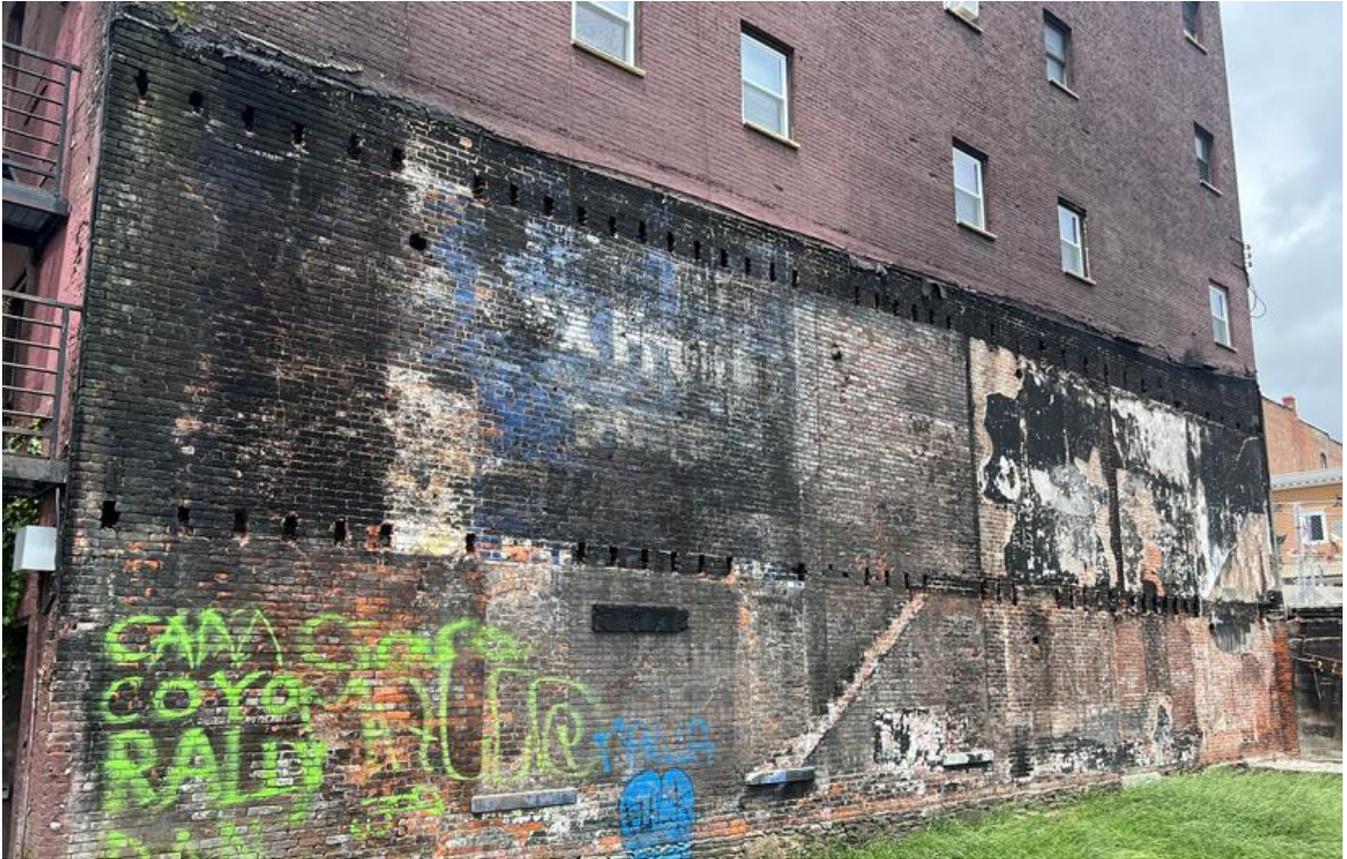
Photo 3. The pockets that were built into 5 Main that supported roof and floor joists of 3 Main. The image was taken post-fire. (Courtesy of the fire department)

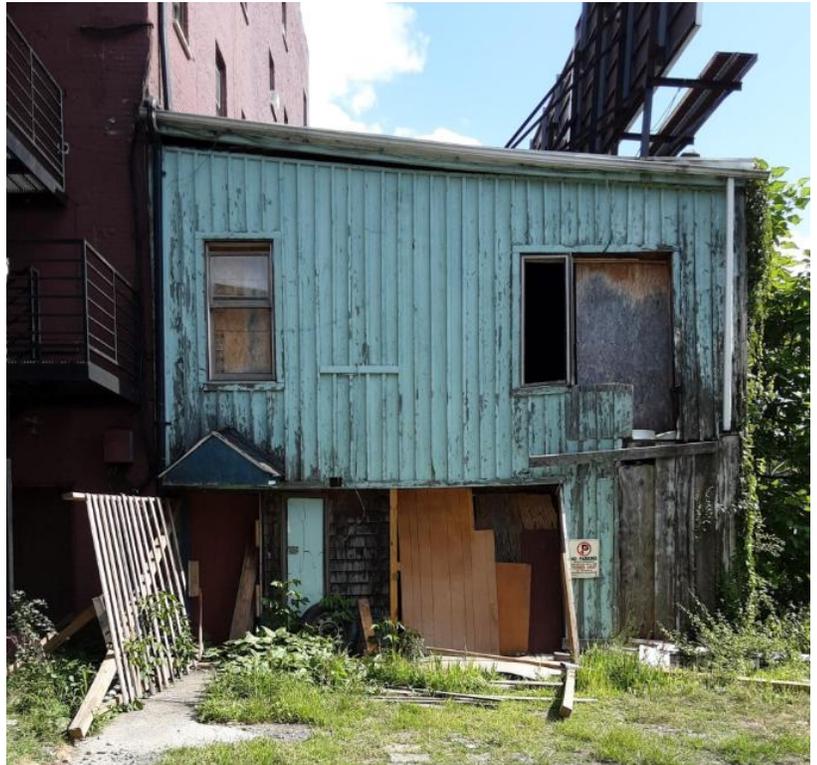
Visual exterior inspections of both 1 and 3 Main were conducted in 2022 by code enforcement. 1 and 3 Main received violation notices for trash accumulation, other property maintenance issues, and the

buildings being unsecured (see **Photo 4**). Per New York State code, the fire prevention division performed fire and life safety inspections once every three years for the type of commercial occupancy at 1 and 3 Main.

Photo 4. Side Charlie of 3 Main in 2022.
(Courtesy of the fire department)

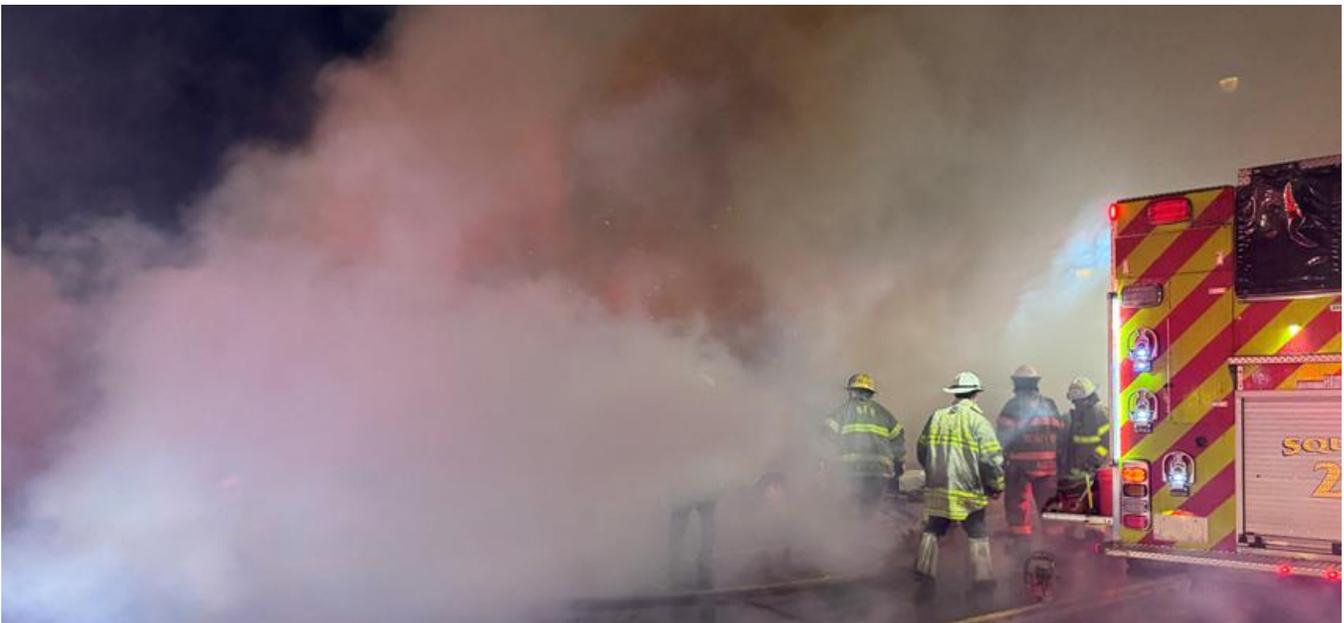
Photo 5. Example of smoke condition on Side Alpha.
(Courtesy of the fire department)

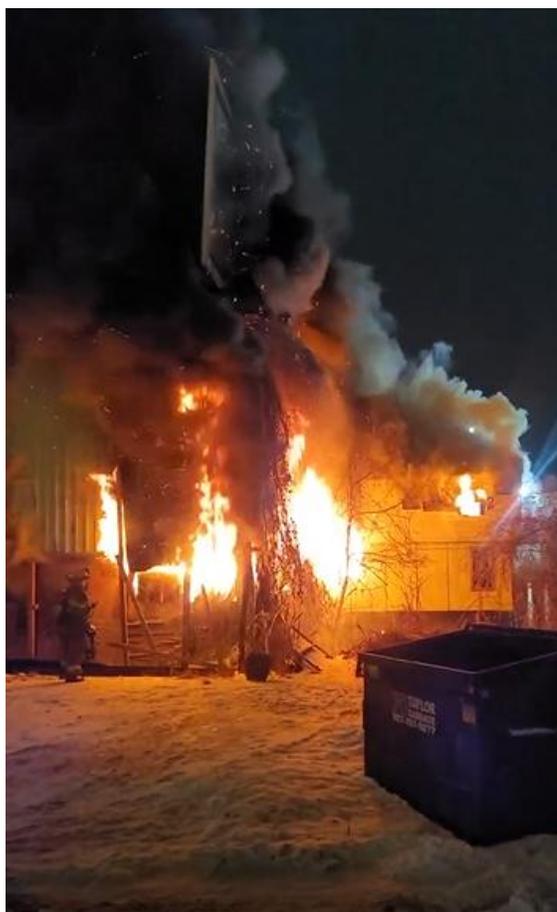
Photo 6. Conditions on Side Charlie upon arrival of QT212.
(Courtesy of the fire department)

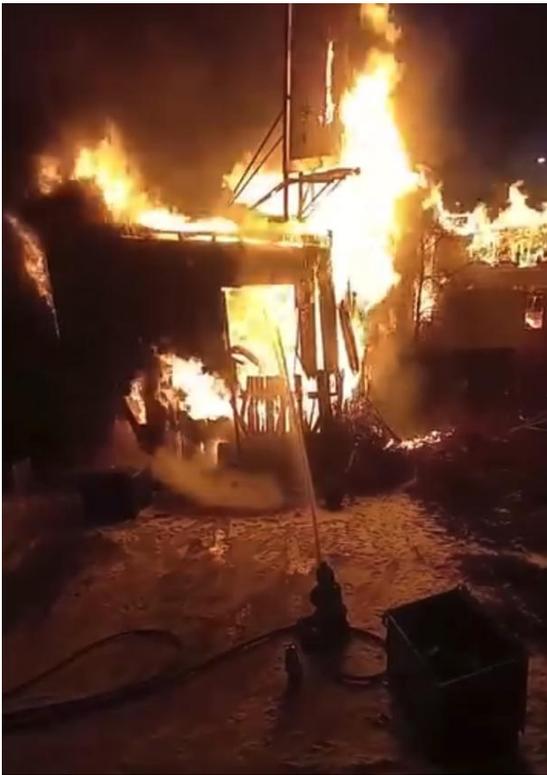
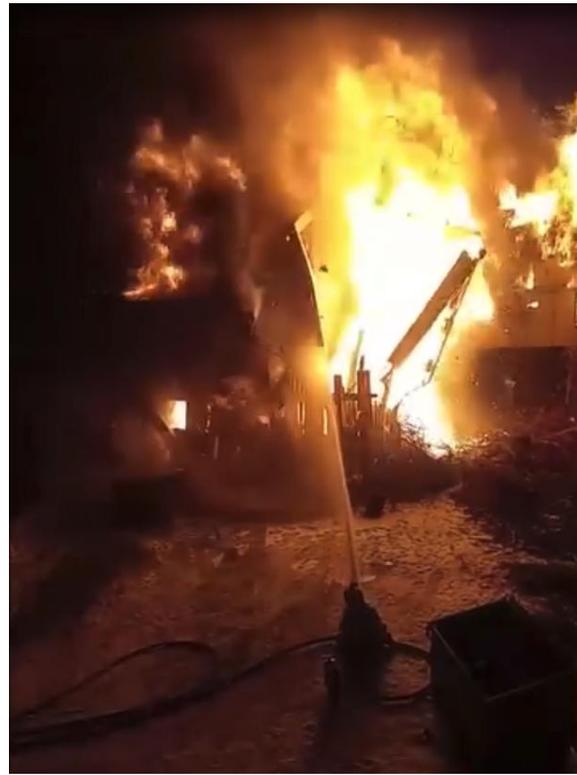
At 21:51 hours, IC reported a major collapse on Side Charlie on both talk group 3 and dispatch channels. 3 Main experienced a progressive collapse that started when the roof failed and caused the billboards to drop (**see Photo 7 and 8**). This caused the Side Bravo wall to fall outward and push the walls of 1 Main. This also caused the facade on Side Alpha to collapse outwards onto the sidewalk toward the street parked cars. The SQ21 firefighter was trapped under the fully intact facade which spanned the sidewalk to a street parked car. His head to his diaphragm were covered by building materials. His waist, one arm, and legs were exposed through a window frame. The SQ21 officer was hit in the head by the facade,

Photo 7 and 8. Progressive collapse of 3 Main showing the billboard drop and pushing out the Side Bravo wall.
(Courtesy of the fire department)

The progressive collapse of 3 Main resulted in the stone facade on Side Alpha falling straight out as a unit. Exterior masonry and veneer walls are not load-bearing. They are attached with ties and supports to the structure [IFSTA 2013]. When the load-bearing walls of 3 Main failed due to the collapse, the weight of and imposed load from the stone on the facade pulled it straight out onto the sidewalk. It is important for firefighters to be aware of how masonry or stone veneer construction influence the potential for structural collapse.

Recommendation #1: Fire departments should establish and enforce collapse zones when a defensive strategy begins.

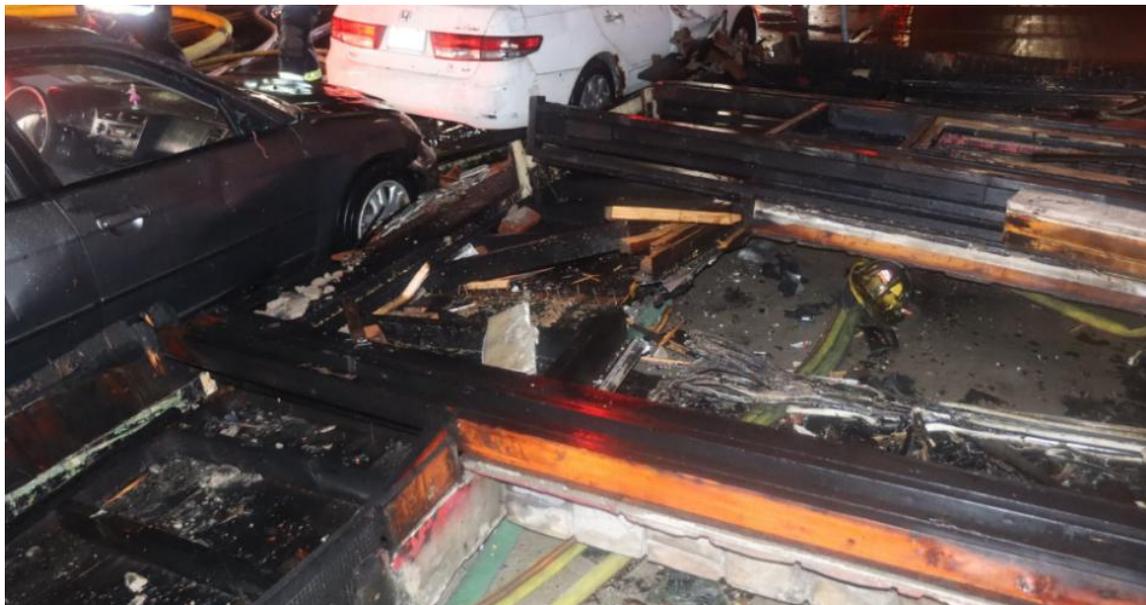
7121 went to the scene from the local hospital as FI212 arrived on-scene. IC requested that EMS bring a stretcher to Side Alpha. A QT213 firefighter reported to IC that the “single-story” building only had part of the Side Alpha and Side Bravo walls left standing. This was followed by IC calling an “urgent” on talk group 3 and requesting all available manpower to Side Alpha to assist with the downed firefighter. The SQ21 officer responded requesting a saw to Side Alpha for crews working the extrication to cut the facade frame apart (see **Photo 9**).

Photo 9. The collapsed facade on Side Alpha.
(Courtesy of the fire department)

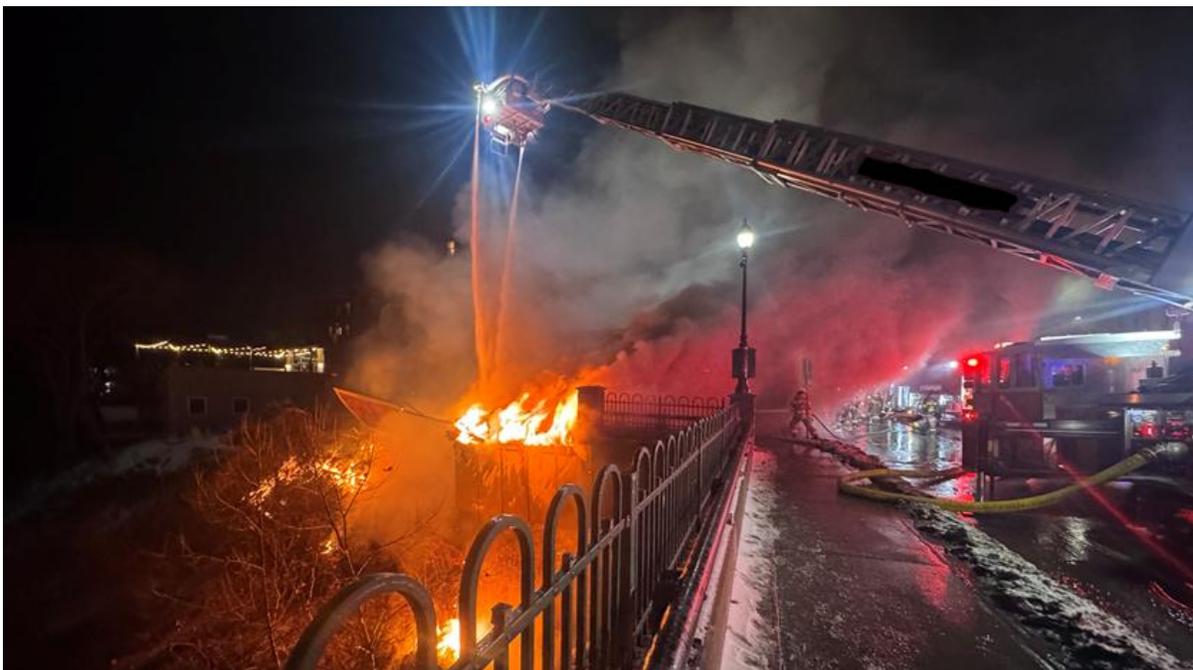
Photo 10. View of fire that became wind-driven from bridge with master streams and hoseline attempting to protect the extrication operation.
(Courtesy of the fire department)
