Health Hazard Evaluation Report

HETA 82-123-1258
GOODYEAR AEROSPACE CORPORATION
AKRON, OHIO

HETA 82-123-1258
FEBRUARY 1983
GOODYEAR AEROSPACE CORPORATION
AKRON, OHIO

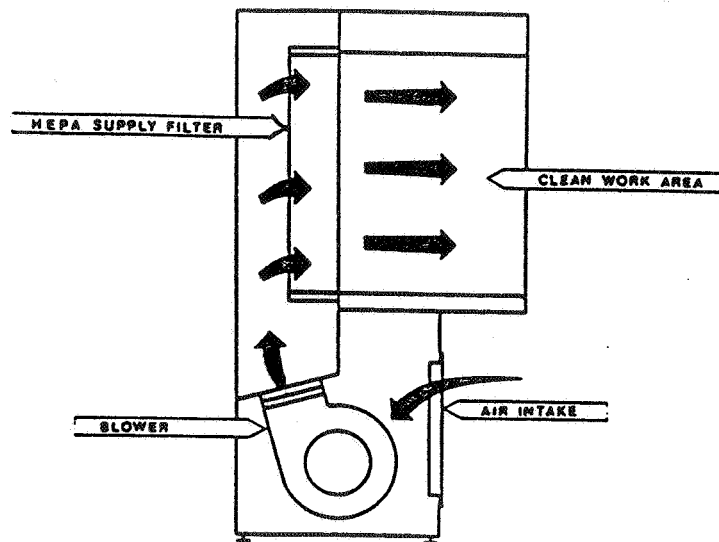
Sketch A. Horizontal Laminar Flow Clean Bench

- a. Open trays of MEK were being used in a horizontal, laminar flow, clean bench. Room air was drawn through high-efficiency particulate air (HEPA) filters in the base of the cabinet, directed up the back of the cabinet, and released through a laminar flow grill toward the face of the hood to prevent dust contamination on the parts being handled (similar to Sketch A, Figure I). HEPA filters do not remove organic vapors; therefore, the solvent vapors from the cleaning solvents are directed at the face of the worker. If solvents are to be used in these cabinets, they should be exhausted to the outside of the hangar (similar to Sketch B, Figure I).
