HETA 86-092-1870
FEBRUARY 1988
50 STANIFORD STREET OFFICE BUILDING
BOSTON, MASSACHUSETTS

NIOSH INVESTIGATOR:
John R. Kominsky, M.Sc., CIH

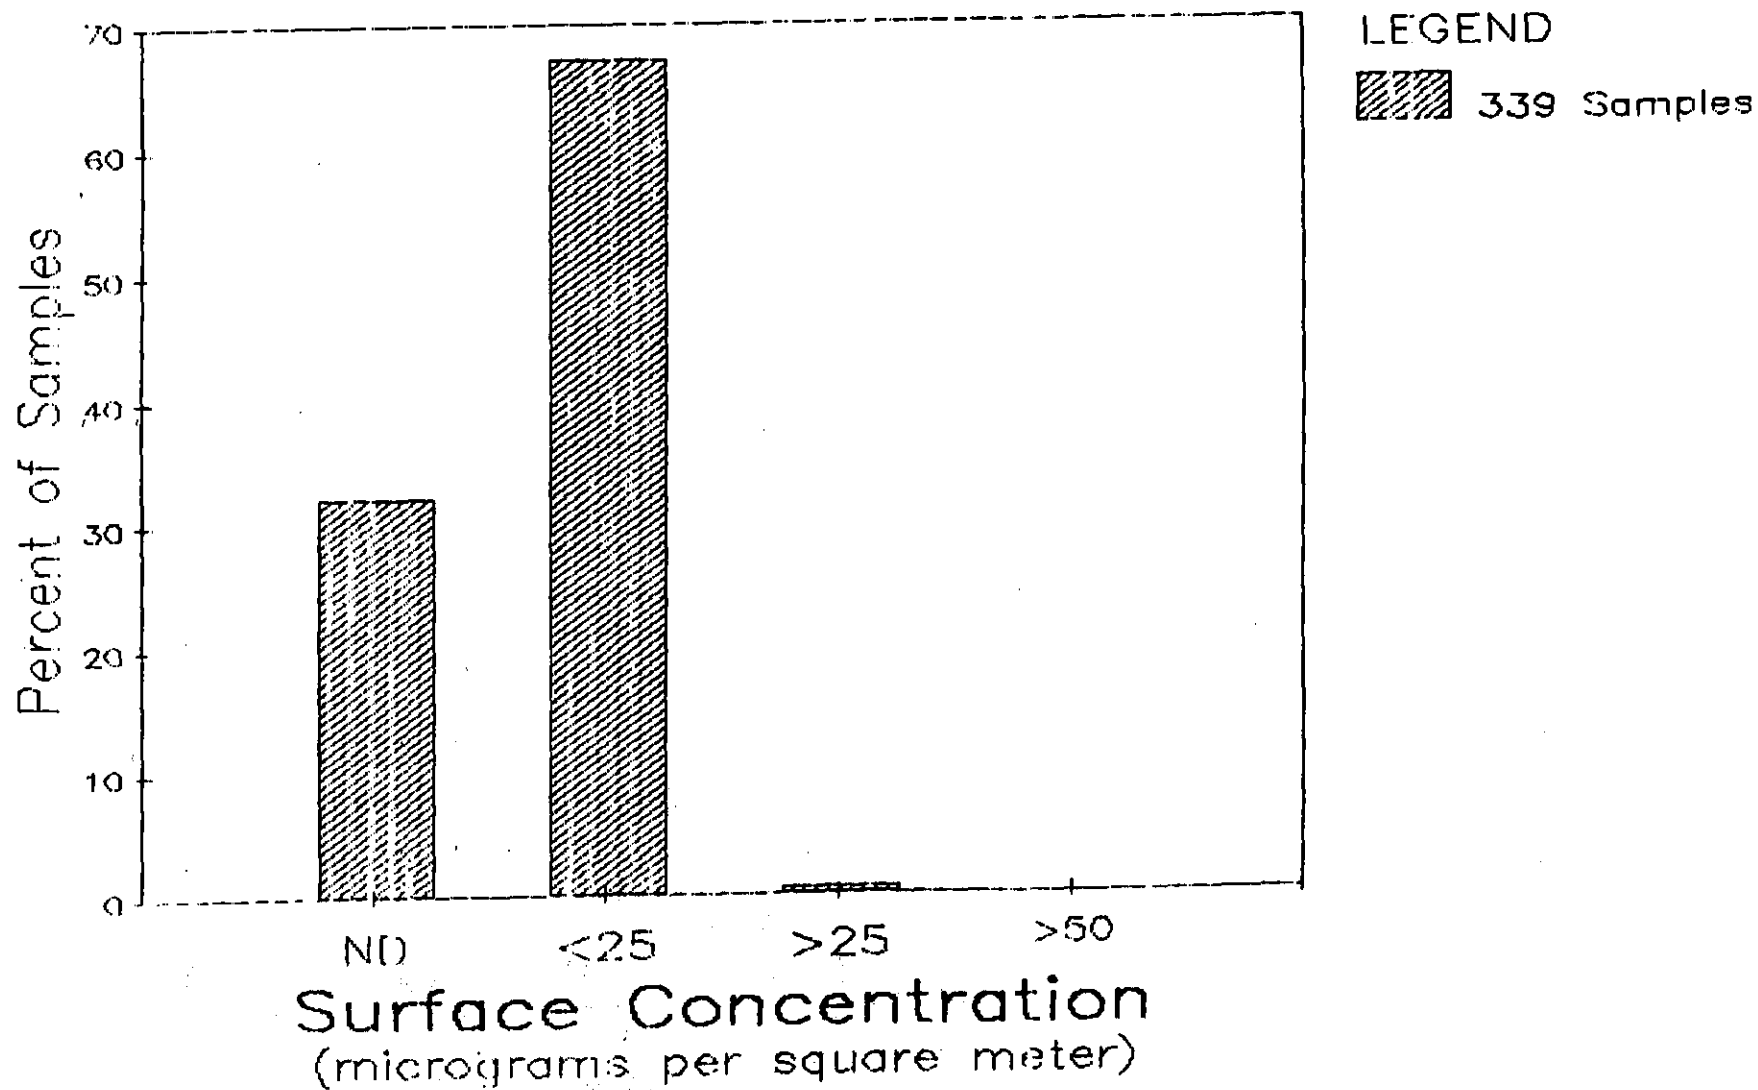
FIGURE 6
PCB Surface Concentration Frequency Distribution
50 Staniford Street Office Building, Boston, MA
February 1986 and January 1987

A total of 339 wipe samples (Tables 1 and 2) were collected on building surfaces for the analysis of PCBs. Building surfaces included walls, floors, ceilings, and miscellaneous office furniture (desks, tables, cabinets, etc.). Figure 6 shows that approximately 32% (109/339) of the samples were none-detected; 67% (228/339) contained measurable concentrations below 25 ug/m²; 1% (2/339) ranged from 25 to <50 ug/m²; and 0% exceeded the 50 ug/m² cleanup guideline.

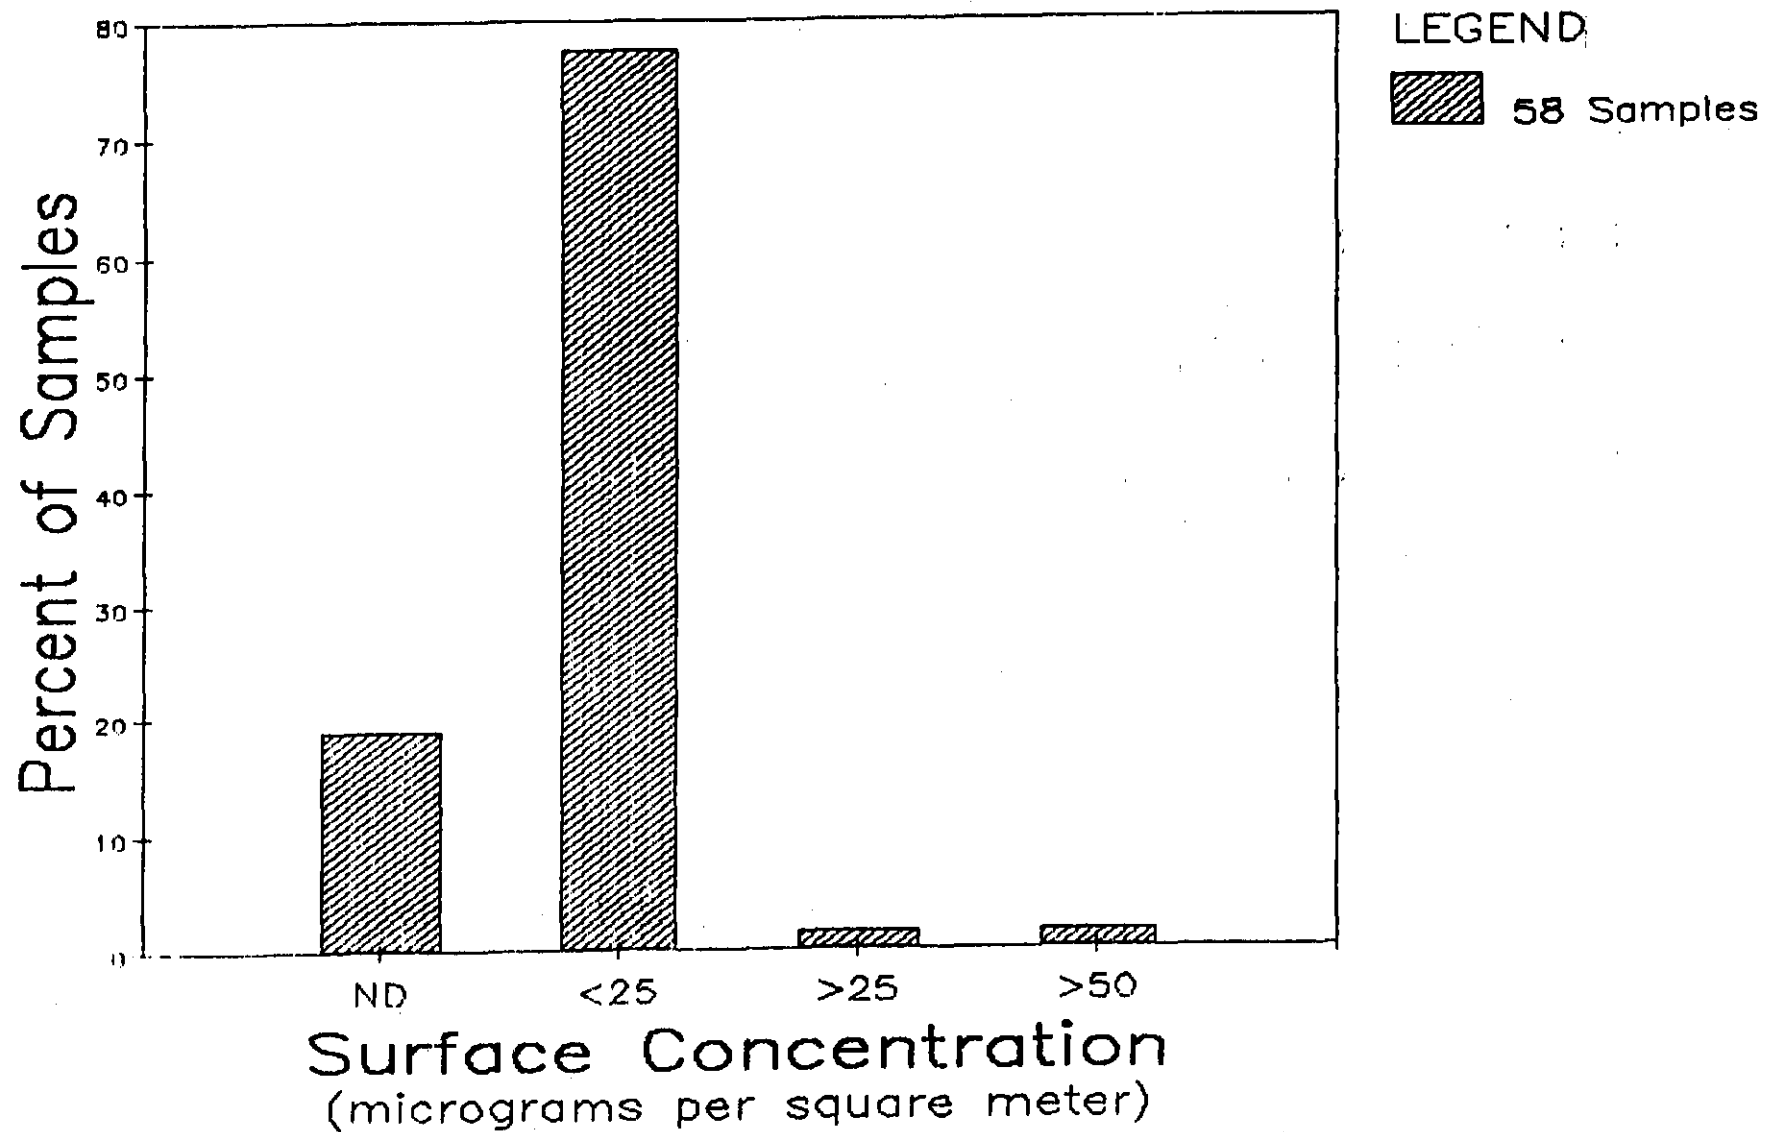
FIGURE 7
PCB Surface Concentration Frequency Distribution
Interior HVAC System Samples (Feb. 1986 & Jan. 1987)
50 Staniford Street Office Building, Boston, MA

A total of 58 wipe samples (Tables 1 and 2) were collected on interior HVAC system surfaces for PCB analysis. The results are summarized in Table 4. Figure 7 shows that approximately 19% (11/58) of the samples were none-detected; 78% (45/58) contained measurable concentrations of <25ug/m²; 2% (1/58) ranged from 25 to <50 ug/m²; and 2% (1/58) exceeded 50 ug/m². All of the samples showed concentrations below the 50 ug/m² guideline, except one. This sample (88 ug/m²) was collected in February 1986 on the exterior fresh air intake louvers above the South entrance to the building. The louvers and supply air ventilation duct were cleaned by the contractor. The followup testing conducted in January 1987 (Table 2 and Figure 8) show that all HVAC system surfaces are within the guidelines.
