HETA 93-0531-2410
MARCH 1994
NATIONAL RAILROAD PASSENGER CORPORATION
CHICAGO, ILLINOIS

In March and April 1993 investigators from the National Institute for Occupational Safety and Health (NIOSH) conducted a health hazard evaluation (HHE) regarding injuries occurring among employees who work in Superliner® sleeper cars for the National Railroad Passenger Corporation (Amtrak). NIOSH investigators specifically evaluated the operation of the Superliner® beds by reviewing records, interviewing employees, evaluating the dynamic forces involved with working the Superliner® beds, and observing work practices during the operation the trains.

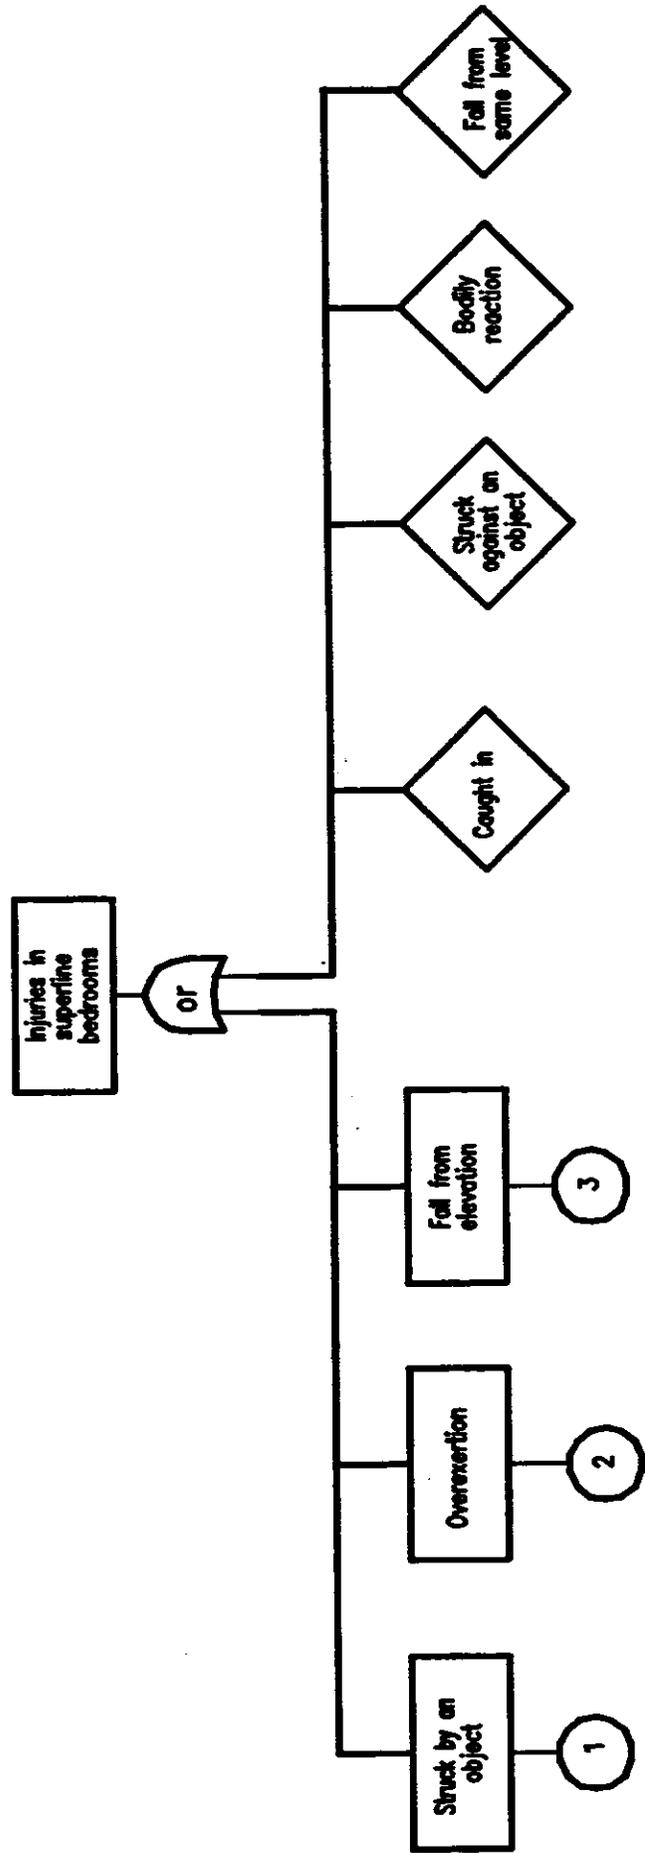
FIGURE 1 - Fault Tree Analysis for Injuries in Superliner® Bedrooms

The train inspections and the review of the injury records revealed that being struck by an object, fall from elevation, and overexertion are the top three injury types in superliner bedrooms. These three categories were analyzed with the fault tree analysis technique and are discussed below and presented in Figures

1-4. Figure 1 presents an overview of the types of injuries seen in Superliner® bedrooms, three of which are further analyzed in Figures 2-4.

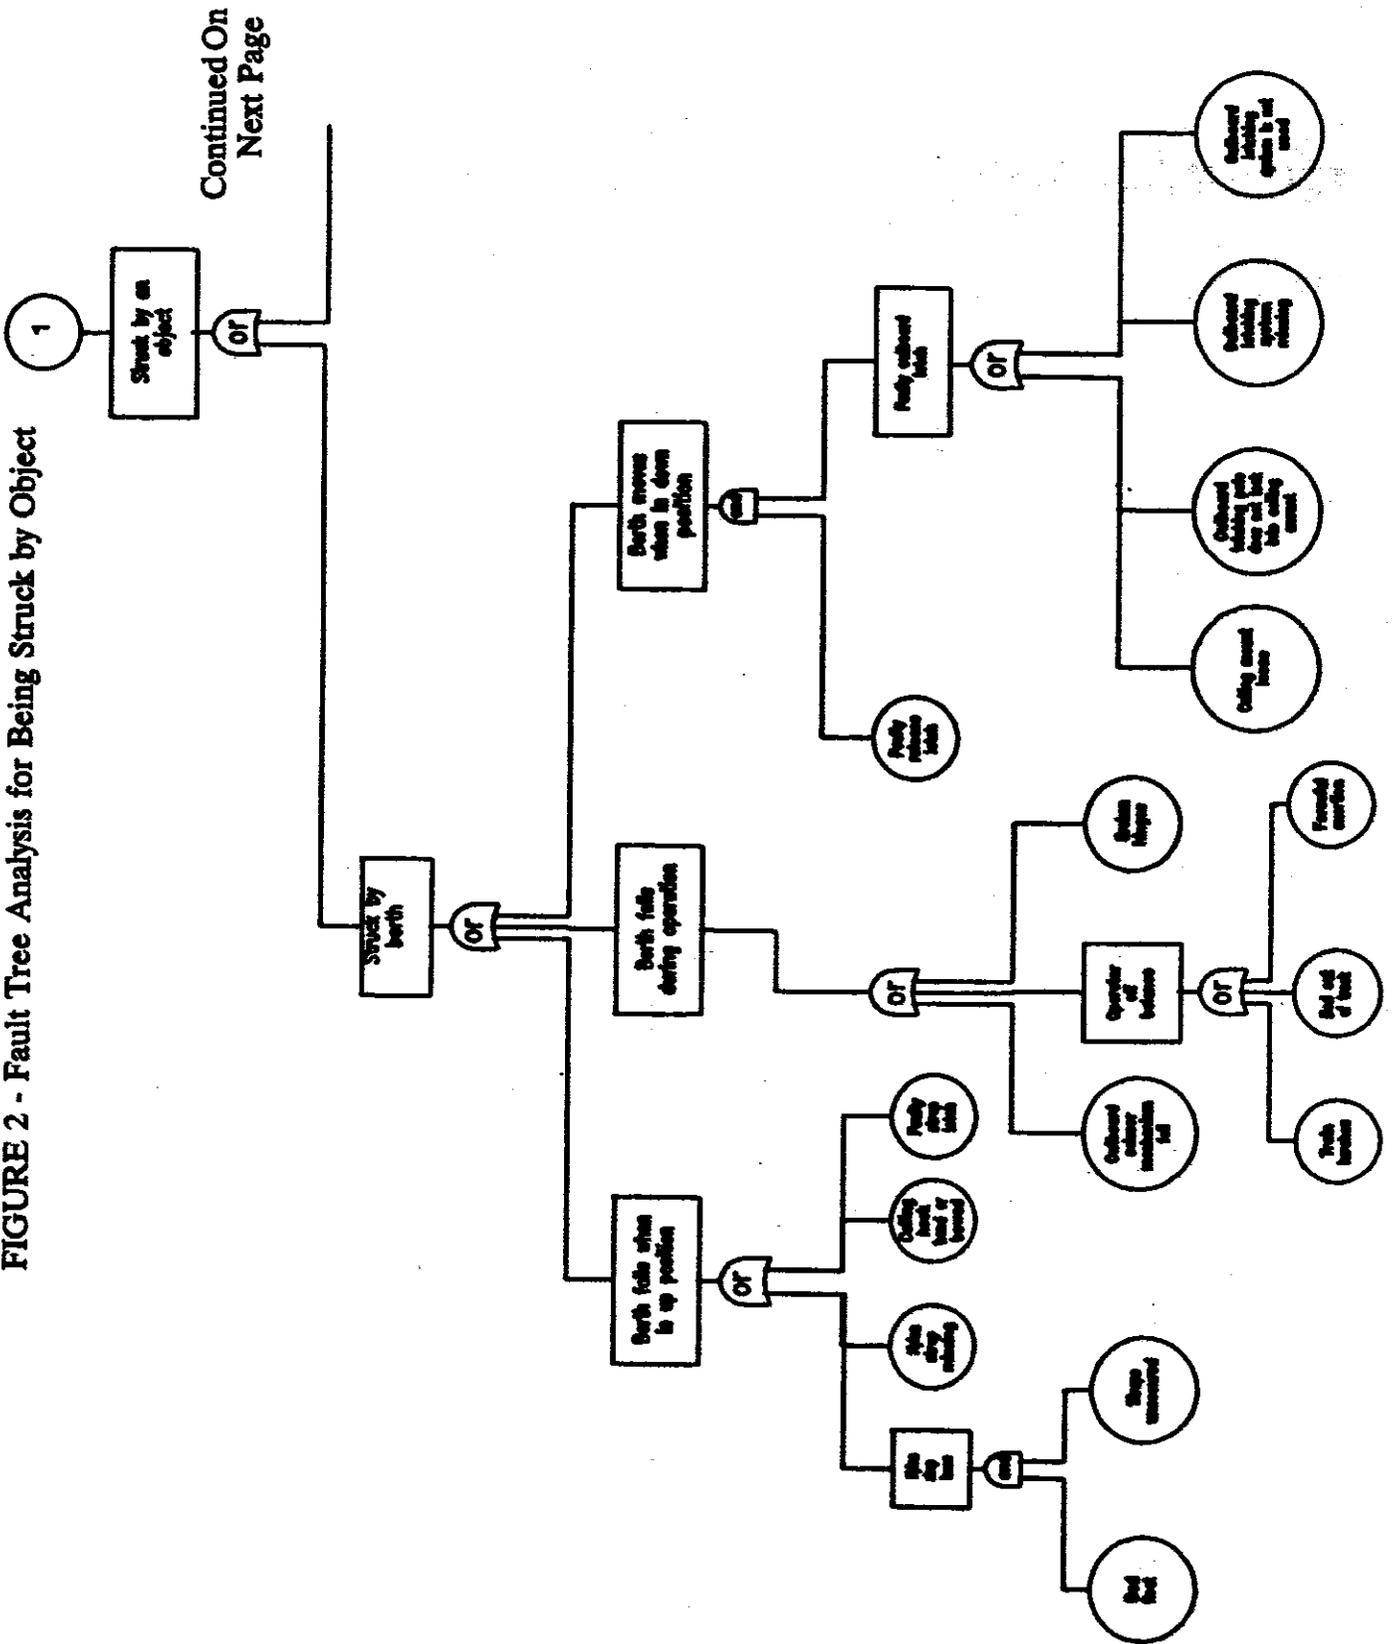
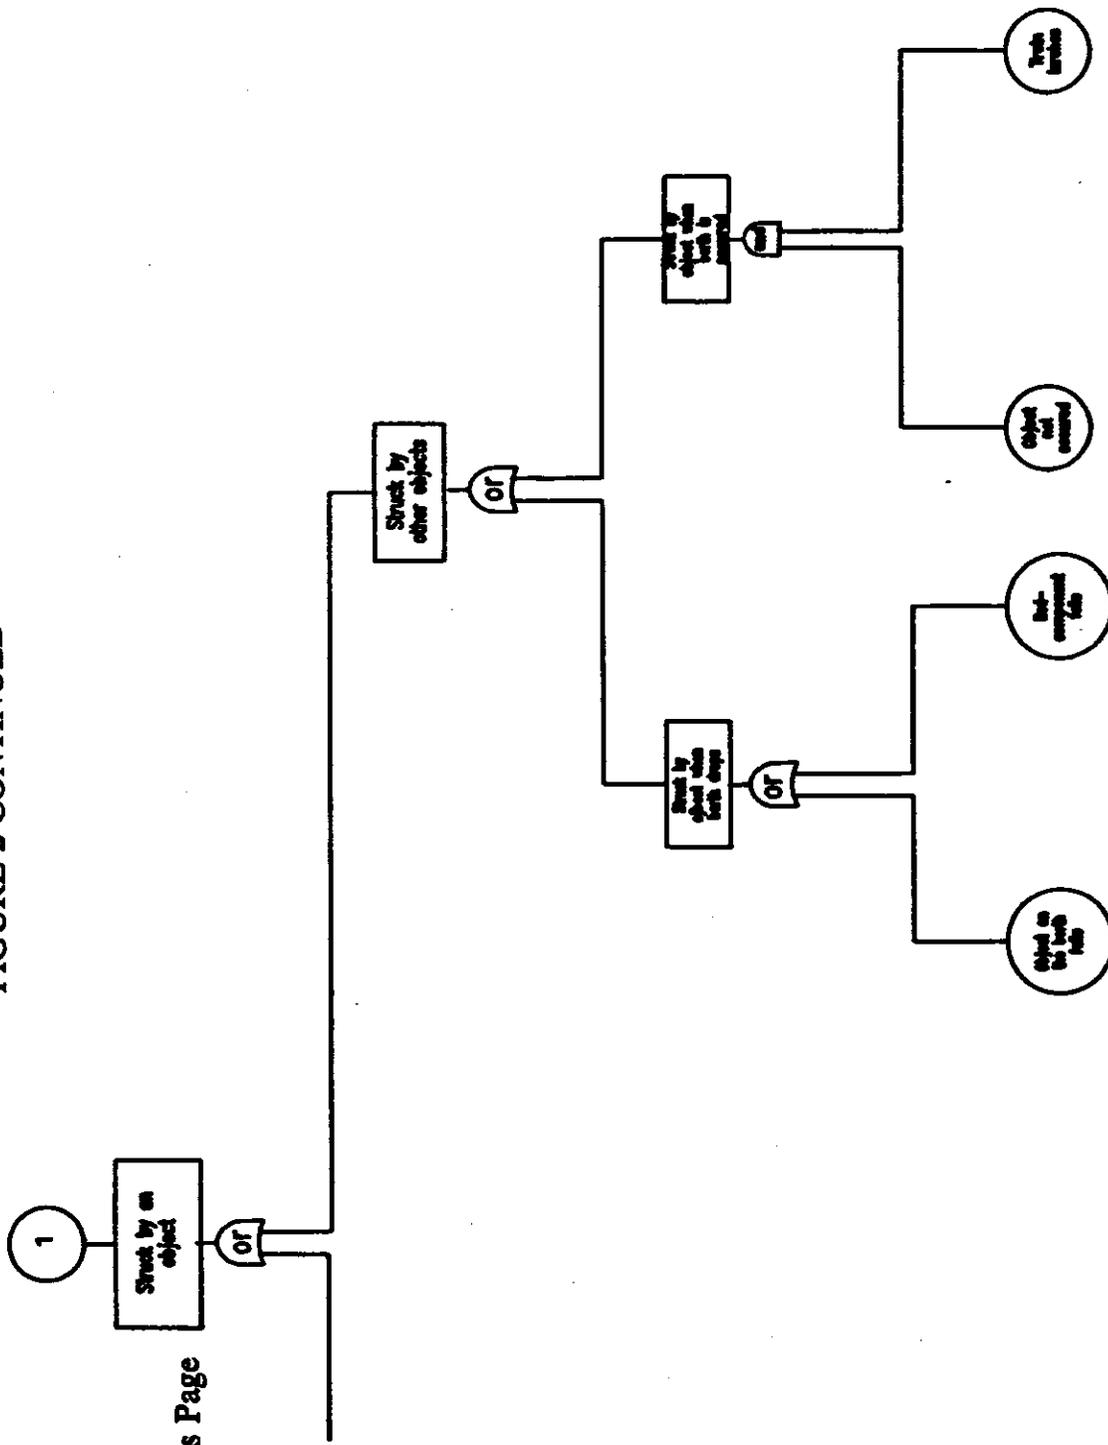
FIGURE 2 - Fault Tree Analysis for Being Struck by Object

The primary fault events for being **struck by an object** (Figure 2) are:

- (1) unsecured nylon straps; (2) missing nylon straps; (3) bent ceiling hooks;
- (4) strap latch defect; (5) defective outboard scissor mechanism; (6) loss of balance; (7) broken hinges; (8) failure of release latch; (9) faulty outboard latching system; (10) object on bed falls when bed falls; (11) object on bed not secured; and (12) sudden movement of train. The primary fault events for **overexertion** (Figure 3) injury in the bedrooms are: (1) bed too heavy;

3. Installation of the positive latch mechanisms in the deluxe bedroom upper beds should continue until they have been installed in the whole fleet of Superliner® sleeper cars. These positive latch mechanisms provide significant improvement in maintaining the beds in the upright position.

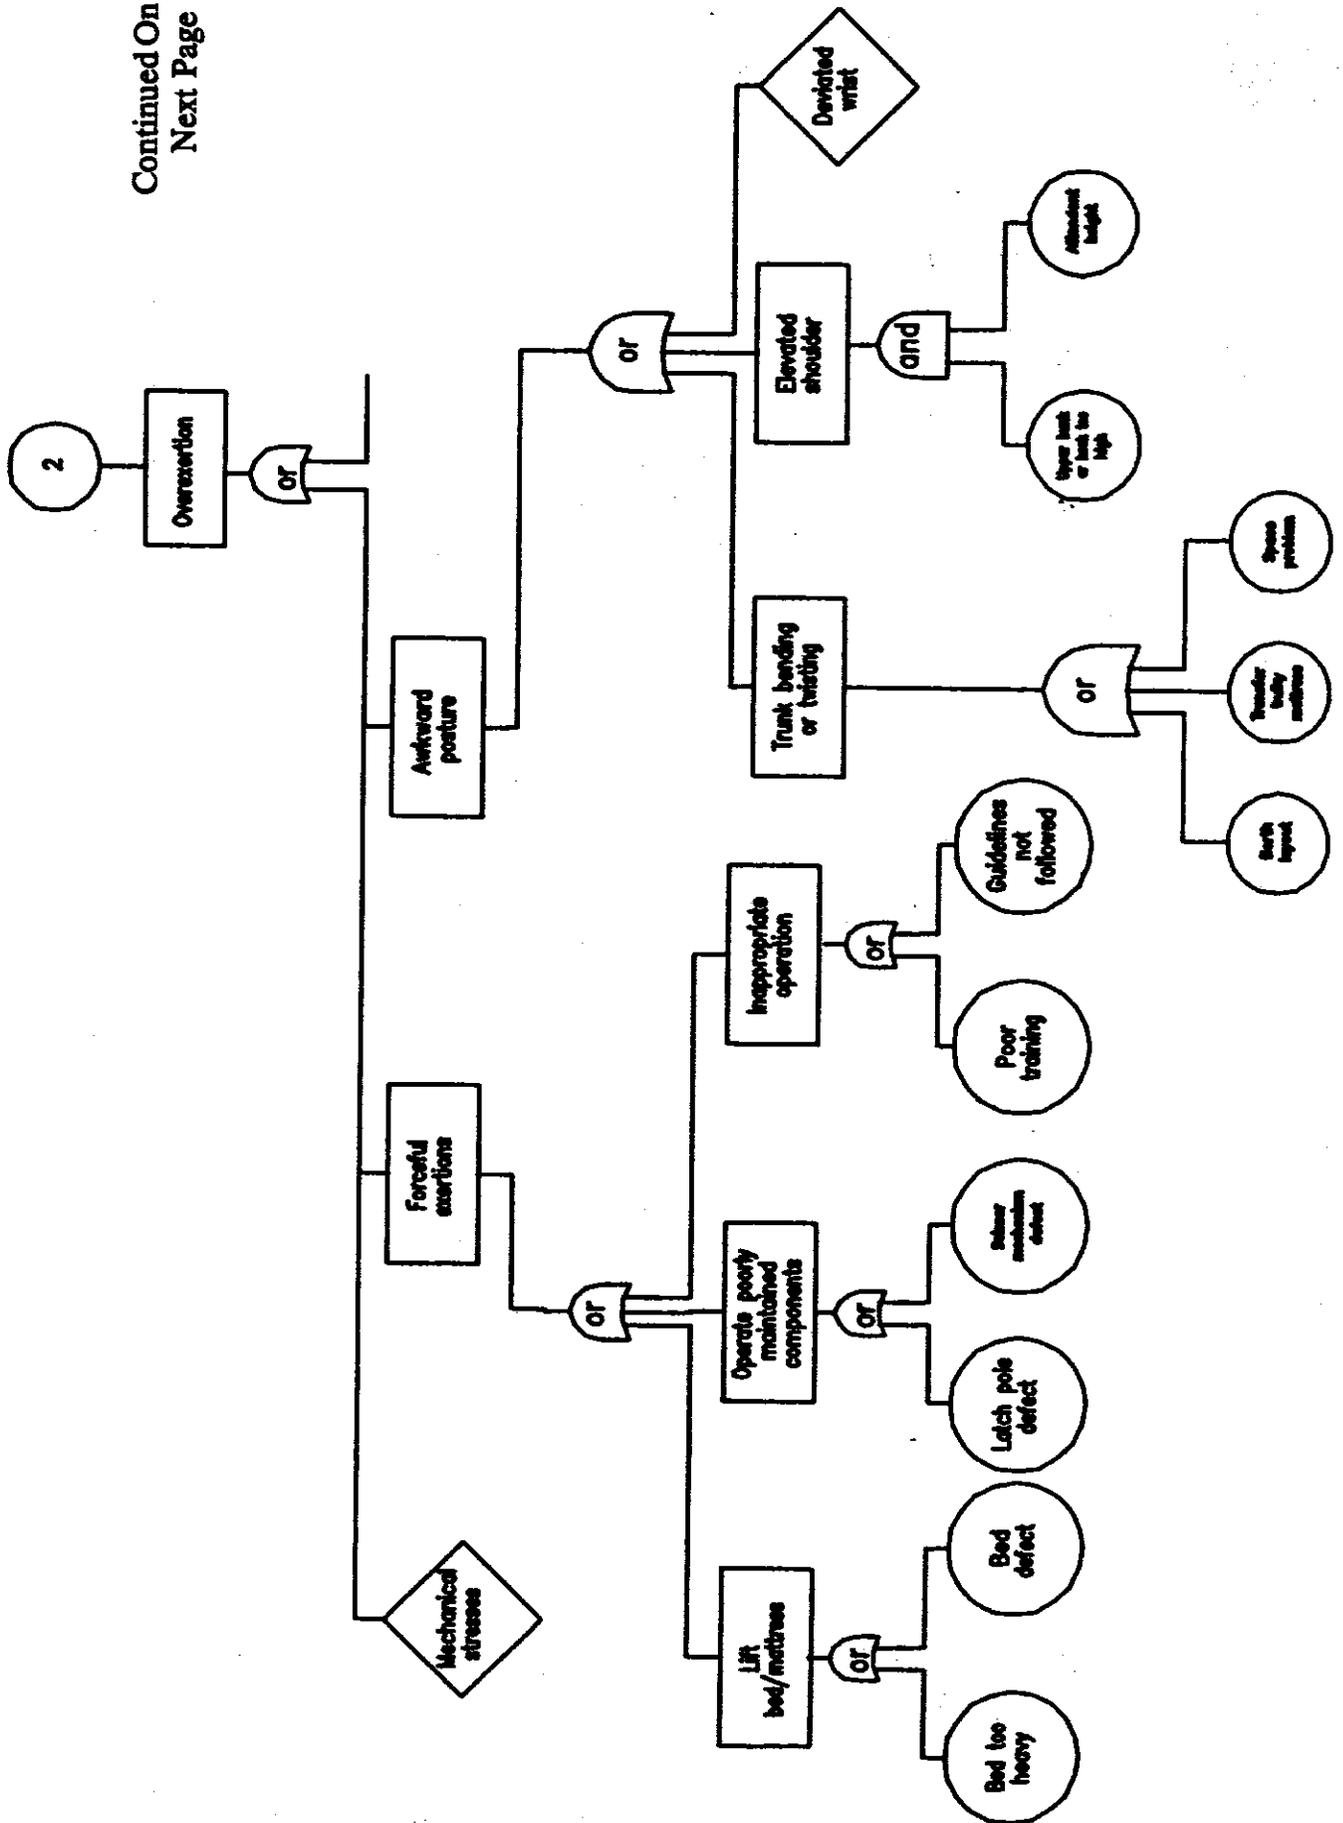
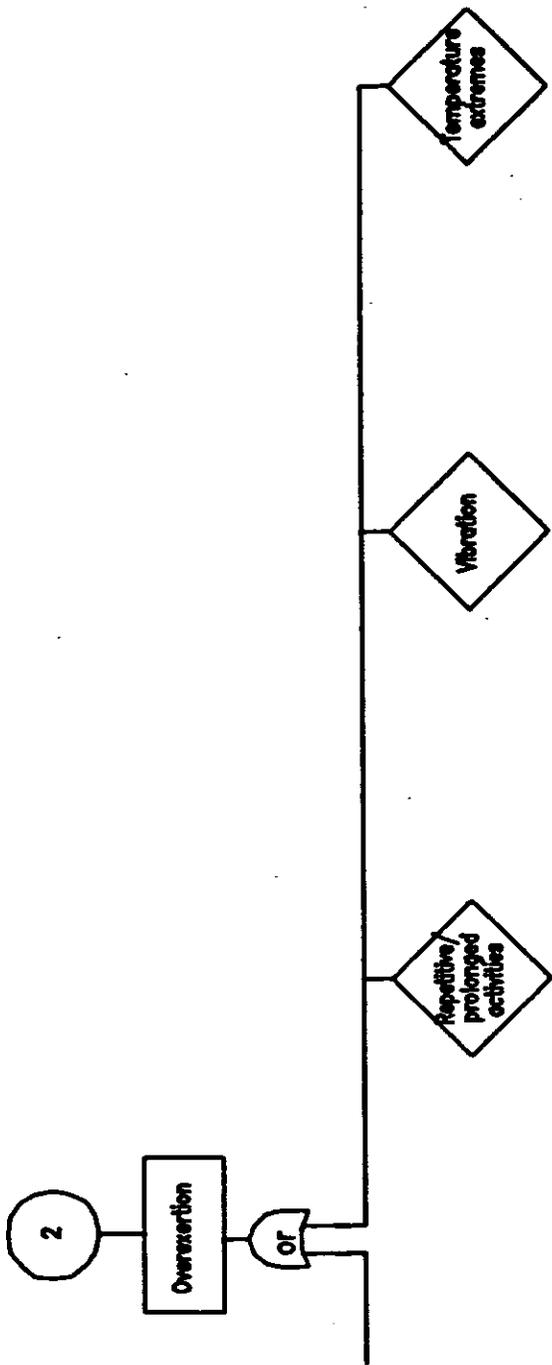
FIGURE 3 - Fault Tree Analysis for Overexertion

- (2) defective bed components; (3) defective latch pole; (4) defective scissor mechanism; (5) inadequate training on how to operate the beds; (6) training guidelines not followed; (7) over-reaching to make beds; (8) transfer of bulky mattress; (9) inadequate working space; and (10) upper bed too high for attendant. The primary fault events for **fall from elevation** (Figure 4) are: (1) sudden movement of train; (2) failure of ladder; (3) carrying an object while climbing ladder; (4) health condition of train attendant; (5) slippery ladder;

4. Overexertion control approaches should be developed and implemented. A foot stand is suggested for attendants to reduce/prevent the overexertion injuries during bed-making. Attendants should also be advised not to use the adjacent sink as a stand during bed-making because of the potential for tripping and falling.

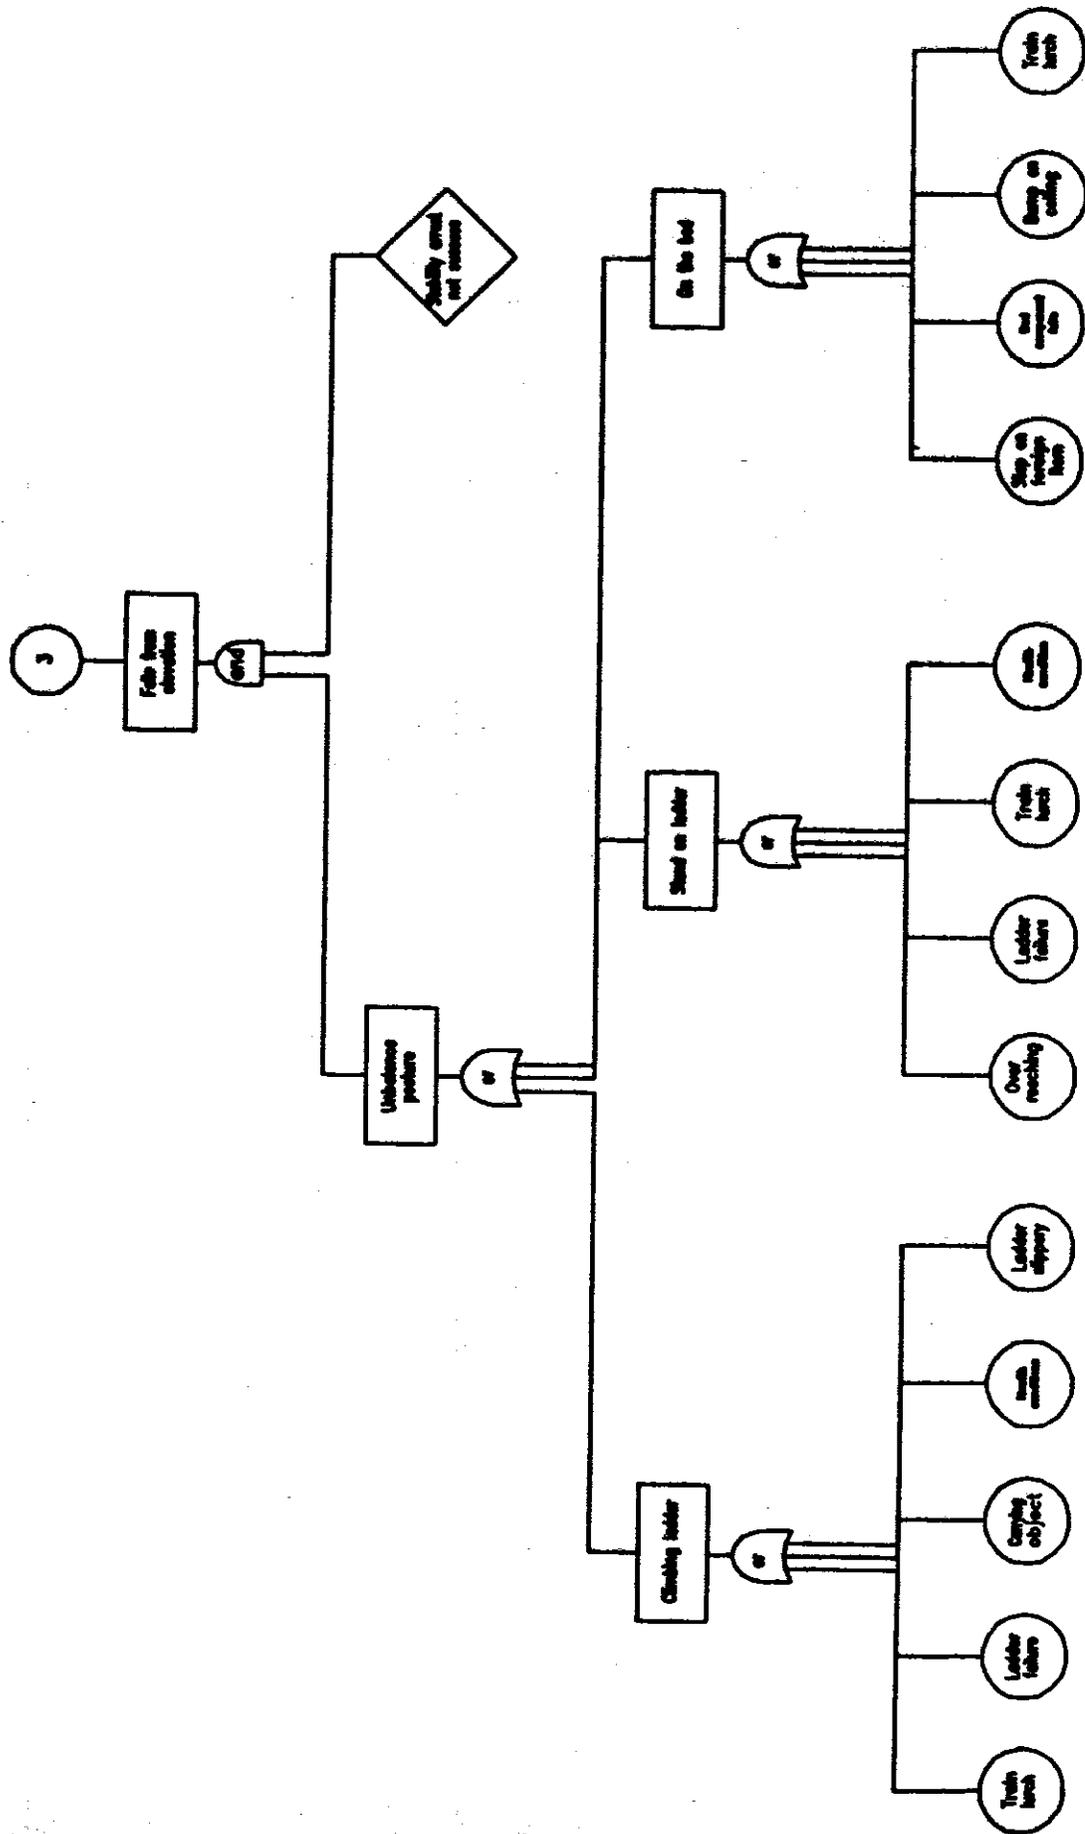
FIGURE 4 - Fault Tree Analysis for Fall from Elevation

(6) over-reaching while standing on a ladder; (7) stepping on foreign objects; (8) failure of bed component(s) when attendant is on the bed; and (9) attendant bumps ceiling when on the bed.
