**HETA 94-0244-2431  
JUNE 1994  
MEMPHIS FIRE DEPARTMENT  
MEMPHIS, TENNESSEE**

**NIOSH INVESTIGATORS:  
Ted A. Pettit, M.S.  
Tim R. Merinar, M.S.**

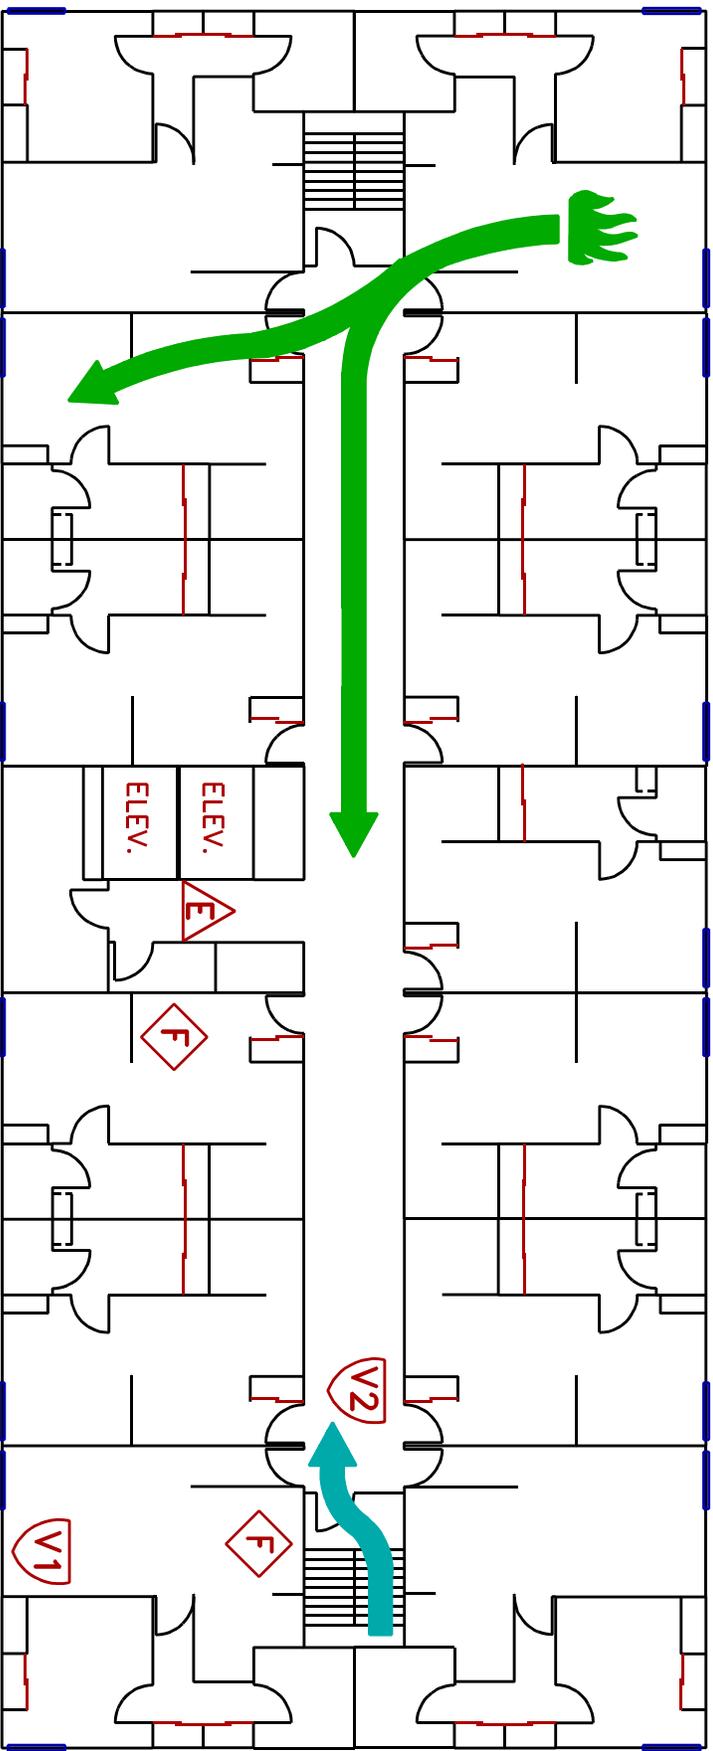
# DIAGRAM OF THE NINTH FLOOR

Fire Fighters No. 1, No. 2, No. 4 and No. 5 entered the small ninth floor lobby (see Figure) directly in front of the elevator. Fire Fighter No. 2 was experiencing problems with his SCBA. Fire Fighter No. 4 stated that he heard air leaking from the back of Fire Fighter No. 2's SCBA and heard Fire Fighter No. 2 cough. Fire Fighter No. 2 radioed that he was having difficulties and asked for the location of the stairwell. Fire Fighter No. 1 was heard on the radio to say "I've got him." At this point, Fire Fighter No. 1 and Fire Fighter No. 2 proceeded into the hallway, turning right. It is not known if Fire Fighter No. 1 was aware that Fire Fighter No. 3 was not on the ninth floor at this time.

On the afternoon of April 20, the NIOSH team and three members of the fire department investigative team toured the ninth-floor fire scene. A walk through of the ninth floor was conducted; starting with the elevator lobby area, then proceeding to the point of origin of the fire, then following the path of the fire. Next, the suspected path of the fire fighters the night of the incident, was followed to the locations where the victims (two fire fighters and two civilians) were found.
