HETA 98-0300-2723
Dollar General Store
Prestonsburg, Kentucky

Health Hazard Evaluation Report 98-0300-2723
Dollar General Store
Prestonsburg, Kentucky
February 1999

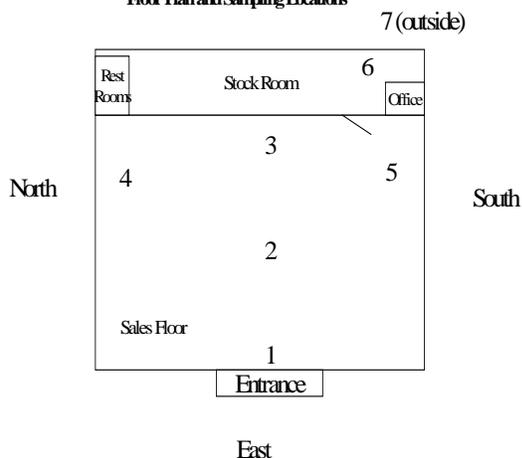
Figure 2: Dollar General Store, Prestonsburg Kentucky. Floor Plan and Sampling Locations

The results of the temperature, RH, and CO₂ measurements are shown in Table 2. The sampling locations and floor plan of the Dollar Store are depicted in Figure 2. On both days sampled, outdoor conditions were optimum (clear, cloudless day). On September 23rd, there were 14-15 people inside the store and between 10-12 people were present during the monitoring on September 24th. On September 24, all measured temperatures were below the American Society of Heating, Refrigeration, and Air-conditioning Engineers (ASHRAE) recommended range (Appendix A, Figure 1). At the time of this

monitoring, the AHU fan was supplying filtered, but otherwise unconditioned (no heating) air to the occupied areas. Adjustments to the AHUs were being made on a periodic basis in an attempt to resolve the odor problem. RH levels in all occupied areas were within acceptable ranges. The CO₂ concentrations in all areas were well below both the 1000 ppm ASHRAE guideline and the proposed guideline of 800 ppm.^{4,5}
