NIOSH HEALTH HAZARD EVALUATION REPORT

HETA #2004-0344-2954

**West Virginia University
Robert C. Byrd Health Sciences Center
Morgantown, West Virginia**

February 2005

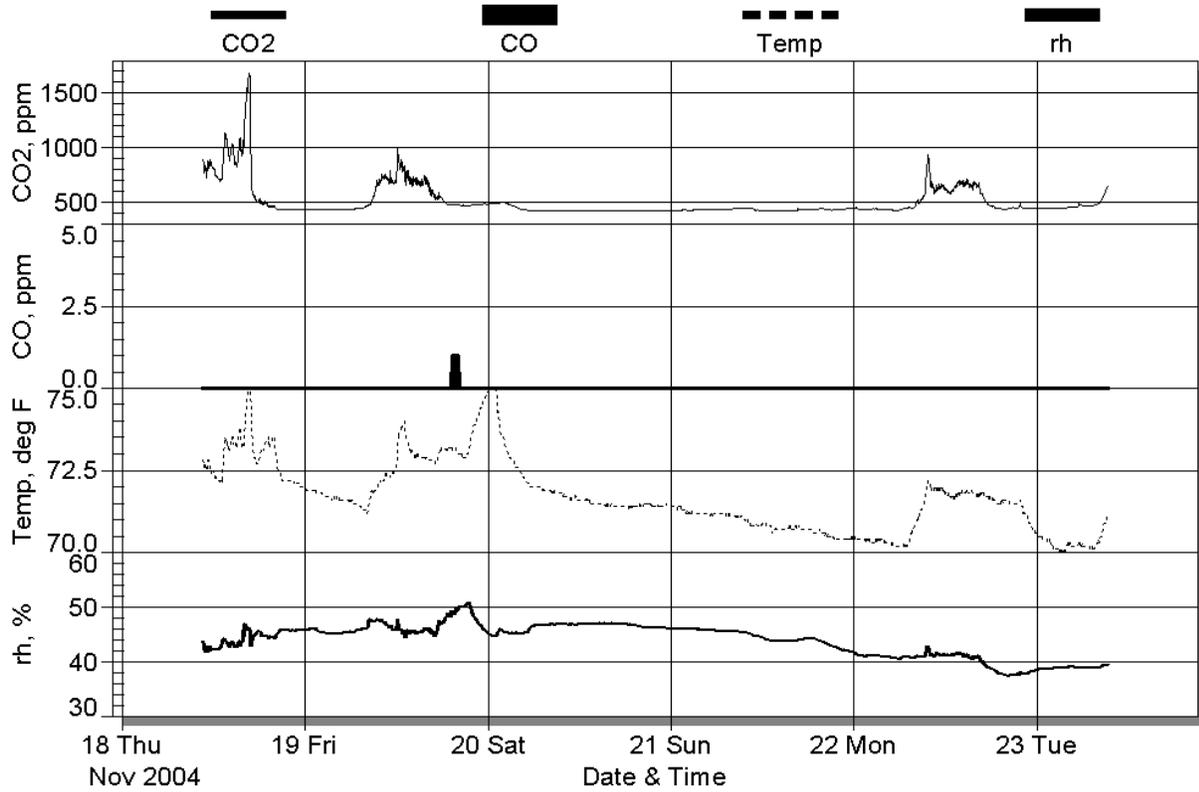
Air quality measurement results collected in the conference room and the clinic hallway are provided in Figures 1 and 2, respectively. Temperature at both monitoring locations was in the range of 70 to 75 degrees Fahrenheit over the five day sampling period and relative humidity ranged from 30 to 60 percent. Carbon monoxide concentrations were very low to non-detectable, i.e., 0-1 parts per million (ppm). Carbon dioxide concentrations ranged from 300 to 1800 ppm in the employee conference room and from 400 to 1000 ppm in the hallway on the clinic side. Neither of the HVAC units that service the Student Health Service draws air from the outdoors. The HVAC unit that services the employee office area appeared to be approximately 10 years older than the unit that services the clinic side.

The elevated levels of carbon dioxide on the office side of Student Health Services exceeded the ANSI/ASHRAE recommendation that indoor carbon dioxide levels be no more than 700 ppm greater than the outdoor concentration.⁴ In most areas of the country, outdoor concentrations are generally in the range of 300 to 350 ppm. Therefore, the usual interpretation of the ANSI/ASHRAE recommendation is a concentration no greater than 1000 to 1050 ppm. The elevated carbon dioxide levels can be attributed to a lack of adequate fresh air in relation to the number of occupants in the space. The Qtrak™ was placed in the conference room as it was a central location on the office side of Student Health Services. Occupants were

Figure 1. Indoor Air Quality Values in the Student Health Service employee conference room.

- If the current HVAC units can be retrofitted to allow for adequate amounts of outside air to be provided to the Student Health Services area, those changes should be made to the system. If the current units are not capable of allowing for outdoor air supply, they should be replaced with units having that capability.
- Relocate the x-ray developer located on the floor above the employee offices or reconfigure the mammography film developer drain system to ensure that additional leakage does not occur.
- Respond to water leaks immediately and provide for thorough methods of discovery for identifying and correcting water damage or mold.
- Re-purpose the two office areas that have experienced substantial lifting of the floor due to subsurface water incursion.

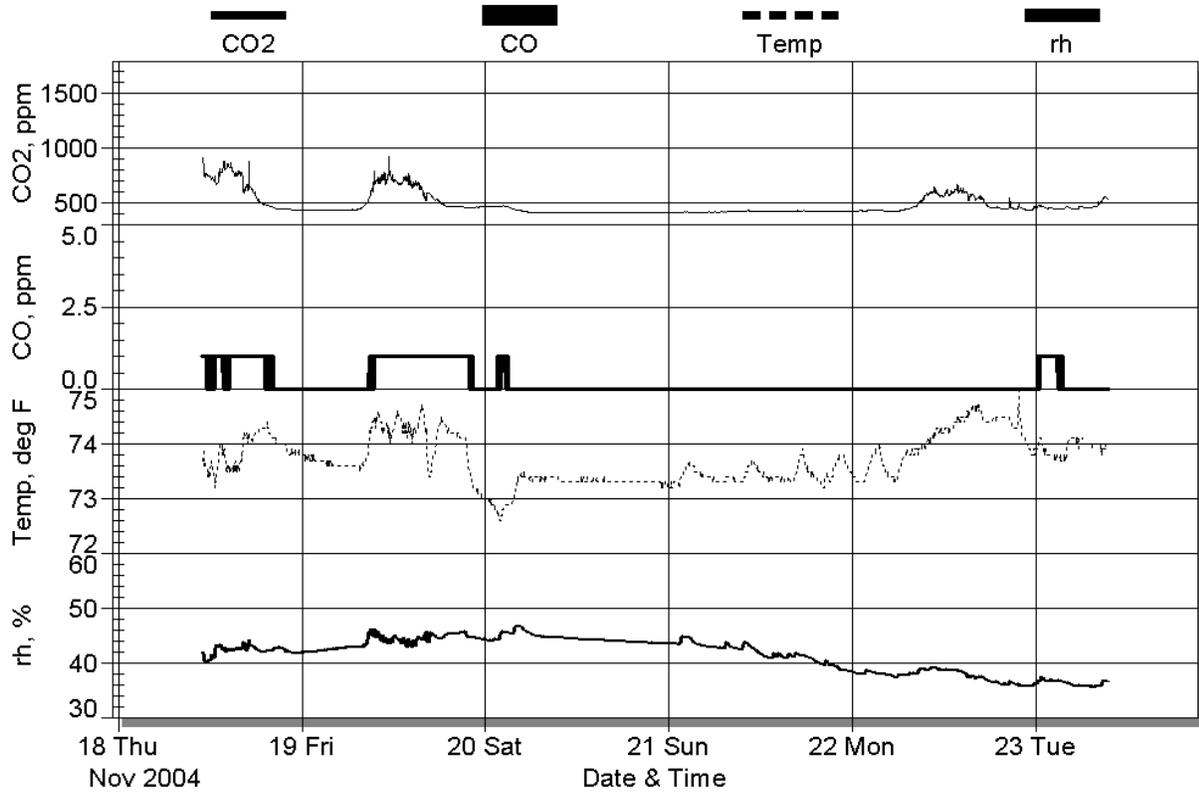
Figure 2. Indoor Air Quality Values in the Student Health Service clinic hallway.
