Evaluation of dampness-associated respiratory symptoms with relocation of staff during remediation of an elementary school

*Rachel Bailey, DO, MPH
Ju-Hyeong Park, ScD, MPH, CIH
Rena Saito, PhD
Kathleen Kreiss, MD
Jean Cox-Ganser, PhD*

Health Hazard Evaluation Report
HETA 2009-0172-3124
North Carolina
March 2011

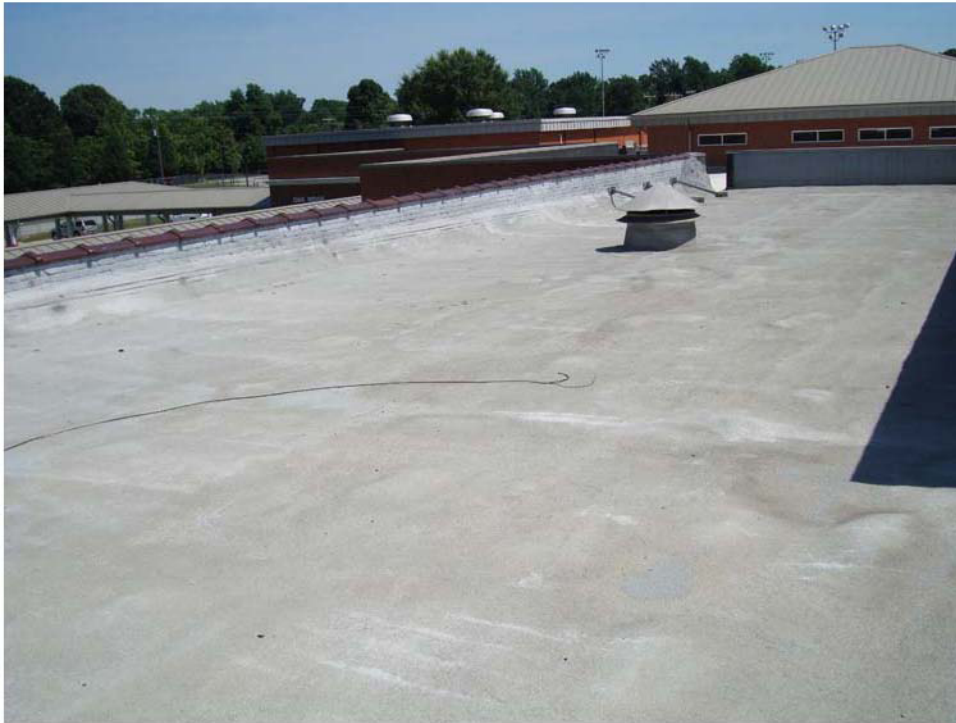
Figure 11. Foam roof over media center wing, July 2009.

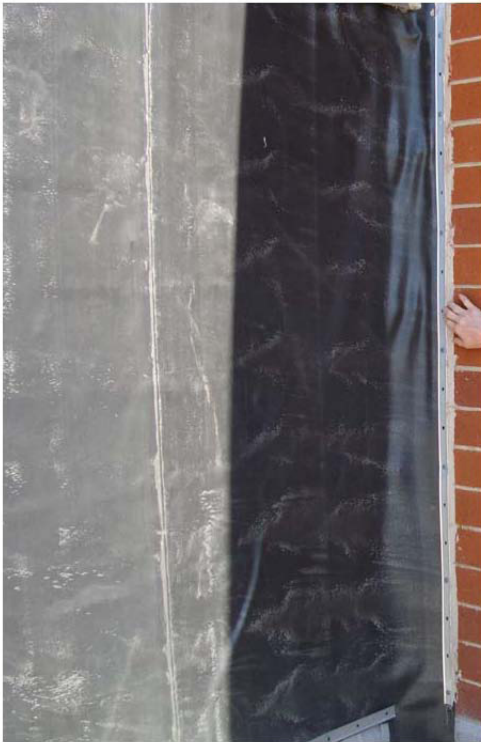
Figure 12. Flashing judged to be inadequate and that appeared to be mounted superficially at the junction between the parapet wall (above room 206) and the gym, July 2009.

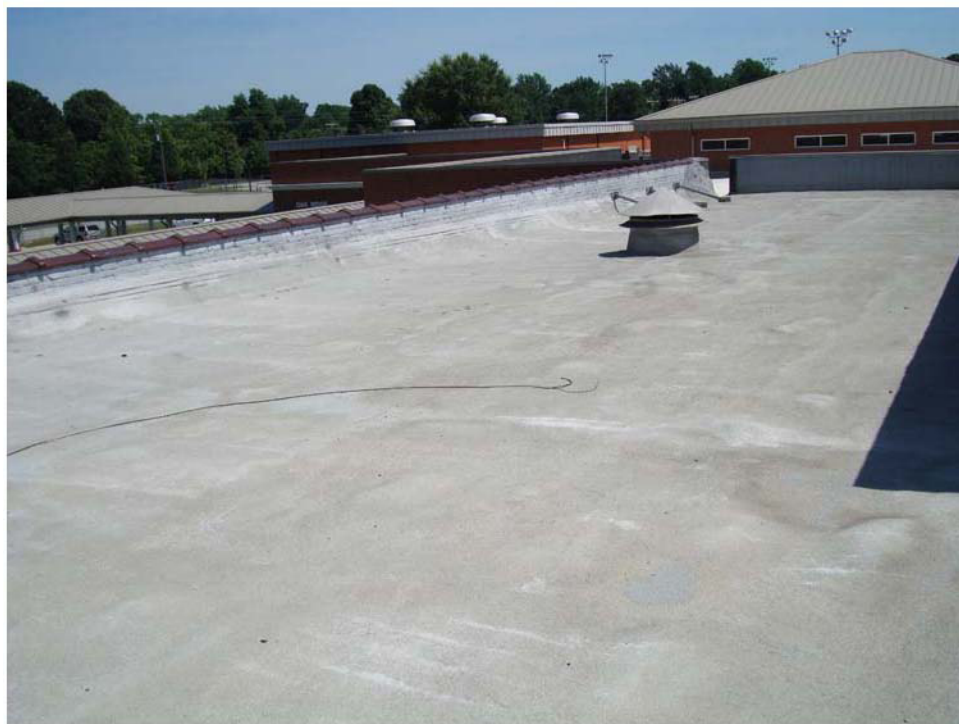
Figure 11. Foam roof over media center wing, July 14, 2009

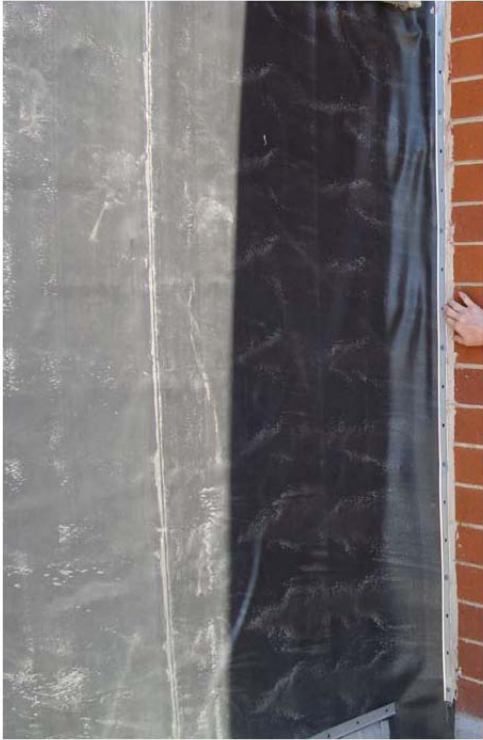
Figure 12. Inadequate flashing that appeared to be mounted superficially at the junction between the parapet wall (above room 206) and the gym, July 14, 2009

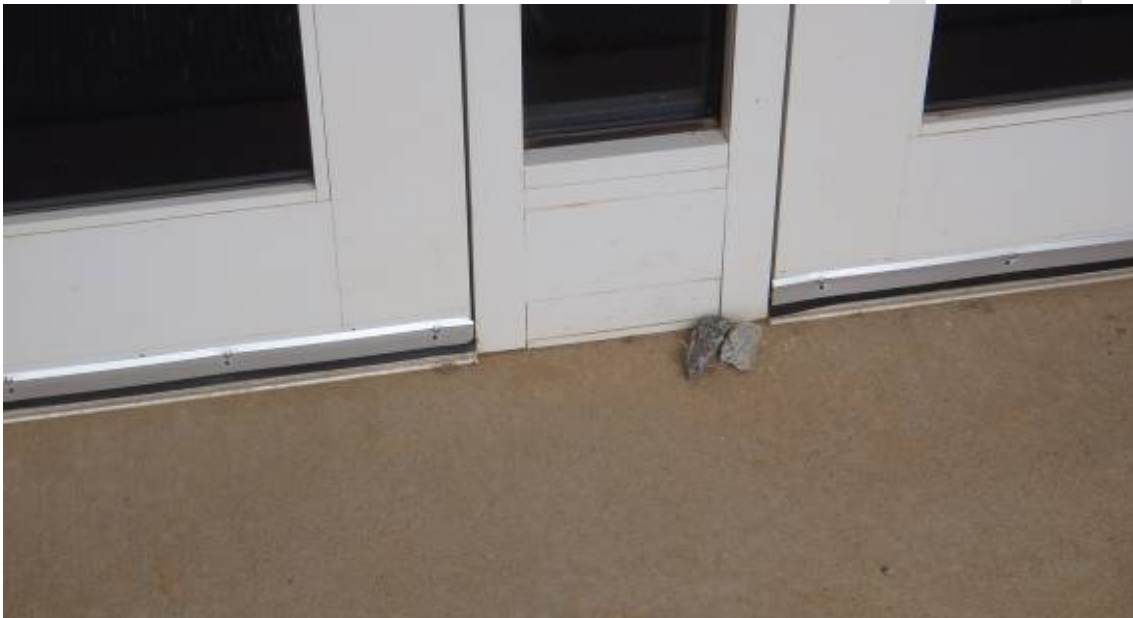
- On 5/6/2010 at approximately 10:30 a.m., classroom 517 was observed while occupied and found to have the outside door propped open and the operable windows open. Outside conditions at the time were approximately 80 degrees and 74% relative humidity. The teacher in this classroom, Mrs. Jones informed EMC that she had been instructed by the principal, Ann Kraft to open the door and windows.
- All hallway doors leading to the outside were closed, however a number of these doors had a rock or some other heavy object located by the door opening. Discussion with various Oak Ridge school personnel indicated that these were used to prop the doors open at times. The following photographs were taken of doors where these objects were found:

Figure 1 - Rocks found at double doors at east-end of 400 hallway

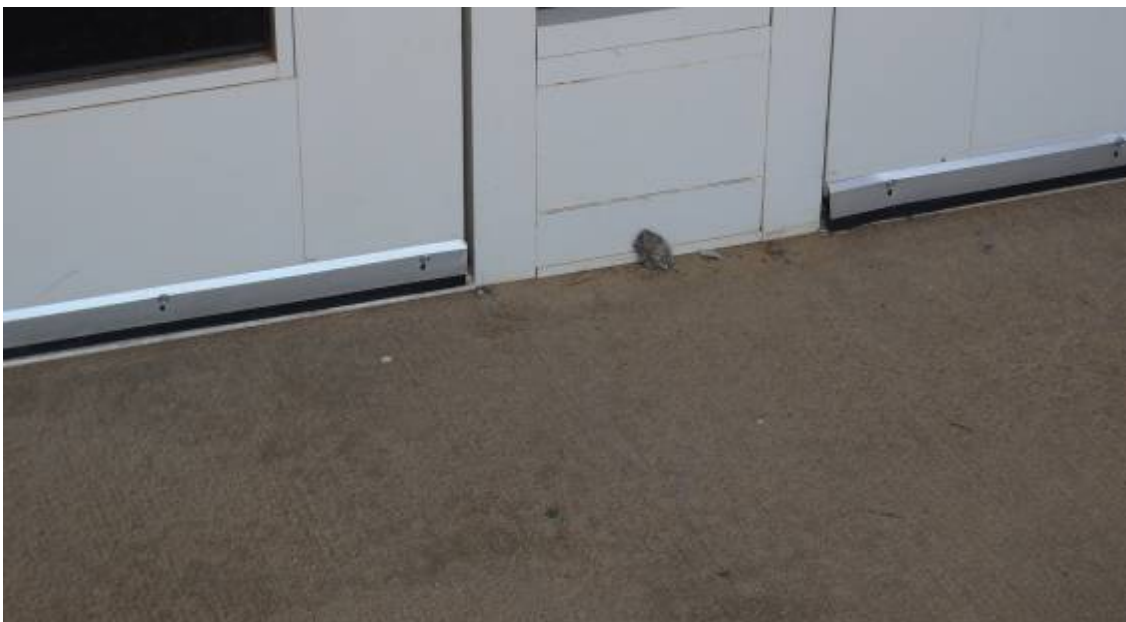
Figure 2 - Rock found at double doors at north-end of 600 hallway

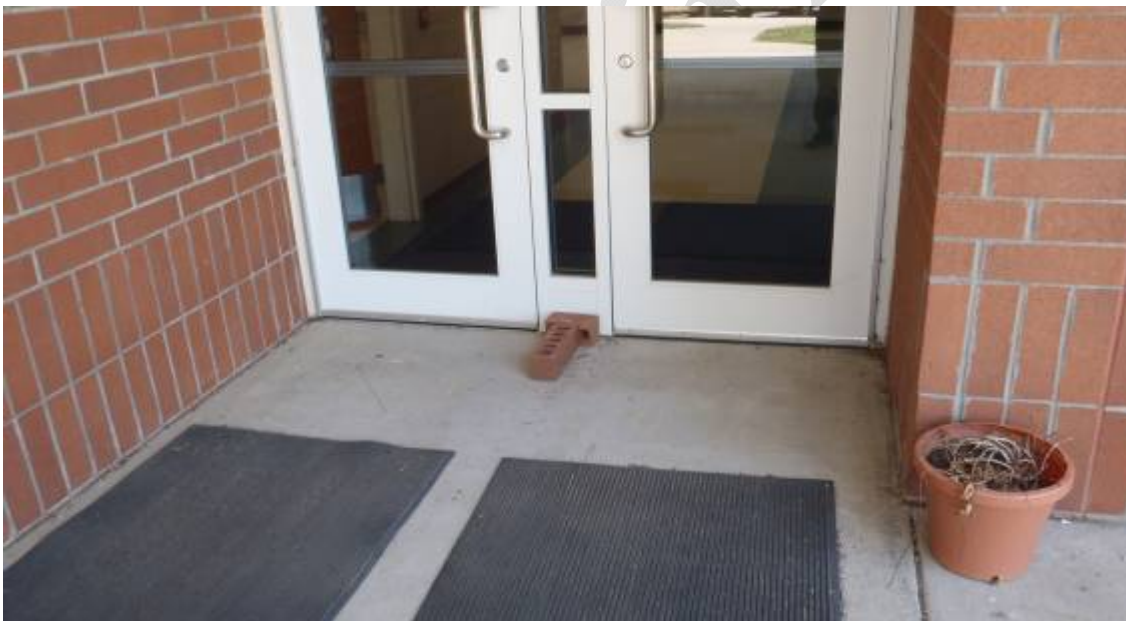
Figure 3 - Bricks found at double doors at middle of east-side of 600 hallway

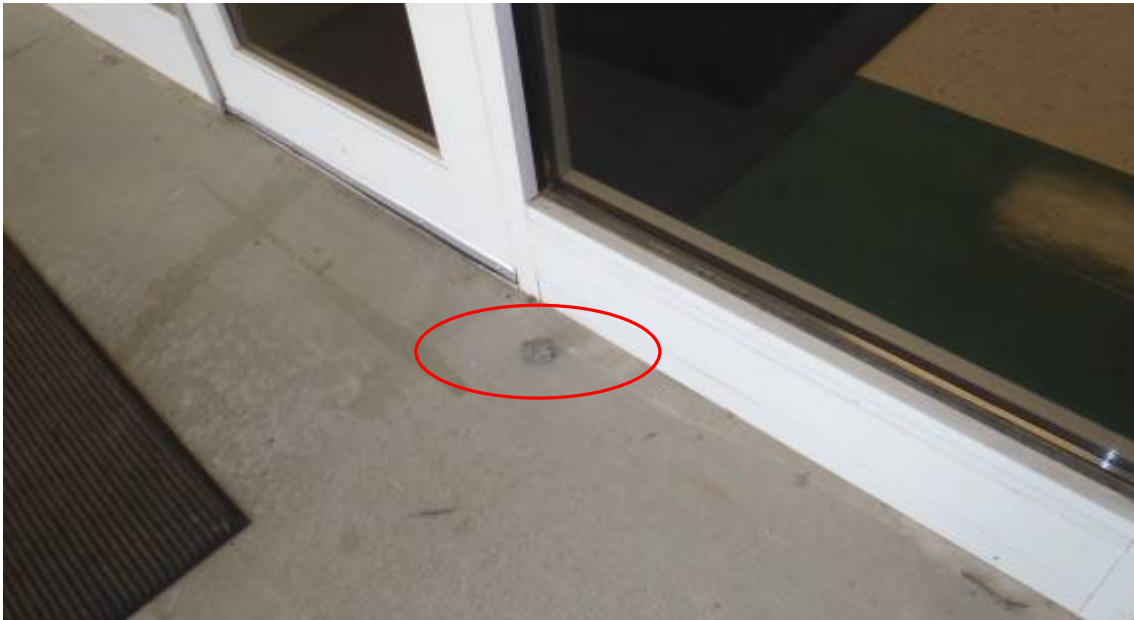
Figure 4 - Rock found at door on Linville Road side of main hallway

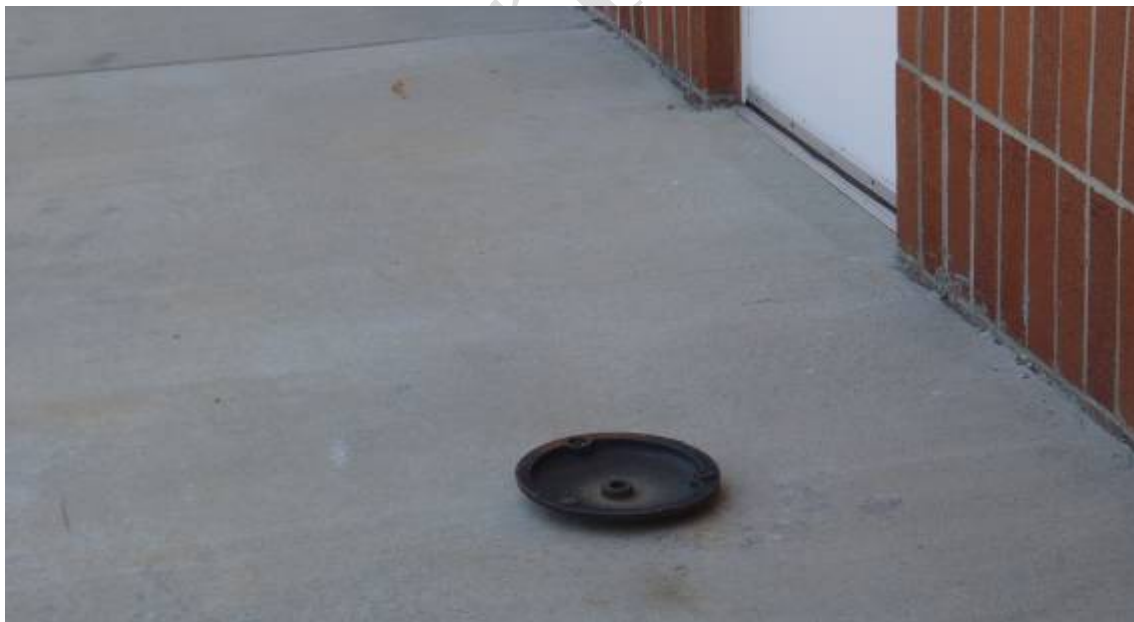
- Other classroom outside doors were found to have either a rock or another heavy object located beside them, which have also been used to prop these doors open. These are shown in figures 5 and 6.

Figure 5 - Microphone stand base found outside classroom 407 outside door

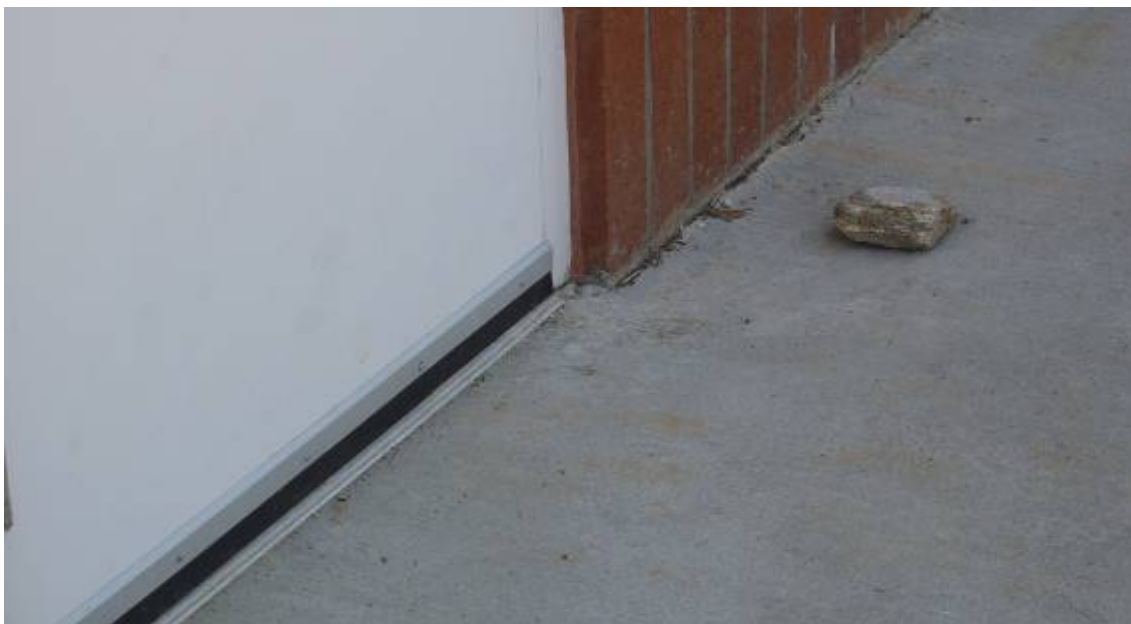
Figure 6 - Rock found beside outside door of room 505

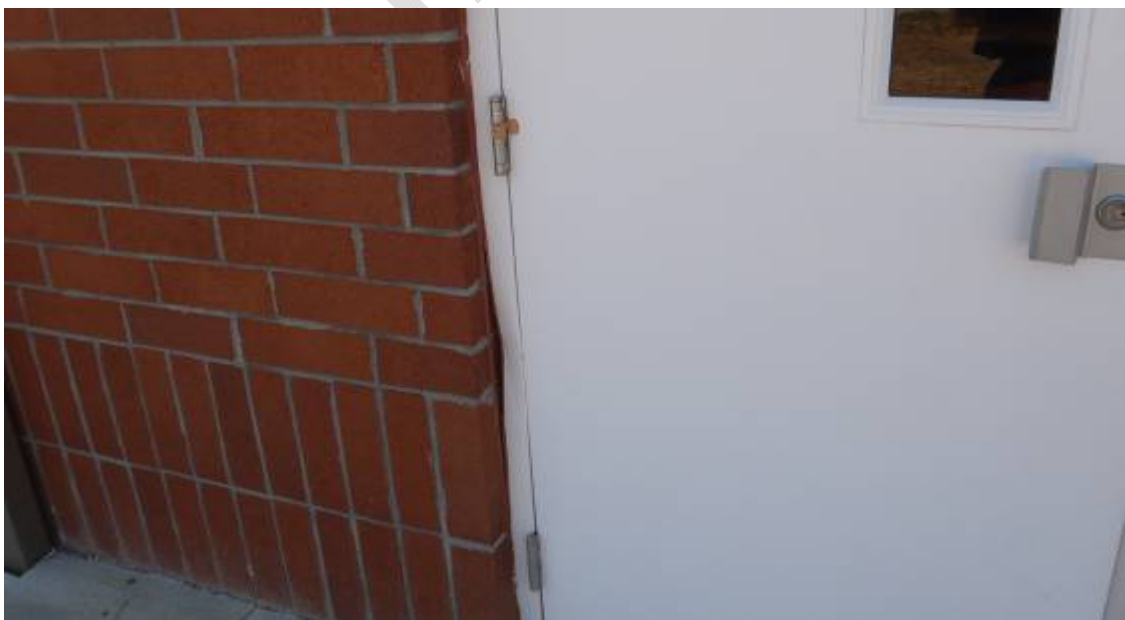
- Figure 7 shows the outside door to classroom 521, and the door frame which has been badly damaged. The resulting misalignment of the door now requires deliberate action to pull the door shut to the point of latching. Figure 8 shows the door sweep and the spot the door is dragging on as a result of the door misalignment. There is a large open area when the door is not pulled shut shown in figure 9, which not only allows conditioned air to escape the room, but also has the potential to allow unauthorized access to the school if the door is not latched.

Figure 7 – Frame of outside door to classroom 521 damaged

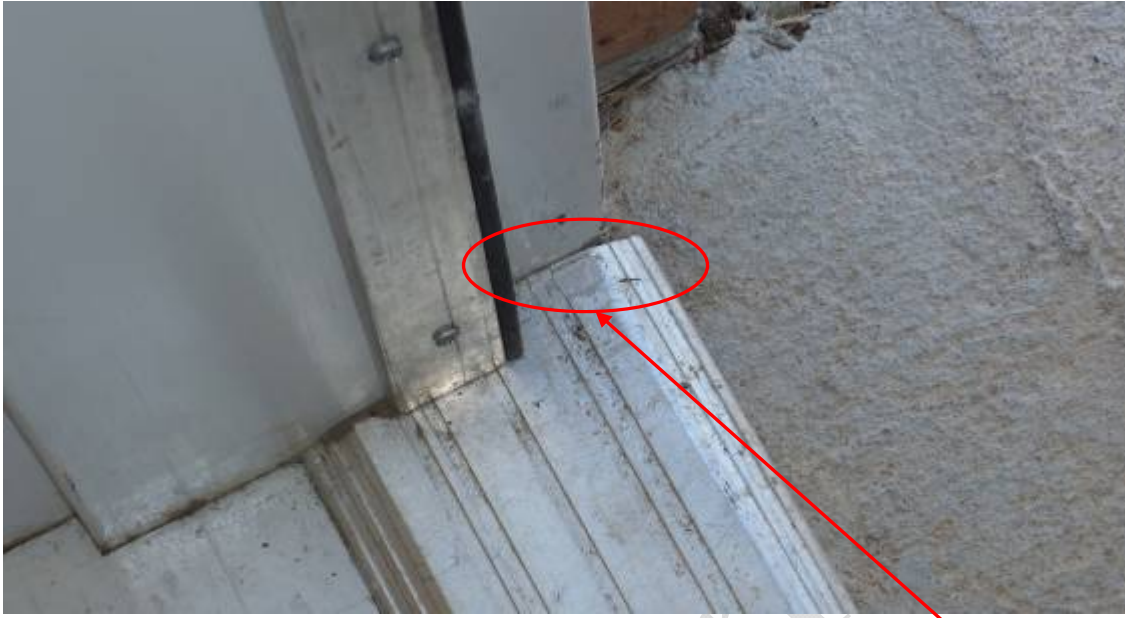
Figure 8 – Outside door of classroom 521 dragging on threshold

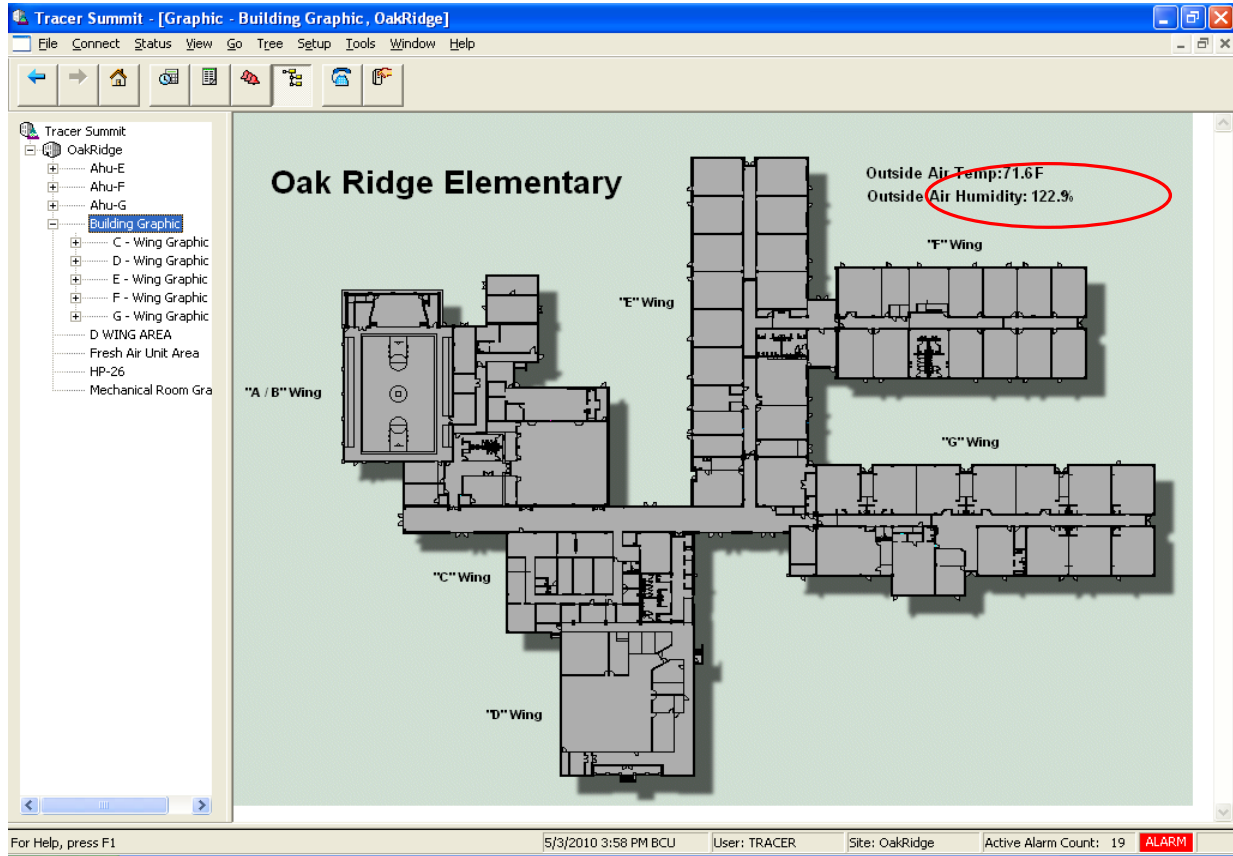
- The outdoor Air Humidity sensor connected to the BAS was found to be reading incorrectly. Using a calibrated test instrument, outdoor humidity at this sensor was found to be 74%, while the BAS reading showed 122.9%

Figure 10 - Outdoor Air Humidity reading 122.9% RH

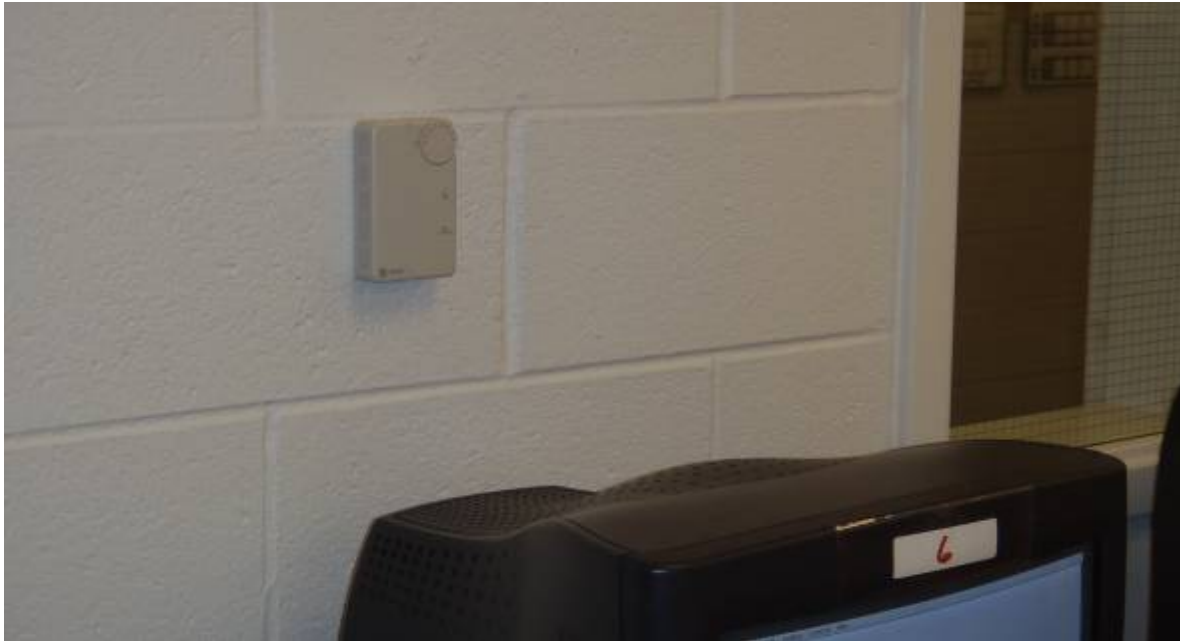
- Classroom 501, located on the BAS graphic screen does not have a link to HP-48.
- A computer monitor (CRT) was found to have been placed directly beneath the thermostat of HP-55, in classroom 401 (Figure 11). The heat generated by the CRT was directly influencing the thermostat and keeping the room much colder than the BAS setpoint.

Figure 11 - CRT directly beneath thermostat in classroom 401

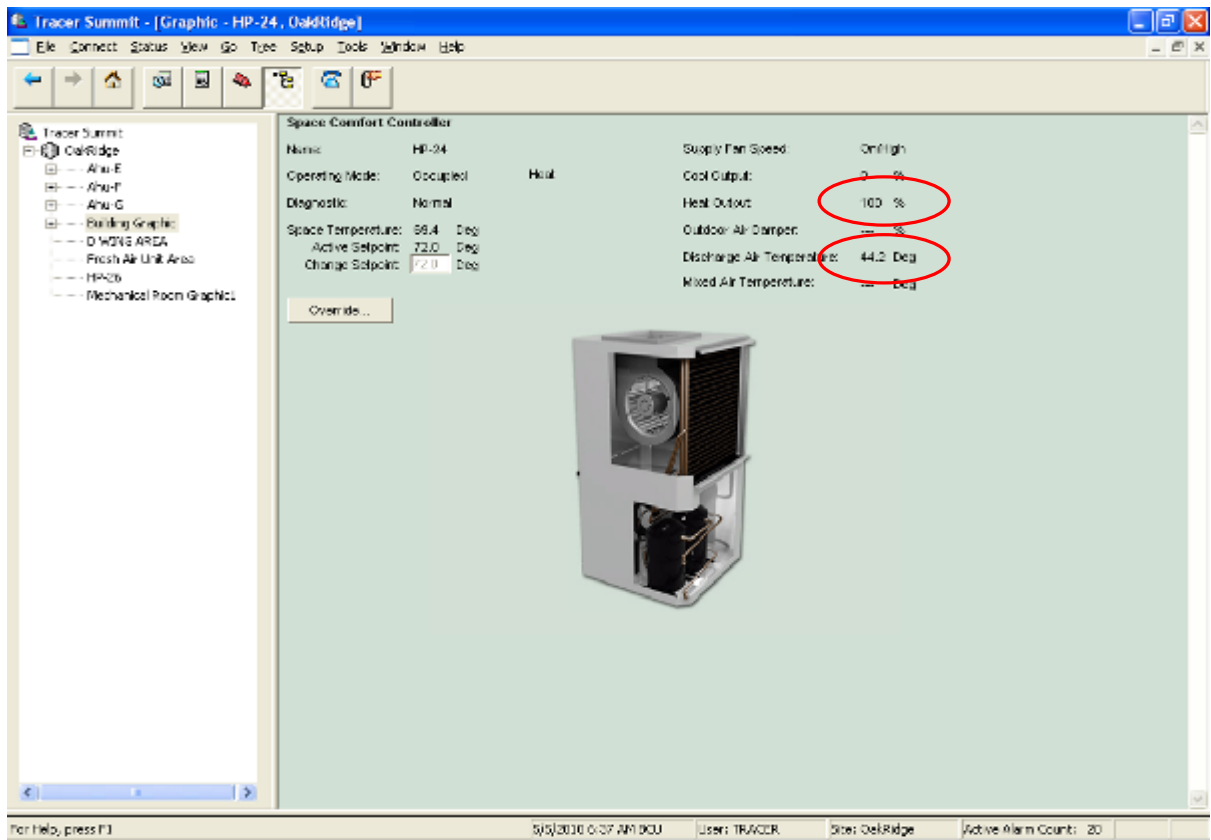
- HP-24 was found to constantly energize its reversing valve, thereby causing the unit to continually produce cold air. Temporarily altering the setpoints caused the heat pump controller to change to heating mode, however discharge air temperature remained at levels consistent with cooling operation. The reversing valve was tested and found to be operating properly, however the heat pump controller is constantly energizing the reversing valve.

Figure 12 - HP-24 heat output @ 100%, but discharge air temp. @ 44.2 deg F.

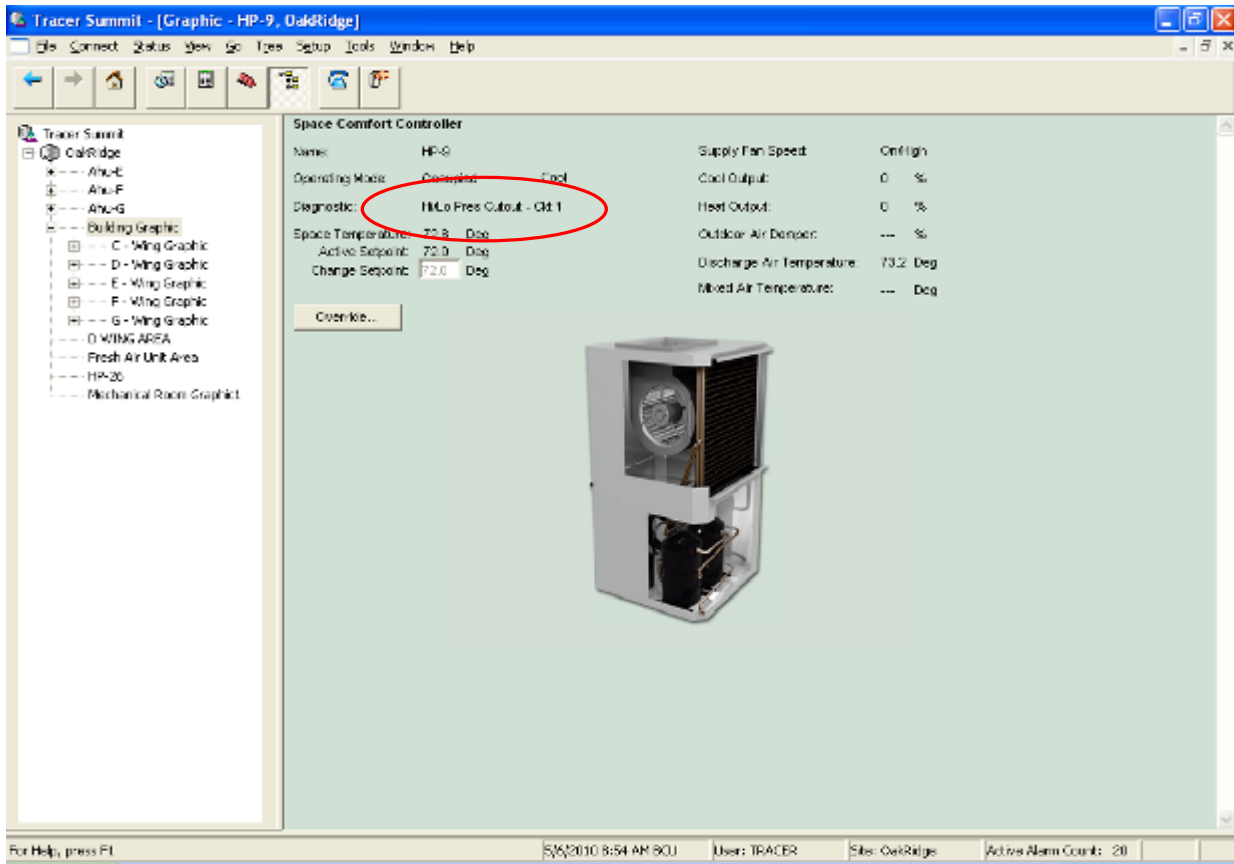
- HP-9 circuit #1 was found to be off on the low refrigerant pressure switch. Subsequent investigation by GCS personnel revealed that this circuit's refrigerant charge had escaped.

Figure 13 - HP-9 low pressure safety cutout

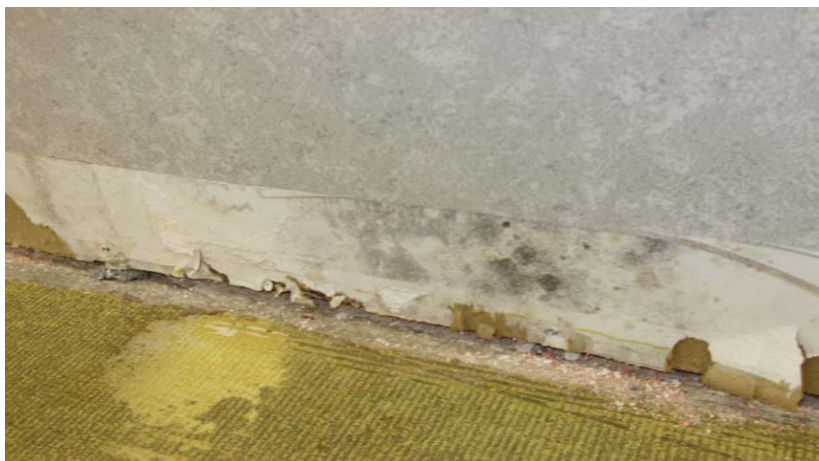
FINDINGS FROM EXPLORATORY AND
BASE COVE WORK

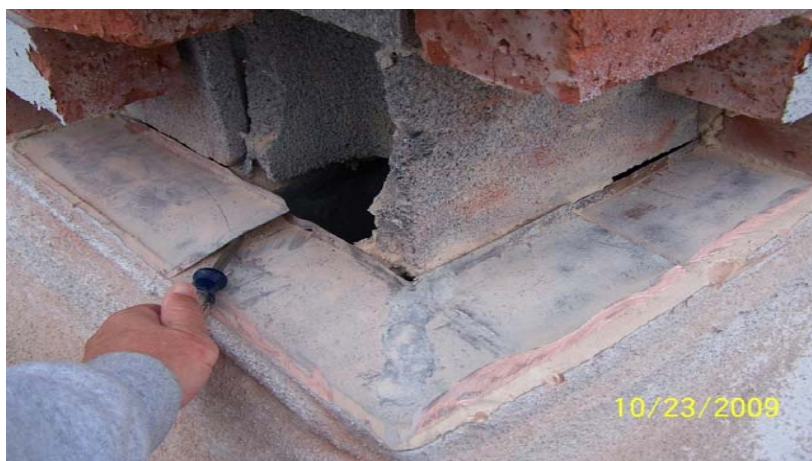
PROBLEMATIC ROOF FLASHING

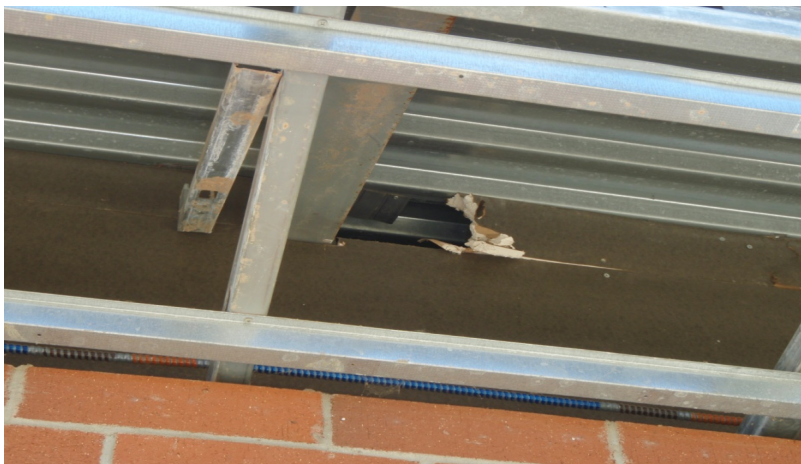
PROBLEMATIC SOFFIT CONDITIONS

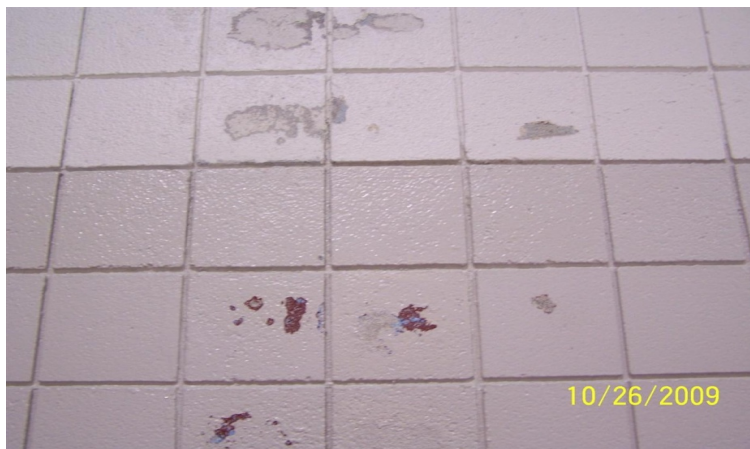
**MOISTURE INTRUSION ON GYM
WALL**

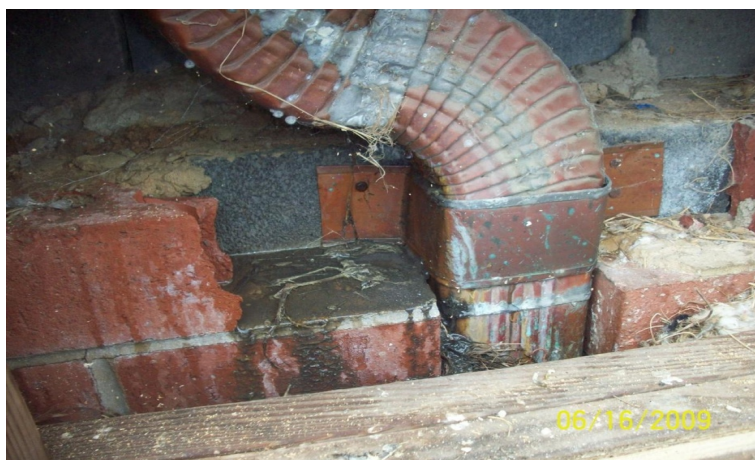
**DAMAGED DRAIN CAUSING MOISTURE
INTRUSION**

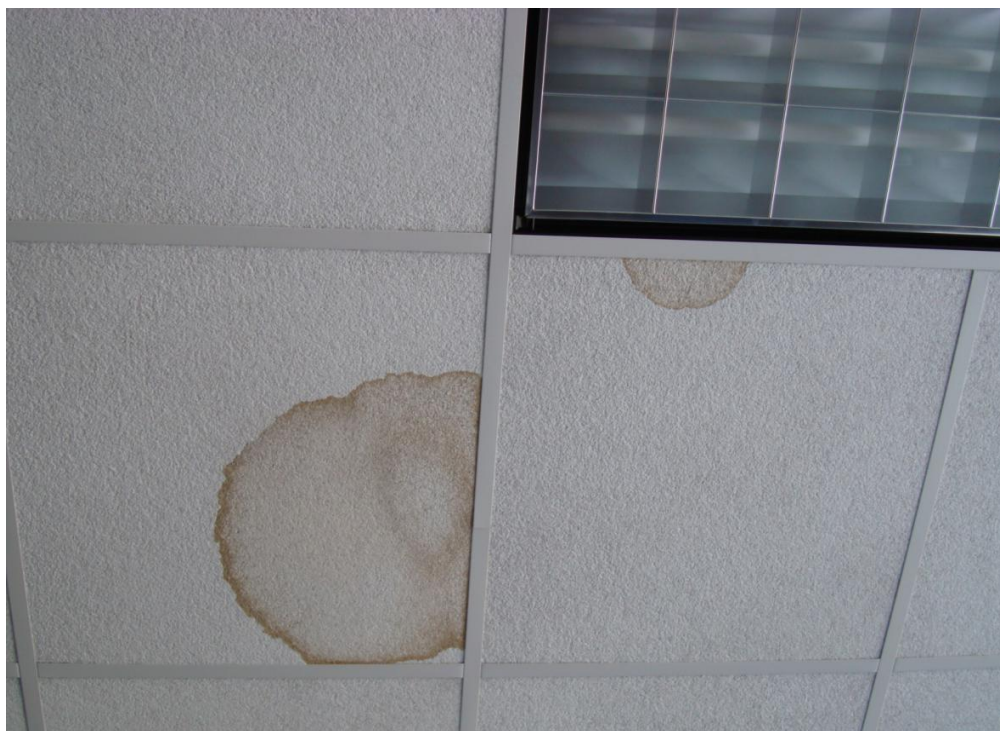
Picture of stained ceiling tiles. These two stains were the only stains observed on the entire ceiling in this room. If there were other areas of damage/stain, visible mold, or damp/wet conditions, you would also combine the size of those areas for one score for the entire ceiling.

The damage to this ceiling area appears to be somewhat extensive. A score for this would be a 2 because both stains together are bigger than the size of the assessment form but smaller than a standard interior door.

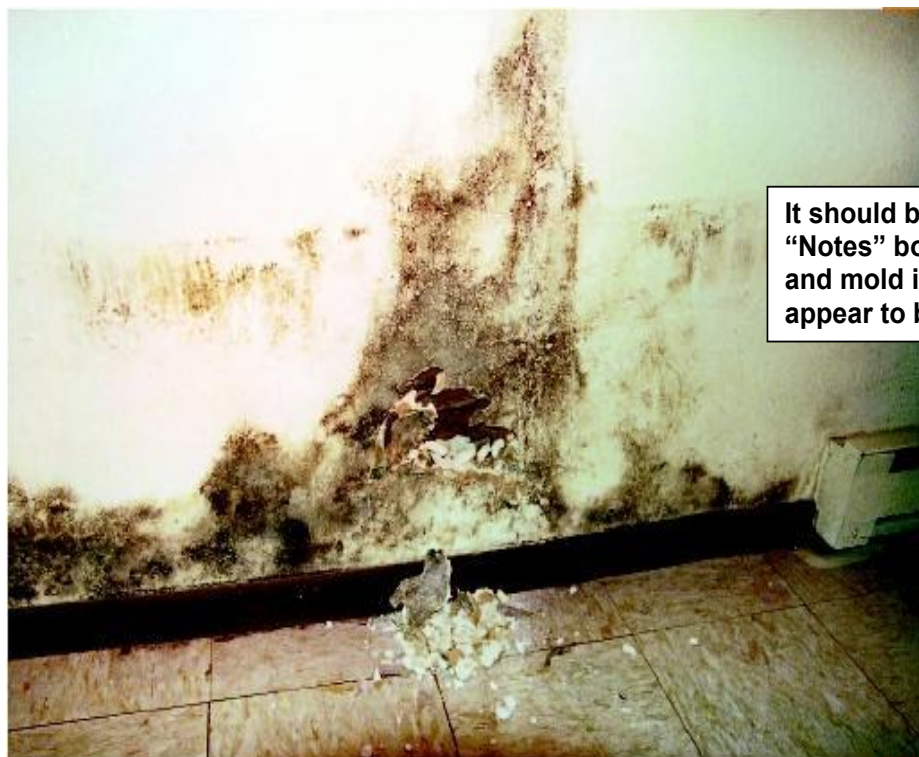
Picture of wall and floor. This area of wall damage and mold is the only problem area observed on all the walls in this room. If there were other areas of damage/stain, visible mold, or wet/damp conditions, you would also combine the size of those areas for one score for all the walls in the room.

It should be noted in the "Notes" box that the damage and mold in this example appear to be severe.
