Evaluation of indoor environmental quality at an accounting office

Health Hazard Evaluation Report

HETA 2011-0096-3176

April 2013

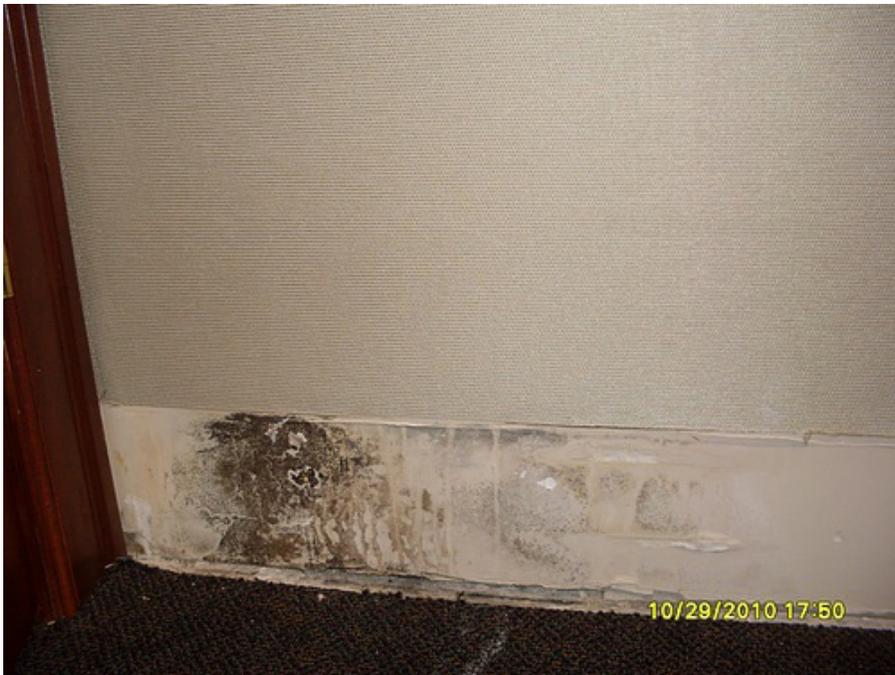
Figure 13. Suspect mold in Room 3 at base of wall shared with Hall 5, October 2010 (picture courtesy of building manager).

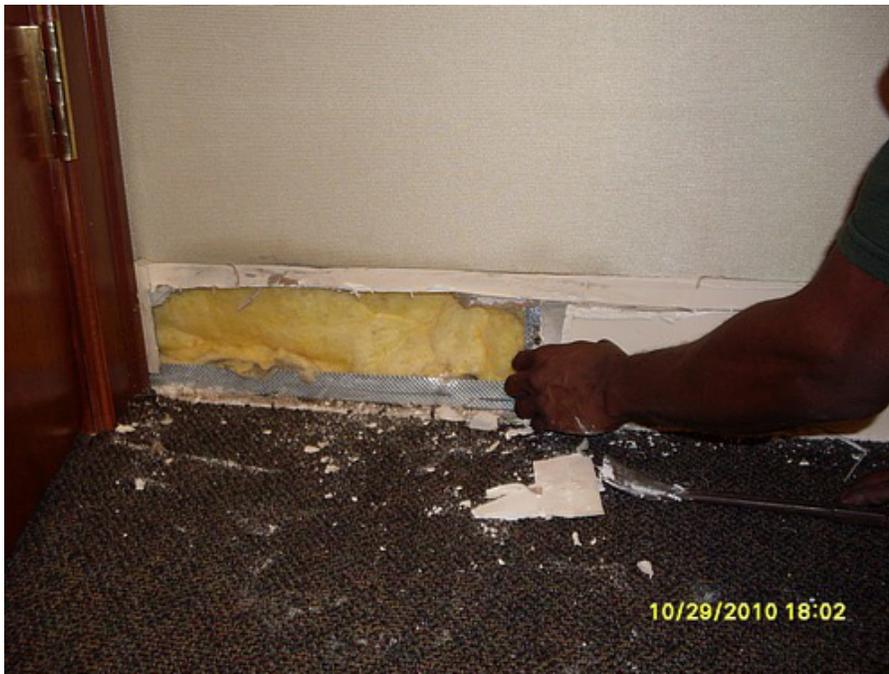
Figure 14. Suspect mold-damaged drywall removed in Room 3 at base of wall shared with Hall 5, October 2010 (picture courtesy of building manager).

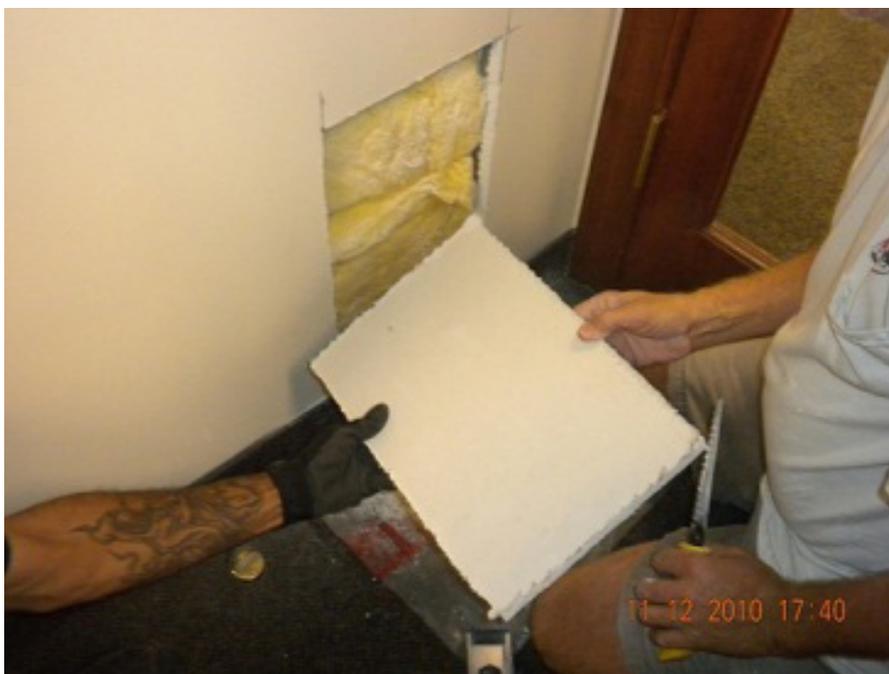
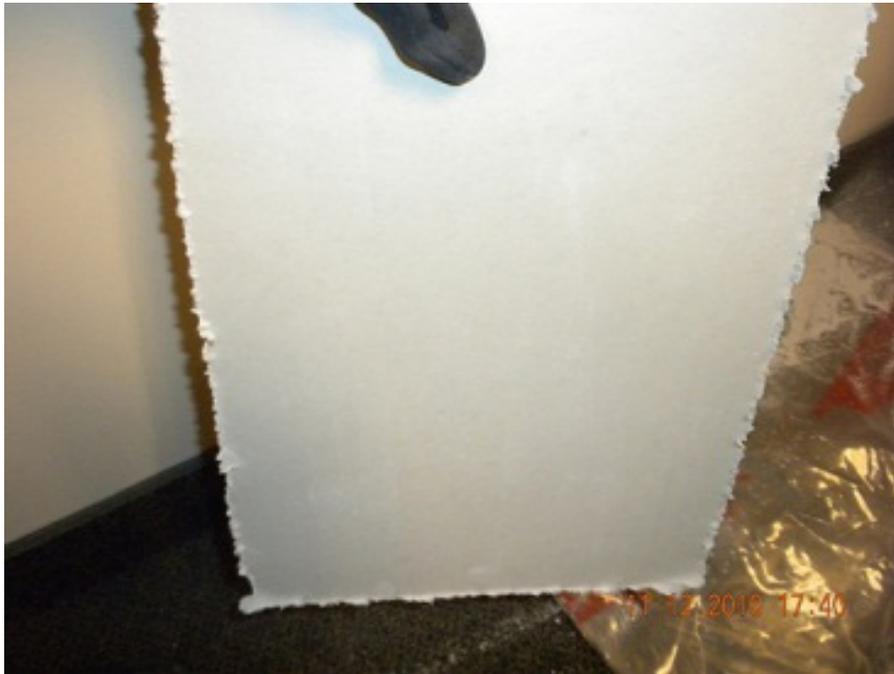
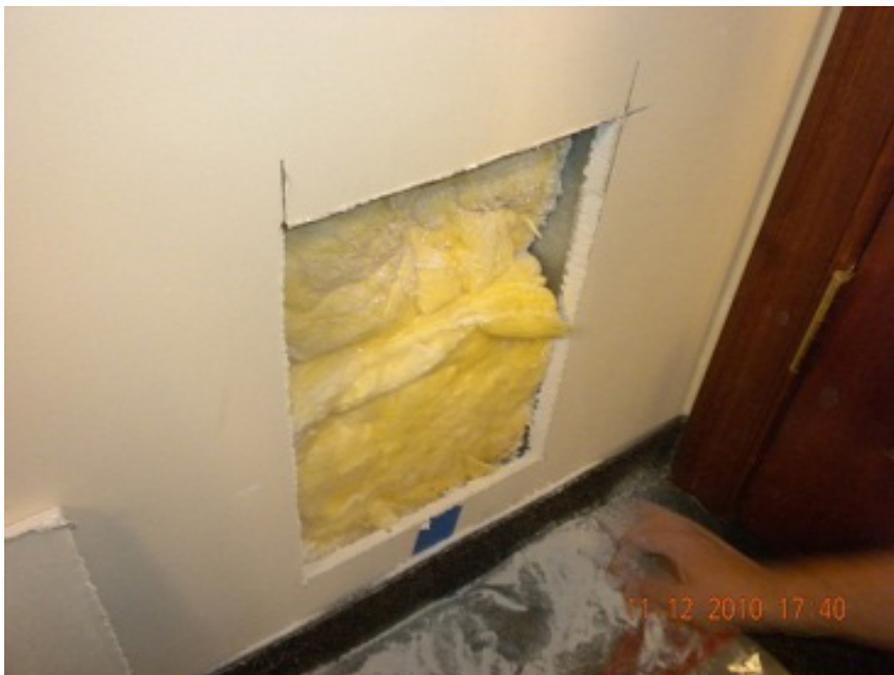
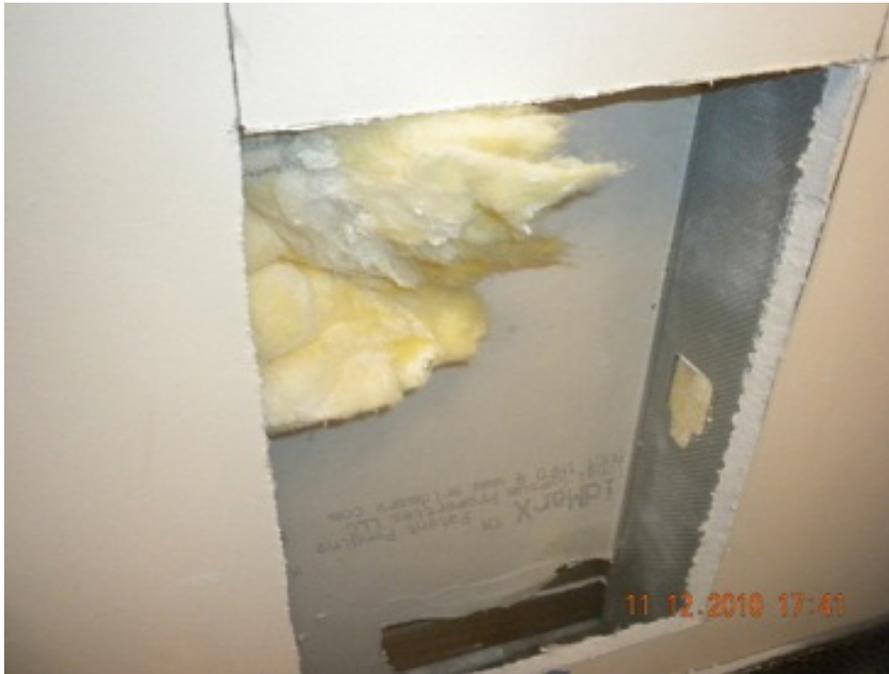
In October, the building manager inspected the wall between Hall 5 and Room 3. We were told by building occupants that a plugged AHU-1 condensate drain caused water to leak into the wall. The building manager replaced the baseboard in room 3 along the wall shared with Hall 5, and suspect mold was found (Figure 13). The damaged section of the drywall was removed (Figure 14), and the baseboard was replaced. In November, a large section hole was cut near the base of the Hall 5 wall shared with Room 3. No visible mold was found (Figures 15-18).

Figure 15. Wall cavity inspection inside Hall 5 wall shared with Room 3, November 2010 (picture courtesy of building manager).

Figure 16. Wall cavity inspection, November 2010 (picture courtesy of building manager).

Figure 17. Wall cavity inspection inside Hall 5 wall shared with Room 3, November 2010 (picture courtesy of building manager).

Figure 18. Wall cavity inspection inside Hall 5 wall shared with Room 3, November 2010 (picture courtesy of building manager).

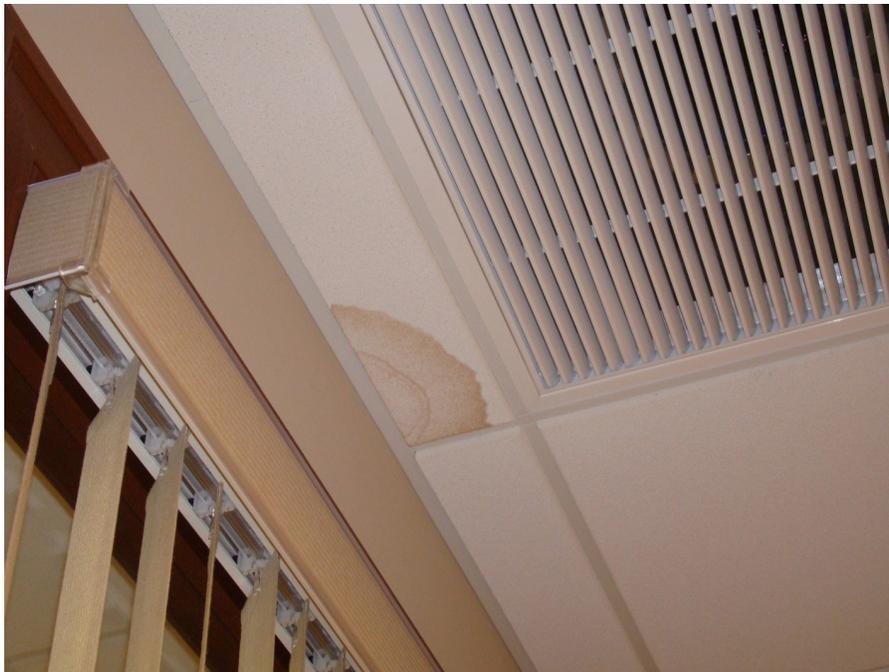
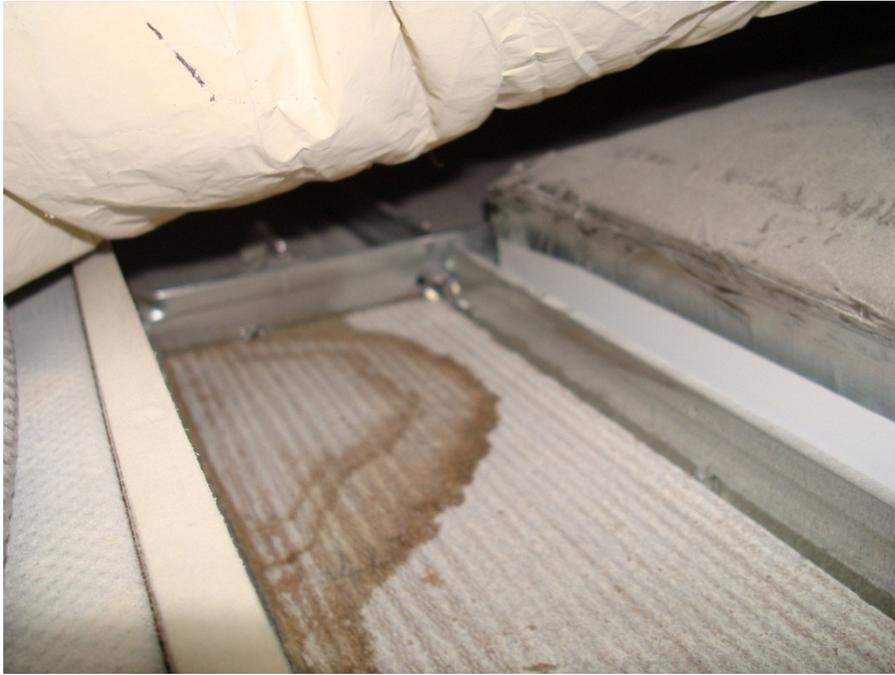
We observed stained ceiling tiles in Room 23 and the adjoining hallway (both at the shared wall) and Rooms 28, 32, and 37. Investigation of the sources indicated that the stains in Room 23 (Figures 19 and 20) and the adjoining hall were likely associated with the penetration area of an AHU-5 duct through the roof. The Room 37 stain was under a roof drain penetration (Figures 21 and 22). A small nail-sized hole in the metal roof panel was located directly above the stained tile in Room 28, and the stain in Room 32 was under a roof lap joint.

Figure 19. Ceiling stain in Room 23, June 2011.

Figure 20. Top of stained ceiling tile in Room 23, June 2011.

1. Determine water source for ceiling stains and repair any defects leading to water intrusion or leaks.
2. Replace stained ceiling tiles.

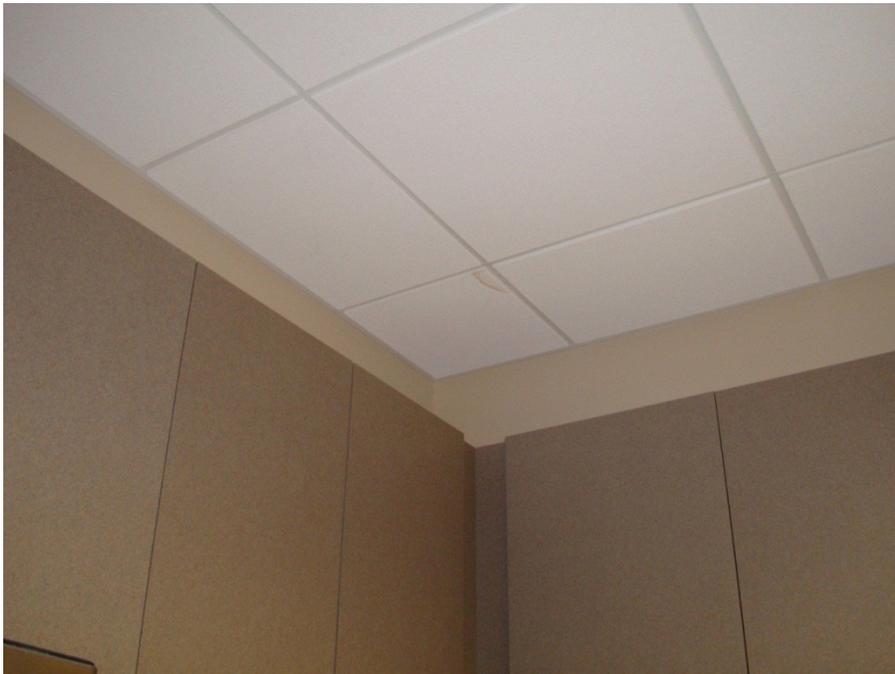
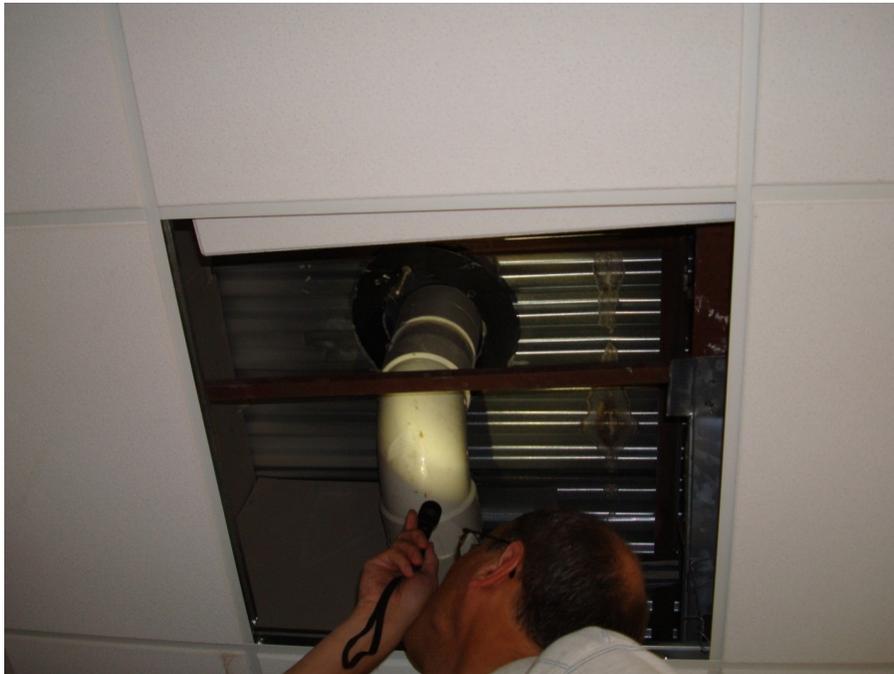
Figure 21. Ceiling stain in Room 37 (kitchen), June 2011.

Figure 22. Roof drain above ceiling stain in Room 37 (kitchen), June 2011.

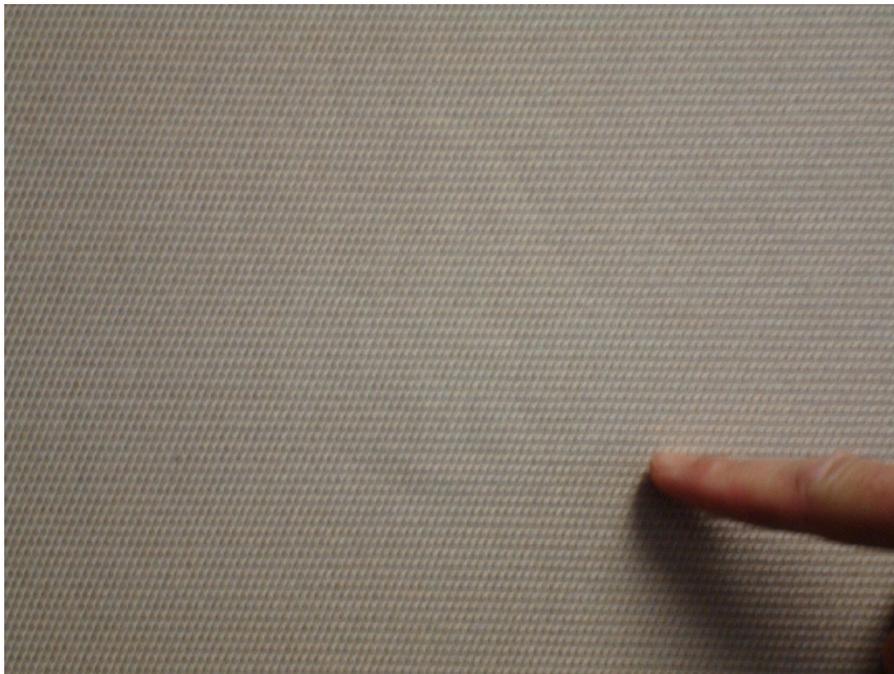
In Room 3, on the wall shared with Hall 5, there was a raised area of the cloth wall paper from the ceiling down that was likely from the water leak that had previously occurred (Figure 23). In Room 19, we observed water stains and blistering paint on the window sill (Figures 24 and 25). By the middle exterior door in Hall 11, we observed vertical water drip marks on the bottom half of the wall shared with Room 10 (Figure 26) that may have come from rain water falling from clothes and/or umbrellas as people enter.

Figure 23. Raised area of cloth wall paper in Room 3, June 2011.

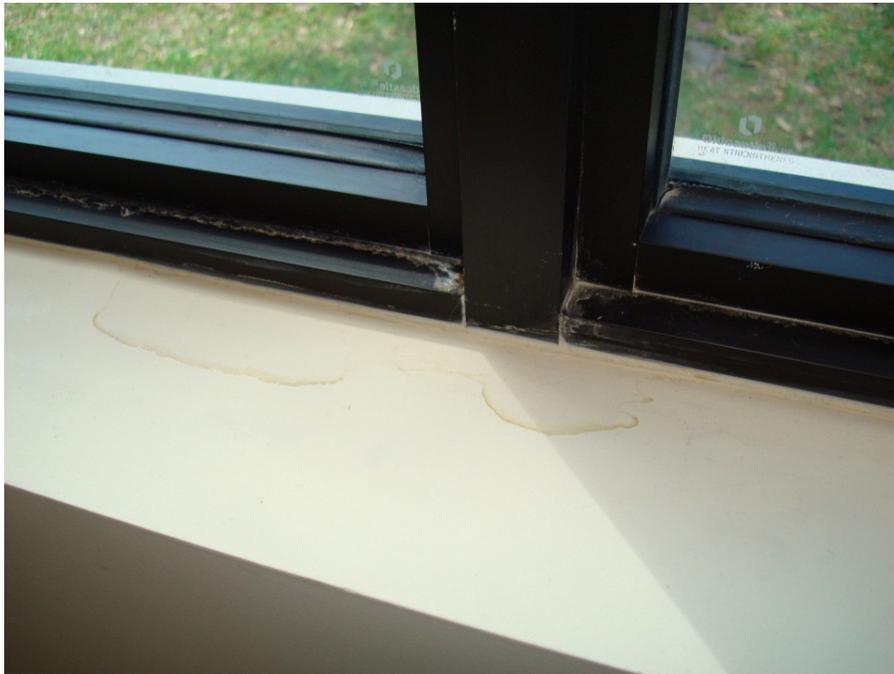
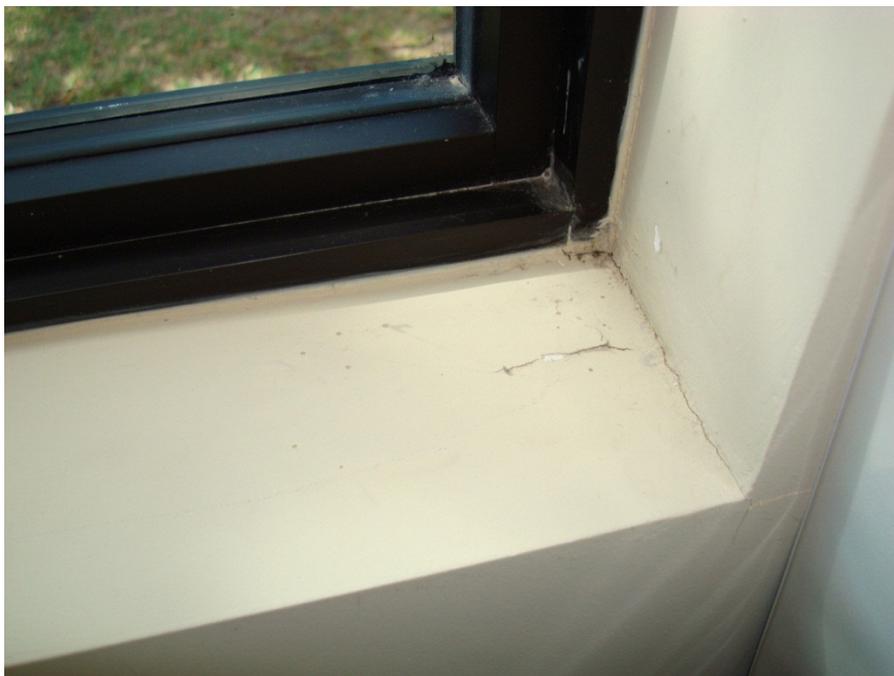
A consultant in June 2010 noticed no odors during his investigation. He reported moisture in the drywall at the bottom right corner of the window in Room 19 and recommended removal of a one foot section of the damaged window sill. He also noted water stains on the interior side of the roof assembly without ceiling tile staining. Low-efficiency filters were in some of the air handlers. Indoor RH measurements were 58%–61%. Concentrations of fungal spores found in indoor air were equal to or lower than outdoors. The consultant also reported visible mold growth (confirmed by microscopic analysis) in some of the air handlers, as well as some with insulation that was wet to the touch. Surface samples taken from ducts at the AHUs identified a large quantity of mold spores, hyphae, and black opaque particulates. He also found similar black opaque particulates on some horizontal surfaces inside the building and noted they were not consistent with typical indoor dust but probably came from outside, and they may have been contributing to the odor and symptoms described by the employees.

Figure 24. Water stains on window sill in Room 19, June 2011.

Figure 25. Blistered paint on window sill in Room 19, June 2011.

We had a teleconference with industrial hygiene consultants hired by the building owner/management company; we reviewed our findings and recommendations and provided our carpet sampling protocol. In a letter from the building management company, dated August 8, 2011, it was reported that the window leak in Room 19 was repaired.

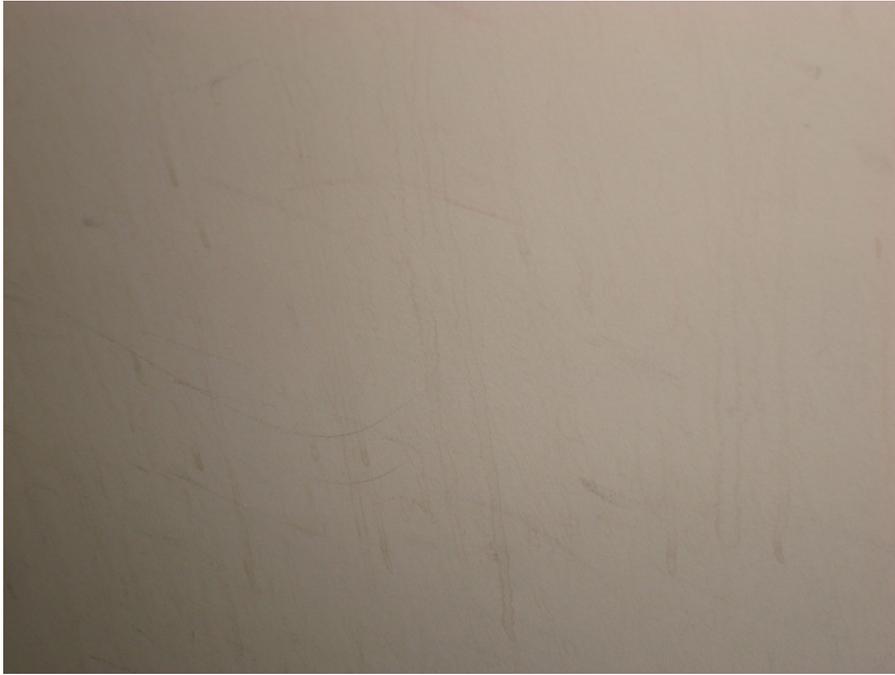
Figure 26. Vertical water marks on wall under window in Hall 11, June 2011.

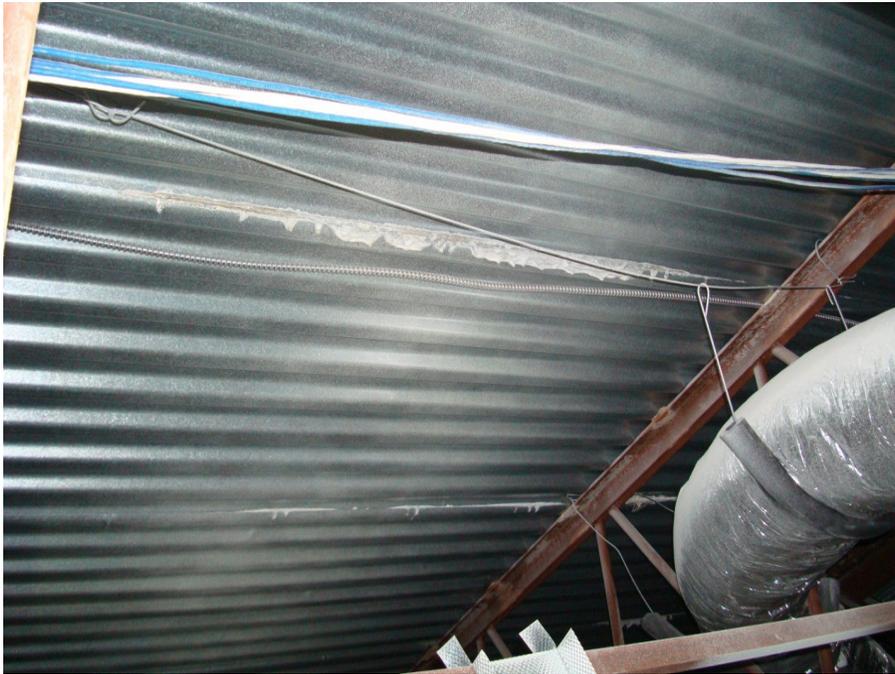
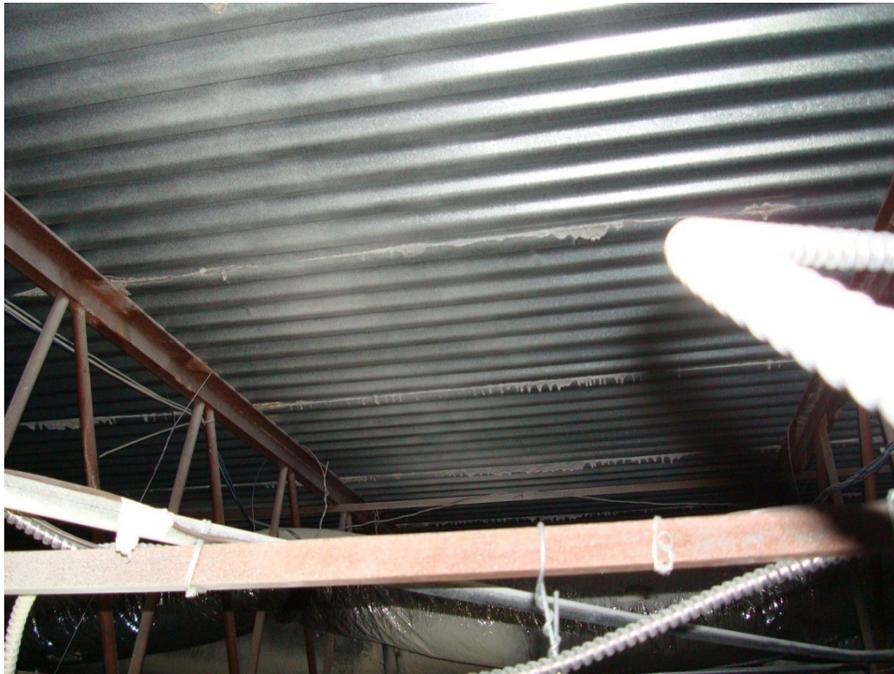
In the ceiling plenum, we saw the cement-like roof insulation material, noted in previous reports that appeared to have oozed out from some roof lap joints during construction (Figures 27 and 28). Some of the roof lap joints had rusty stains, but none appeared to be wet (Figures 29 and 30). The HVAC flexible ducts appeared to be tightly fitted to main trunk lines and supply and return grilles; however, some of the flexible ducts probably had reduced air flow from being crimped by wire hangers (Figure 10). A coating of fine dust was seen on most of the trusses, ducts, and pipes in the

Figure 27. Roof lap joints inside ceiling plenum, June 2011.

Figure 28. Roof lap joints inside ceiling plenum, June 2011.

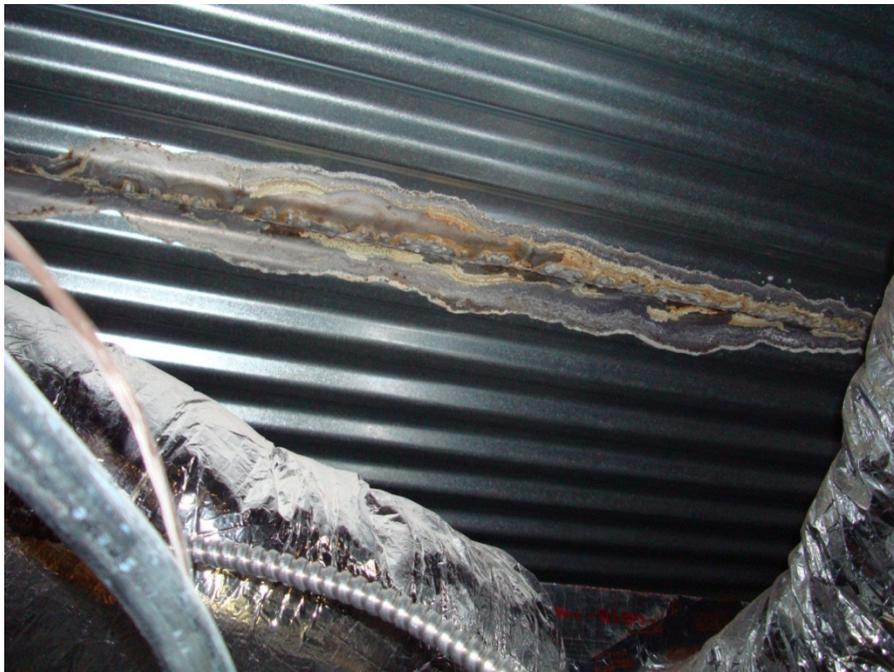
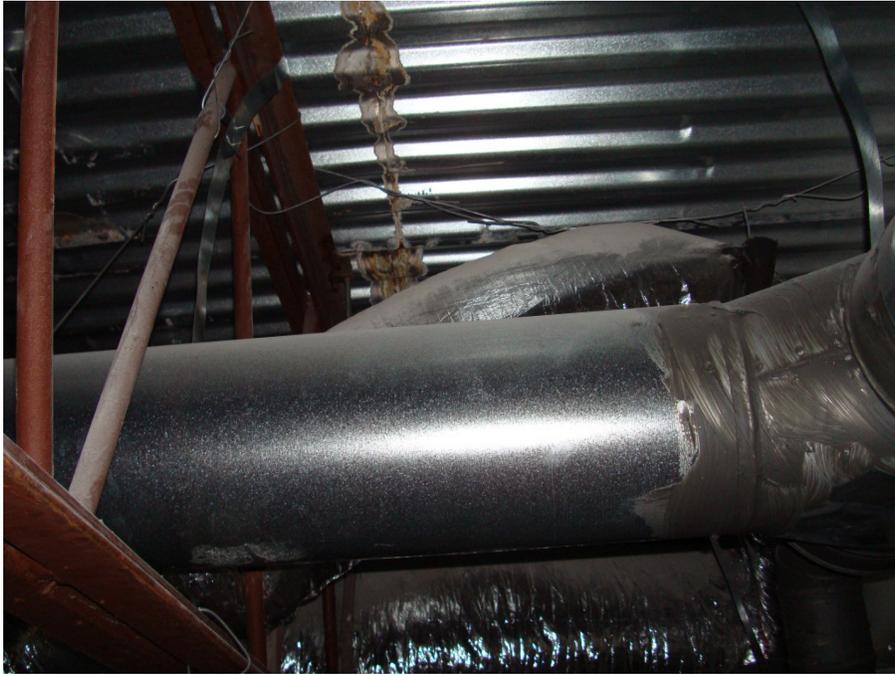
Figure 29. Rusty stain at a roof lap joint in ceiling plenum, June 2011.

Figure 30. Rusty stain at a roof lap joint in ceiling plenum, June 2011.

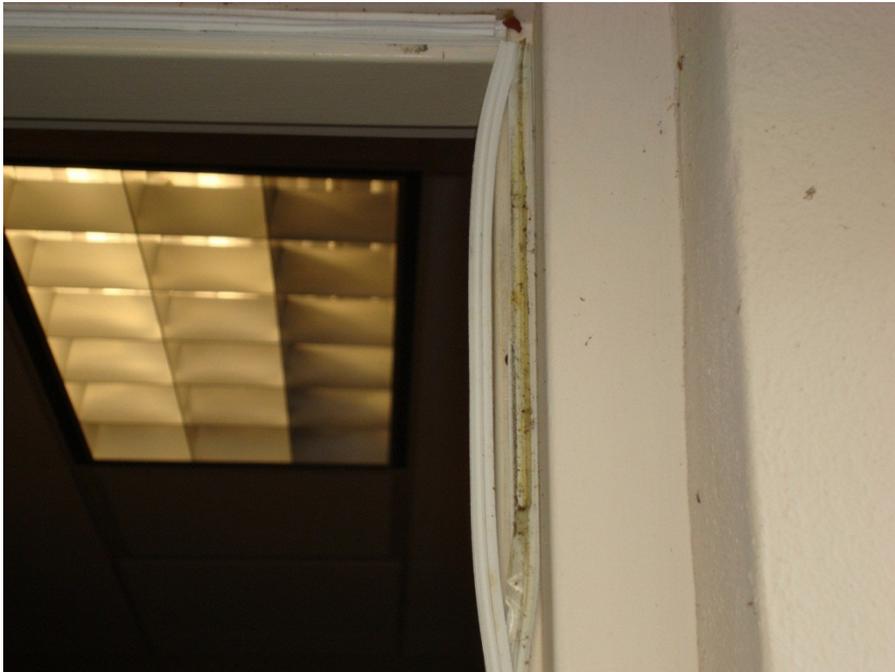
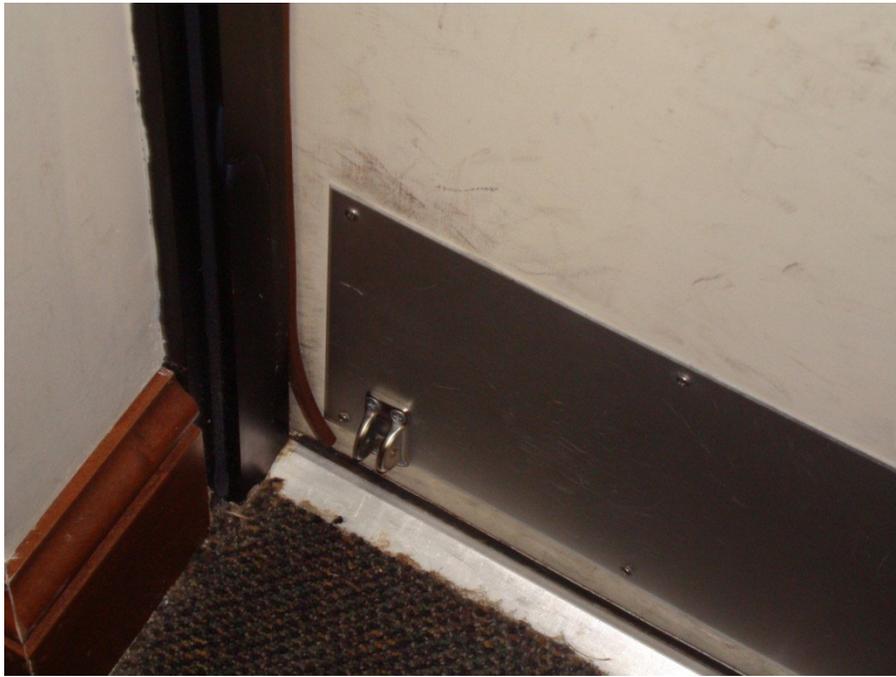
We noted ill-fitting weather stripping around both back doors (Figures 31 and 32). Canvas awnings hung above each door, to the width of the door at Hall 5 (Figure 33a) and to the extent of the adjoining windows at the door at Hall 11 (Figure 34). Building occupants reported that the canvas awnings had been installed within the prior year.

Figure 31. Ill-fitting weather stripping on Hall 5 exterior door frame, June 2011.

Figure 32. Ill-fitting weather stripping on door frame in Hall 5, June 2011.

1. Replace weather stripping around SW back door and middle back door.
2. Fix exhaust fan in men's bathroom so it was under negative pressure in relation to the corridor.
3. Determine the source of the water stain on the window sill in Room 19 and repair.
4. Remove filtration/sanitizer devices in bathrooms.
5. Implement a fragrance-free policy.
6. Walkthrough the building during and after heavy rains to check for leaks. Keep records of damp areas and repairs.
7. During remediation, use proper isolation and containment methods to minimize exposures to remediation workers, building occupants, and unaffected sections of the building.
8. Communicate remediation plans and timeline with the building occupants in advance.

The property management company had replaced the weather stripping around the exterior doors. At the Hall 5 door, the asphalt landing was replaced with a concrete landing and a wider awning was installed (Figure 33b). The southwest wall (back wall with two exterior doors) was waterproofed and a new French drain was installed along the wall. Additionally, some plants that had an offensive odor were removed and the foundation was re-graded for better drainage.

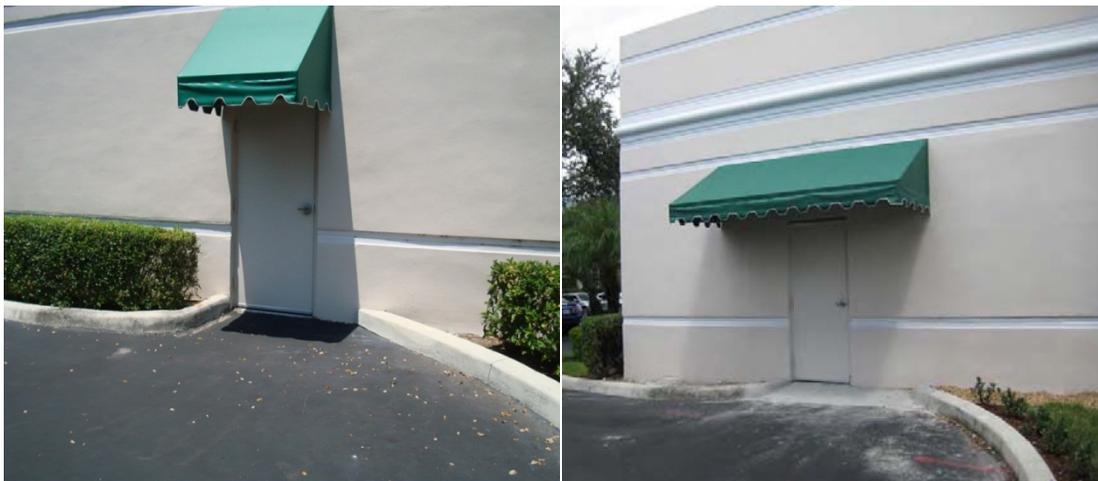
Figure 33. Awning over Hall 5 exterior door
a) June 2011.

b) September 2011 (courtesy of building manager).

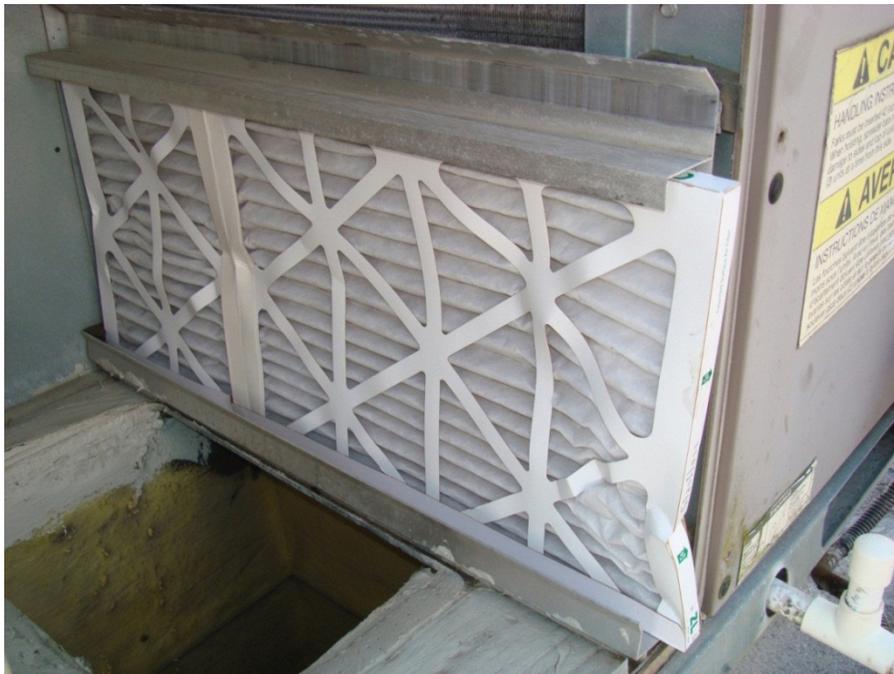
On the roof, we observed no puddling of water from the rainfall just prior to our roof inspection, and the roofing material appeared to be in good condition. We found over-sized high-efficiency filters (Figure 35) in AHU-1, AHU-2, AHU-3, and AHU-5, causing gaps which allowed air to bypass the filters. In AHU-4, condensate water from the coils was found in the filter housing base and dripping into the outside air and return air mixing plenum rather than draining correctly to the drain (Figure 36). The bottom of the filter was wet. We smelled a musty odor and observed dust accumulation and suspect mold growth in AHU-1 (Figure 37) and AHU-4 (Figures 38 and 39a) supply ducts immediately after the fans. Other supply ducts and all return ducts viewed inside the AHUs had only minimal dust accumulation (Figure 39b). We observed dusty cooling coils (Figures 40 and 41), build-up in drain pans, and rusty areas in AHUs (Figures 42-44).

Figure 35. Oversized filter in AHU-2, June 2011.

1. Ensure proper maintenance of HVAC units.
2. Replace incorrectly sized HVAC filters.
3. Develop a regular maintenance schedule.
4. Replace fiberglass ductwork for AHU-1 and AHU-4, preferably with metal ductwork with external insulation.
5. Replace or test fiberglass ducts for AHU-2, AHU-3, and AHU-5 for mold contamination.
6. Consult with ventilation engineers.

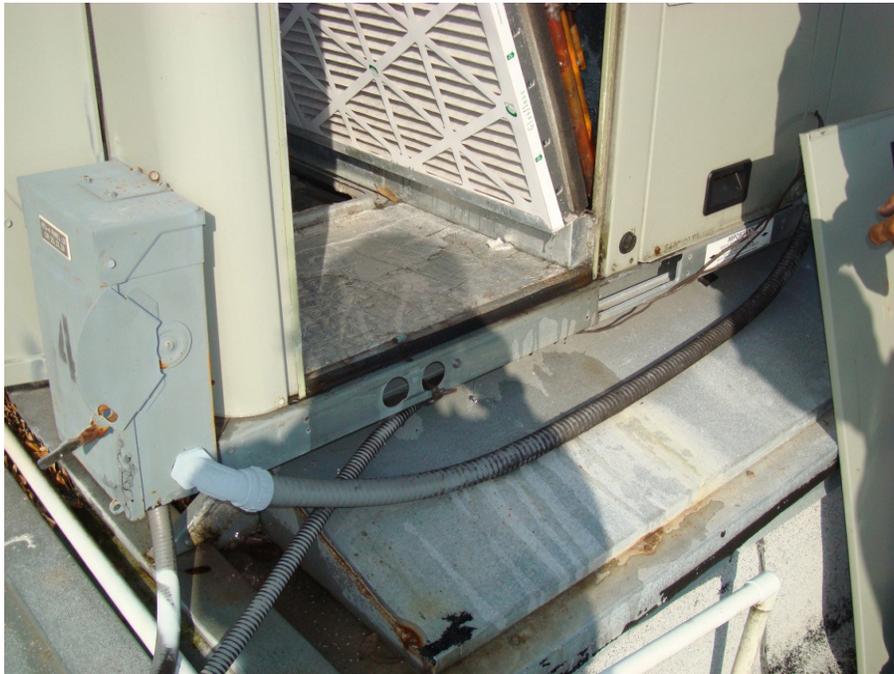
Figure 36. Water dripping into AHU-4 filter housing base and outside/return air mixing plenum, June 2011.

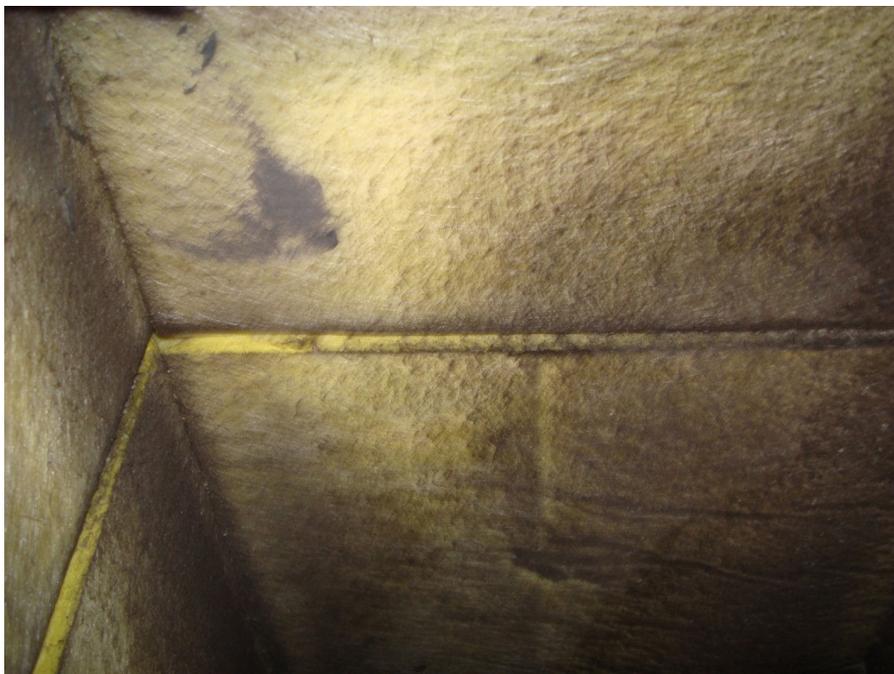
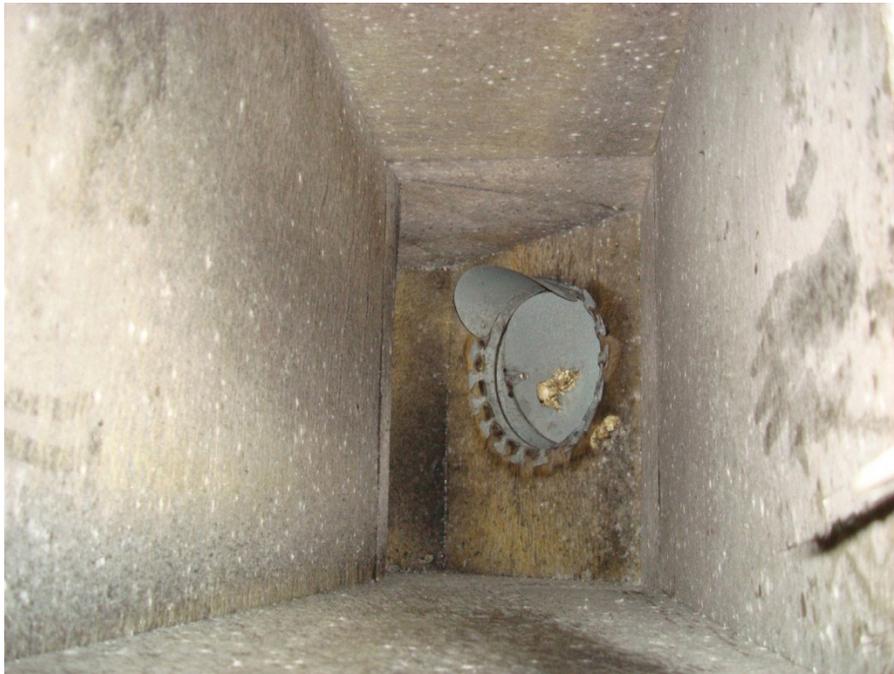
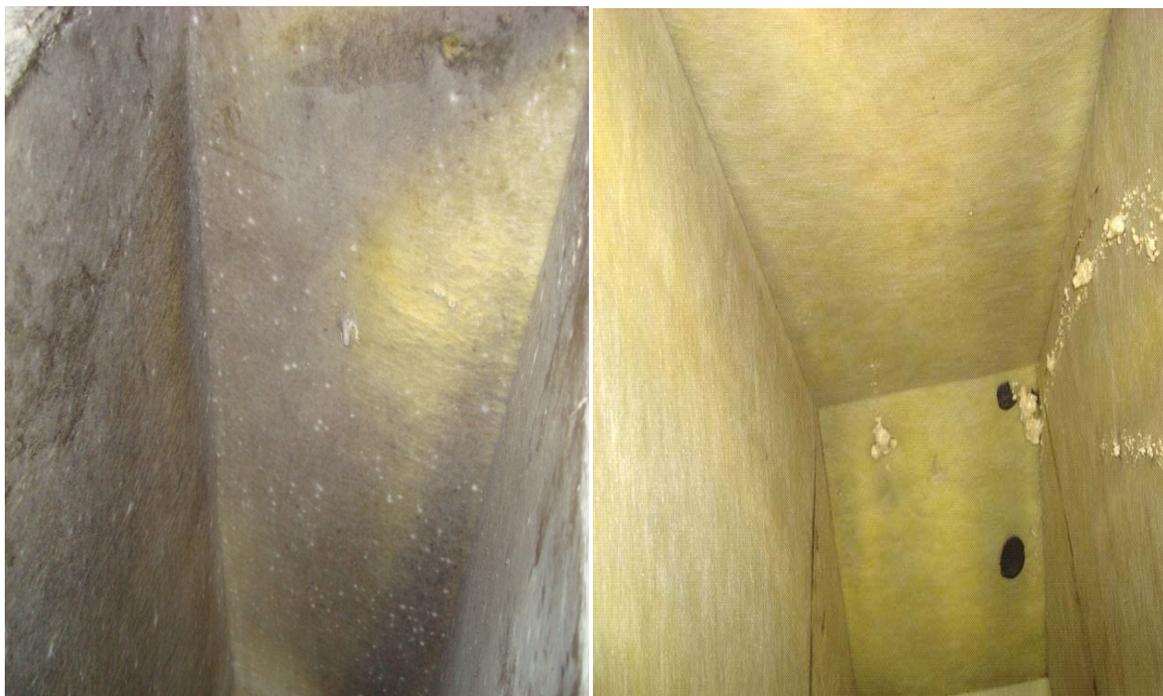
Figure 37. Inside supply duct immediately after fan in AHU-1, June 2011.

Figure 38. Inside supply duct after fan in AHU-4, June 2011.

Figure 39. Inside supply duct immediately after fan, June 2011.

a) AHU- 4.

b) AHU-2 (light spots are sealant foam).

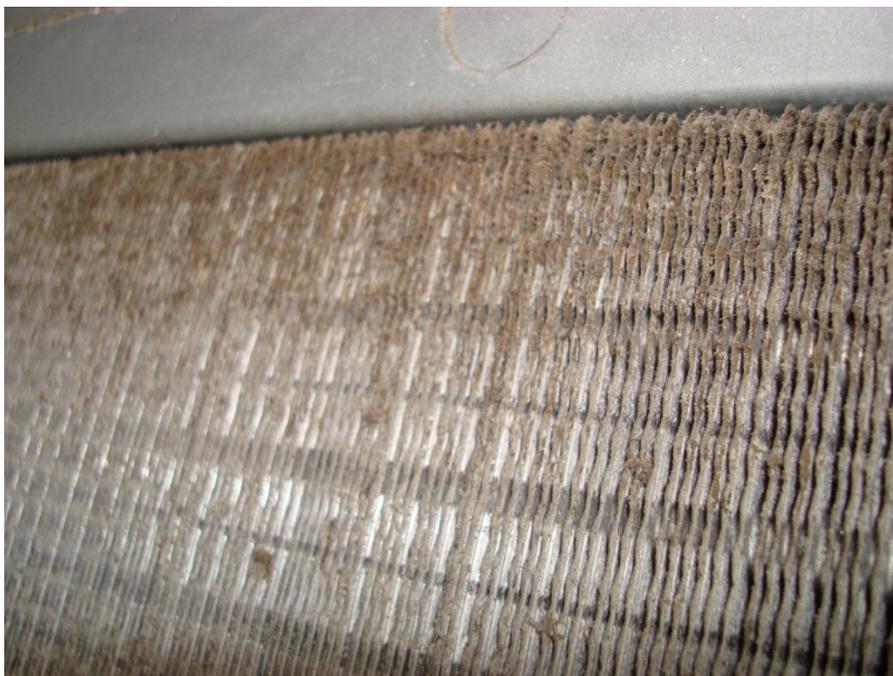
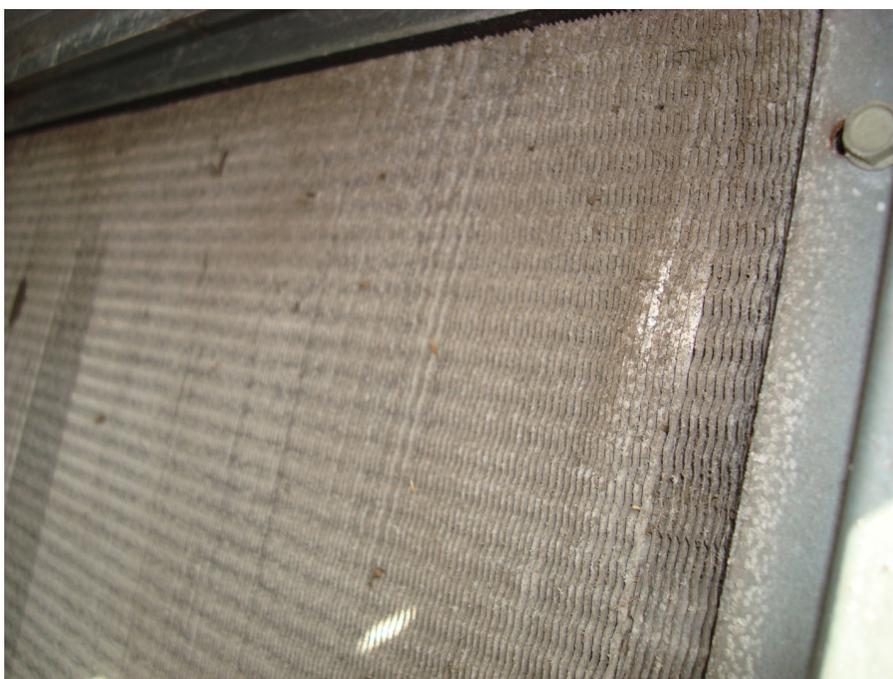
Figure 40. Cooling coil in AHU-3, June 2011.

Figure 41. Cooling coil in AHU-4, June 2011.

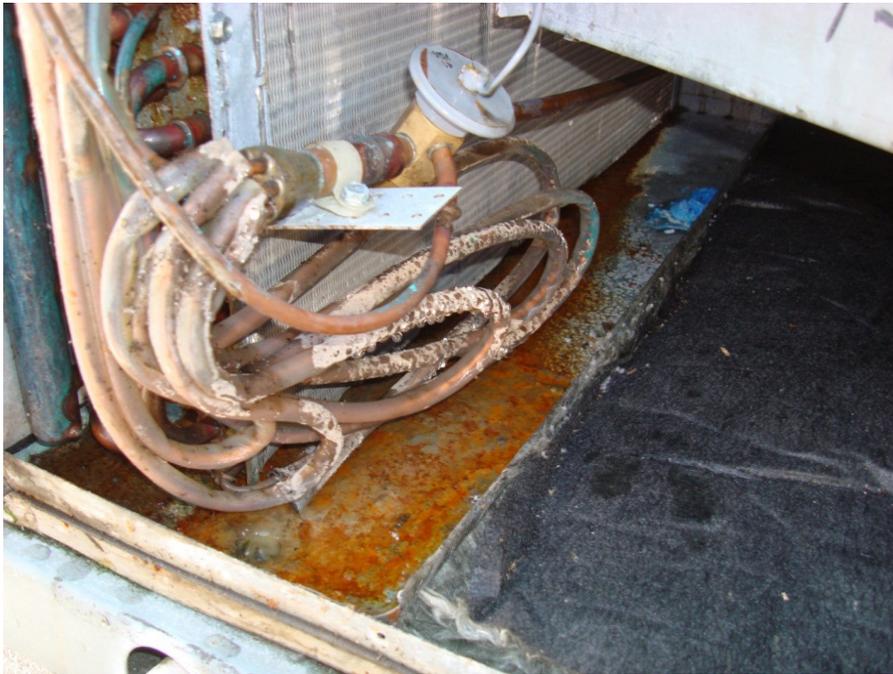
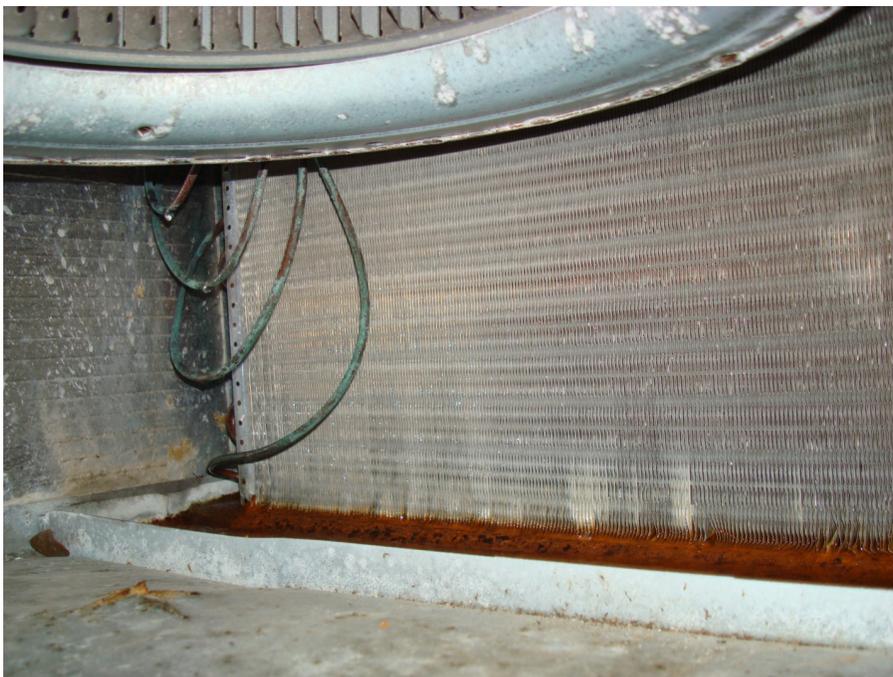
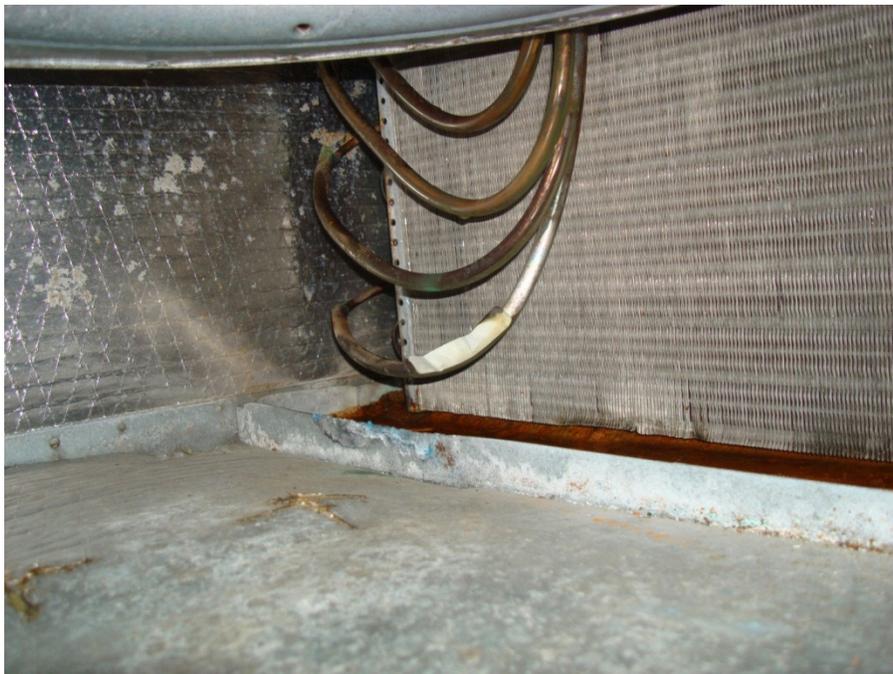
Figure 42. Inside of AHU-1, June 2011.

Figure 43. Inside of AHU-2, June 2011.

Figure 44. Inside of AHU-3, June 2011.
