Evaluation of Environmental Controls at a Homeless Shelter (Trinity Rescue Mission) Associated with a Tuberculosis Outbreak – Florida

Report No. 2012-0265-3183
July 2013

U.S. Department of Health and Human Services
Centers for Disease Control and Prevention
National Institute for Occupational Safety and Health

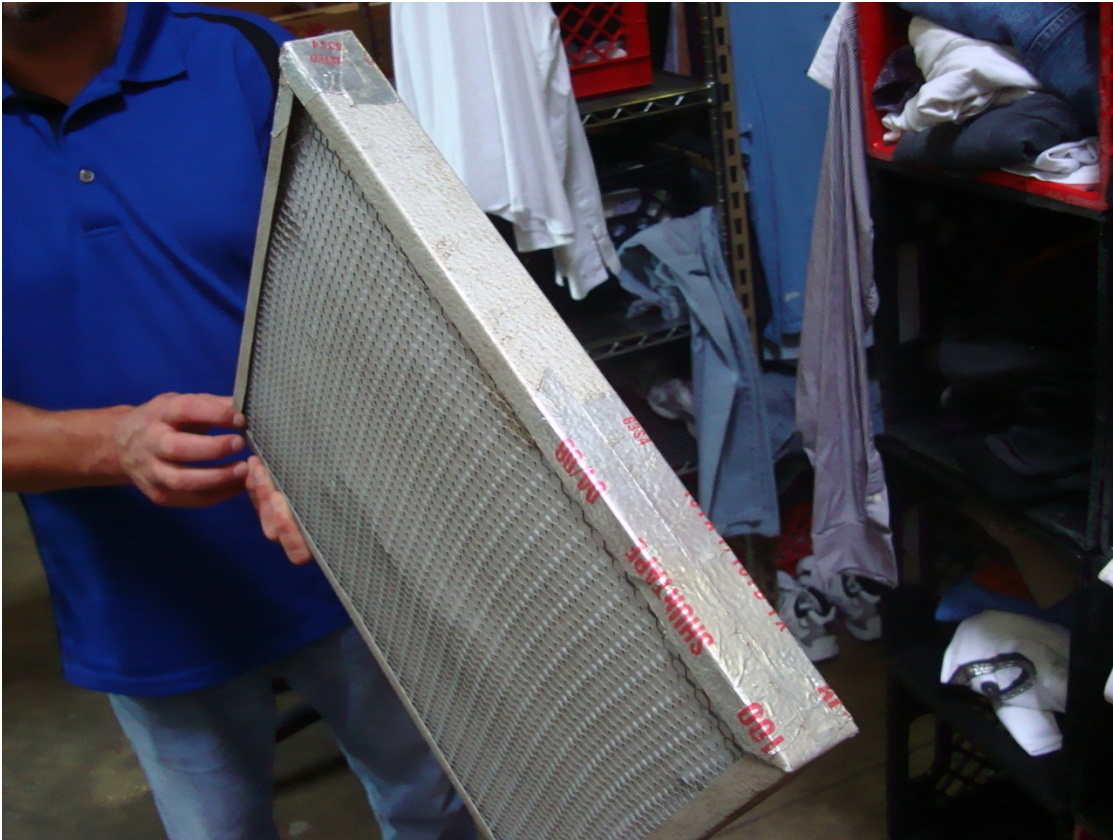
As shown in Figure 1, AHU Men-1, AHU Men-2, and AHU Men-4 had ventilation filters that appeared to be homemade and not commercially-available. Each of the AHUs had four of the homemade filters inside. While the manufacturer prescribes four filters installed in each unit, the size of the homemade filters did not match the prescribed filter size. While the homemade filters provided some level of filtration, the level of efficiency was uncertain as the deviation from intended design provided ample opportunity for filter failure and bypass. AHU Men-3 contained a set of four properly-sized disposable panel filters from Glasfloss Industries (Dallas, Texas). The Glasfloss disposable panel filters do not have a published American Soci-

ety of Heating, Refrigerating and Air-Conditioning Engineers (ASHRAE) Minimum Efficiency Reporting Value (MERV), which relates to filtration efficiency. However, disposable panel filters typically fall into a MERV range of 4 to 6, which corresponds to a removal efficiency of up to 50% for 3.0 to 10 micrometer (μm) particles [ANSI/ASHRAE 2007]. However, MERV 4-6 filters are less than 20% efficient at filtering particles in the 1.0–3.0 μm size range, which includes droplet nuclei responsible for *M. tuberculosis* transmission [ANSI/ASHRAE 2007]. All of the ventilation filters used in the Women and Children's Center were Flanders Corporation (Washington, North Carolina) EZ-Flow disposable panel filters. The EZFlow filters have an established ASHRAE MERV of 4, so their efficiency is likely comparable to the disposable panel filters described above.

The ventilation system preventive maintenance program at Trinity was coordinated by shelter administrators. With the exception of the homemade and low-efficiency filter issues, all of the AHUs were clean and appeared to be adequately maintained. We were unable to determine the frequency of ventilation filter replacement. Unfortunately, there is no written plan outlining the preventive maintenance schedules and procedures for the shelter HVAC systems. A written HVAC Operation and Maintenance (O&M) Plan should be developed. Combining all maintenance tasks, schedules, procedures, and training requirements into a written plan would help ensure that all equipment is properly maintained at appropriate time intervals and that any emergency maintenance issues are addressed correctly. Consultation with the filter media manufacturer or their vendor representative(s) should provide the recommended filter replacement frequency for inclusion into the O&M plan. A detailed plan would also help ensure that the quality of work remains consistent as staff changes. Once developed, this written plan should be revised periodically to be current with any ventilation system and equipment modifications at the facility.

Figure 1. A representative ventilation filter from inside AHU Men-1, AHU Men -2, and AHU Men-4.

- Install the highest efficiency air filters in the AHU that will still allow adequate airflow to meet the AHU's conditioning requirements. Adjust and balance the system as necessary to ensure proper air flows at all times when the room or curtain enclosure is used for respiratory separation and normal purposes. Ensure that adequate outdoor air is supplied to each space at all times (see Recommendation 2 above).
