Evaluation of Ventilation in Aircraft Maintenance and Restoration Hangars

HE Health Hazard
Evaluation Program

Report No. 2014-0067-3243
October 2015

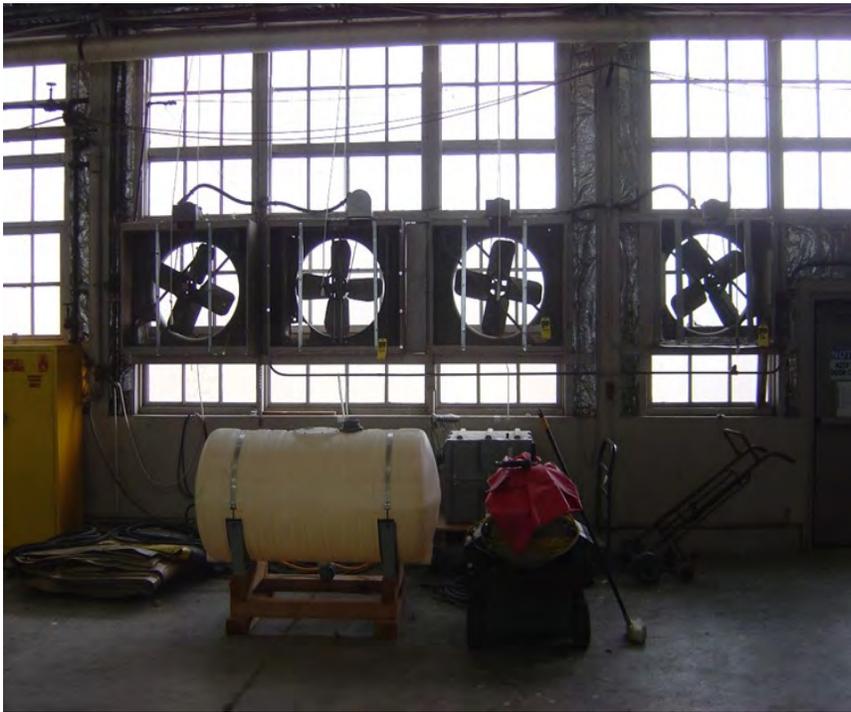
Figure 4. Photo of window-mounted wall exhaust fans inside a restoration hangar. Photo by NIOSH.

The restoration hangars have variable air movement created by portable cooling fans, which provide some comfort during warmer days. However, the inoperability of the window-mounted exhaust fans may lead to a buildup of air contaminants. Because the air movement

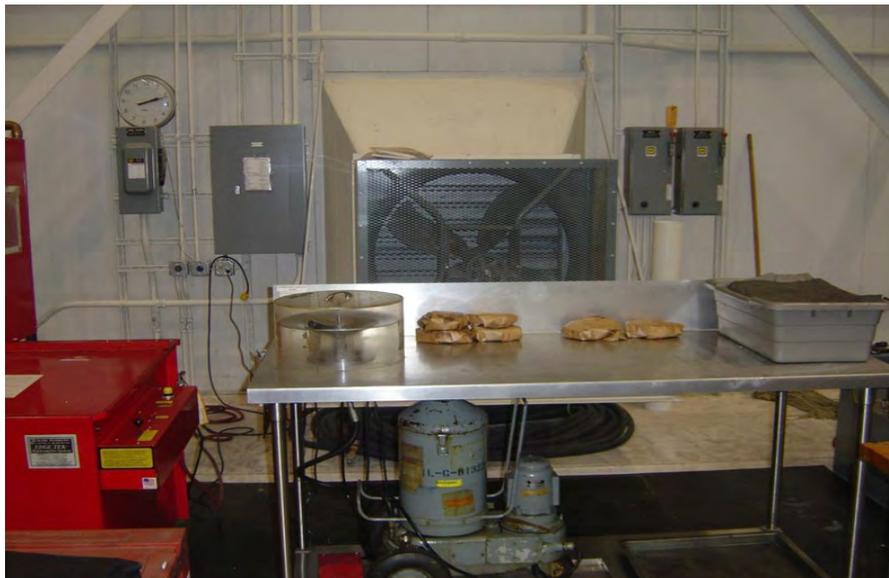
Upon closer investigation, we found in each maintenance hangar a supply air fan that was either not functioning or had a louver stuck in the closed position. Additionally, we noticed tables, equipment, and hangar supplies that were blocking some of the exhaust fans (Figures 10 and 11). When any fan is blocked, the air velocity is reduced, and the flow pattern becomes more turbulent. Such effects are shown in Tables A1 and A2 as well as Figures B1 and B2. Air velocities were always higher on the supply side of the aircraft than the exhaust side because the supply air fans were not blocked. These fans also operated closer to design specifications. The lowest air velocities were above the aircraft, which can be attributed to the supply air fans being oriented downward towards the floor. Ideally, the air from individual supply fans would spread and combine to create a consistent air mass that would “wash” the entire aircraft work zone and move air towards the exhaust fans.

Figure 10. Photo of table and equipment blocking exhaust fan outlet. Photo by NIOSH.

1. Move equipment and supplies that block any fan so that airflow is not impeded.

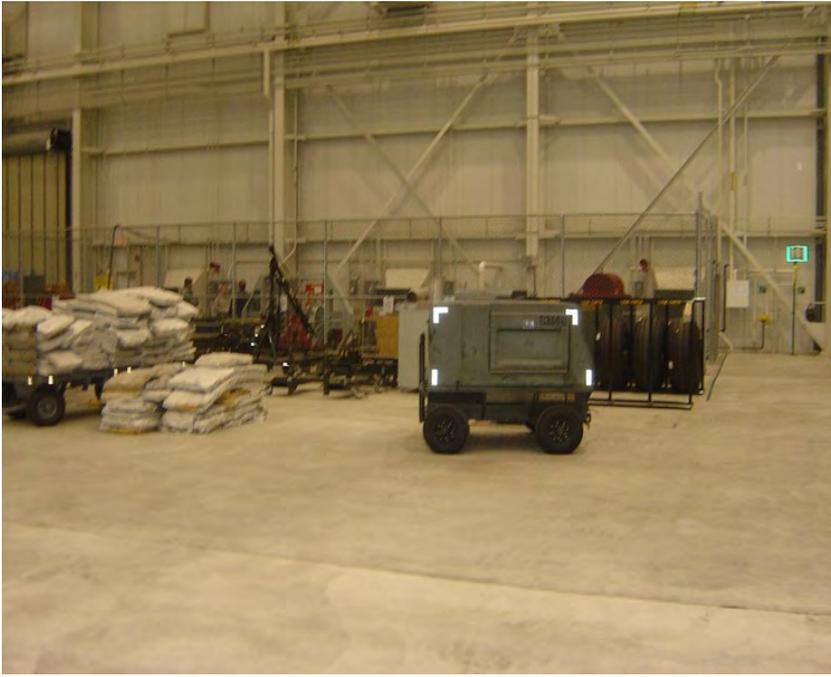
Figure 11. Photo of fenced area blocking three exhaust fans. Photo by NIOSH.

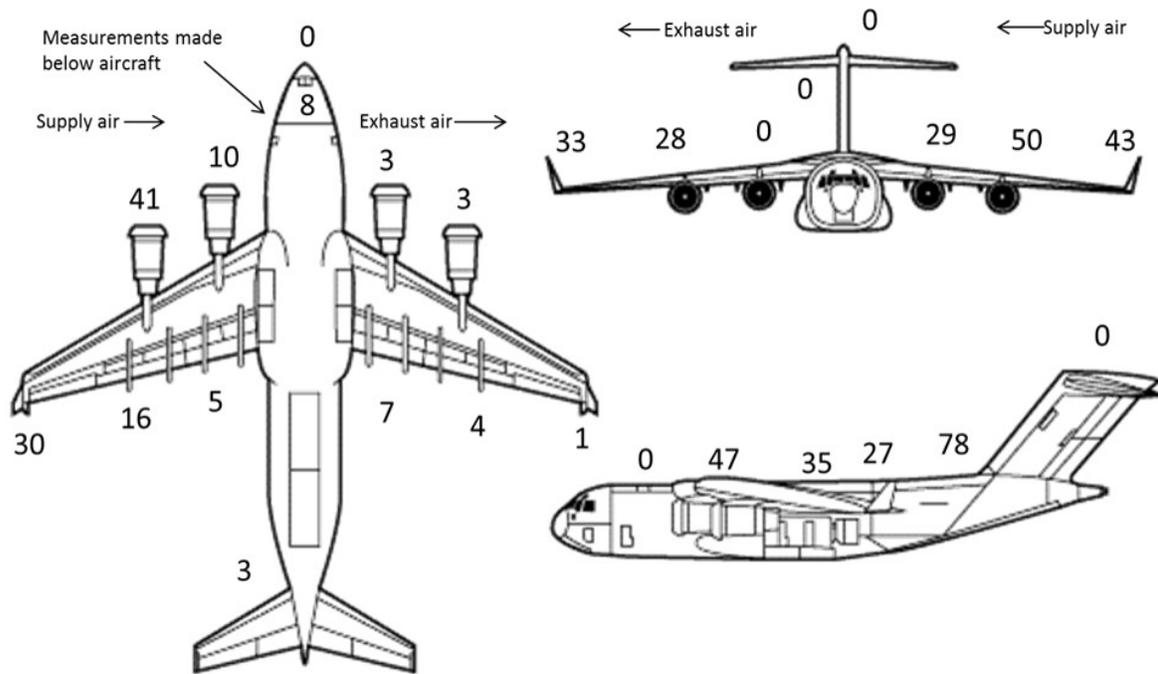
specification. Air velocities around the C17 aircraft in building 4015 ranged from 0 to 78 feet per minute (Figure B1). Air velocities around a C17 aircraft in building 4016 ranged from 0 to 227 feet per minute (Figure B2). Clearly, there were areas of no air movement (confirmed by the smoke tests) and areas where the air from a supply fan reached the aircraft work zone. Most areas of little to no air movement were noticed in the area above the wings and fuselage and also on the exhaust fan side of the aircraft (Figures B1 and B2).

Figure B1. Building 4015: Air velocity in feet per minute around C17 aircraft.

1. Repair, adjust, and maintain all fans associated with the ventilation system in the maintenance hangars. Two supply fans, one in each maintenance hangar, were inoperable while another unit had louvers stuck in the closed position. The ventilation system should operate according to design specifications. Once the fans are repaired, test each fan to verify proper operation according to design specifications.
2. Repair the exhaust fans in the windows of the restoration hangars and perform area and personal air monitoring for possible air contaminants associated with each work task.

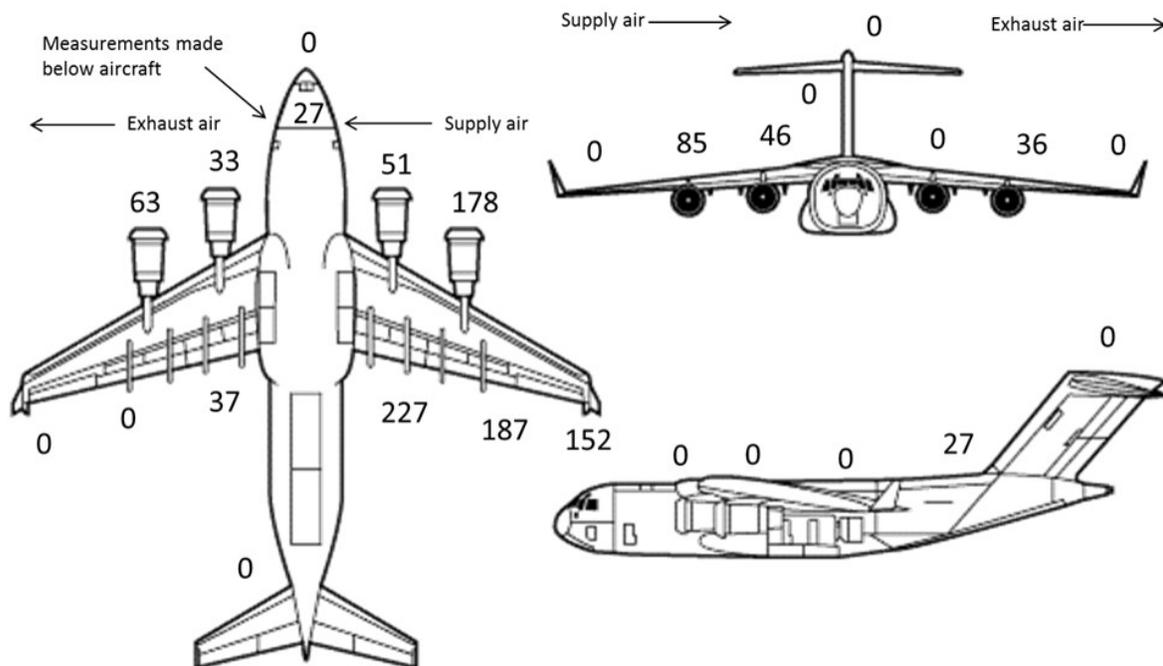
Figure B2. Building 4016: Air velocity in feet per minute around C17 aircraft.

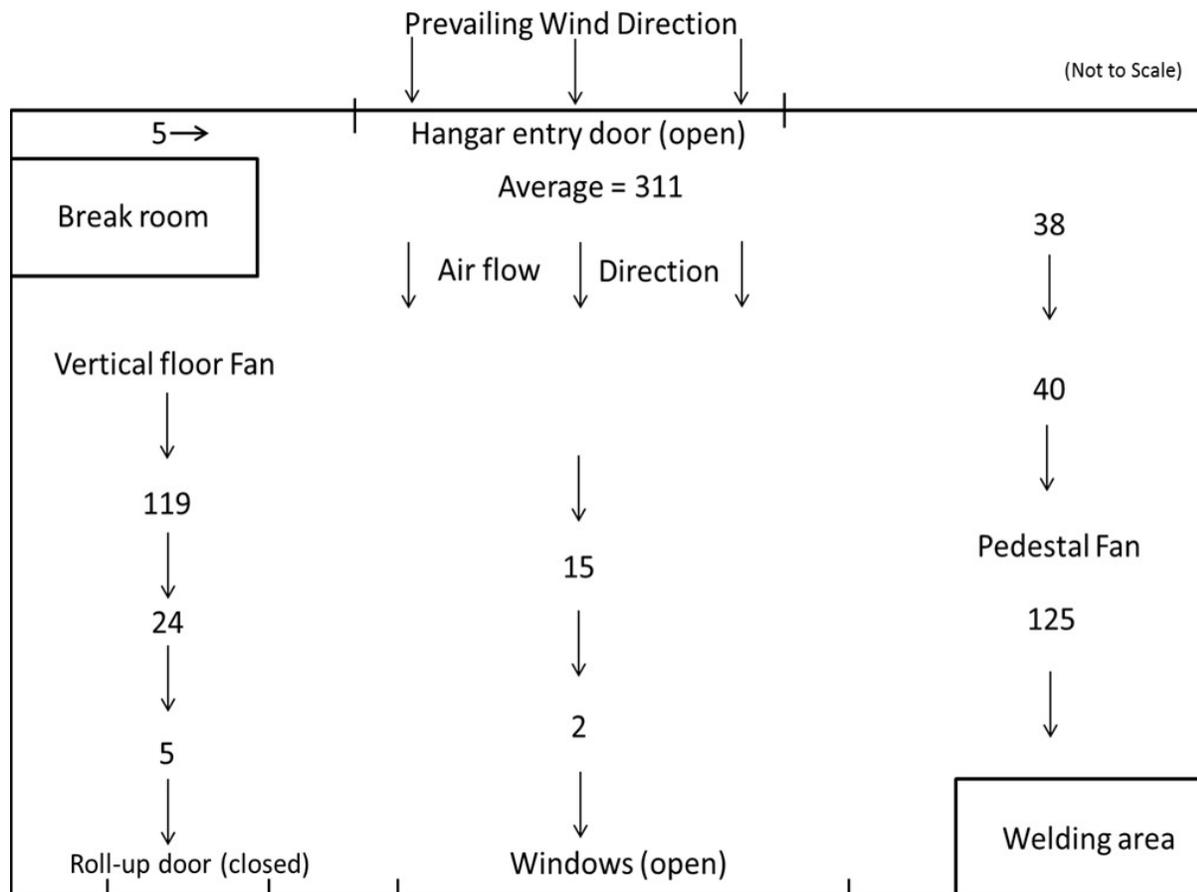
Airflow patterns and velocities were highly variable within both restoration hangars (Figures B3 and B4) as a result of the absence of a conventional supply and exhaust ventilation system. Also, the use of portable fans of different sizes in different locations resulted in variable air velocities and increased turbulence. In general, air velocities decreased with distance away from each fan, with the lowest values measured near the back wall of each restoration hangar.

Figure B3. Building 20004 C: Air velocity in feet per minute in restoration hangar.

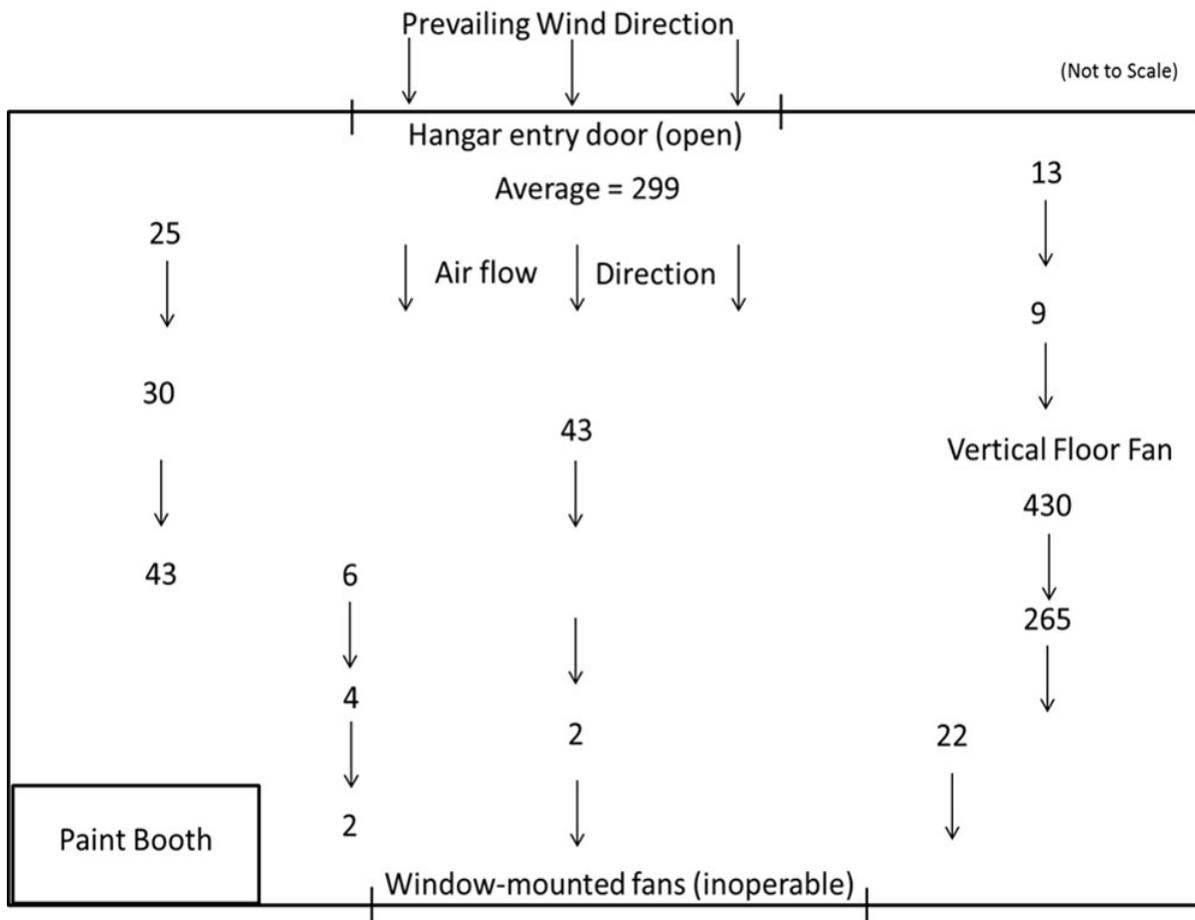
Figure B4. Building 20004 D: Air velocity in feet per minute in restoration hangar.
